Corrosion and Erosion in Pulverized Coal based Fluidized Bed Combustion Boiler in Power Plants

This paper describes the investigations carried out on wear due to corrosion and/or erosion occurred in captive thermal power plant using FBC boilers for their steam requirement.

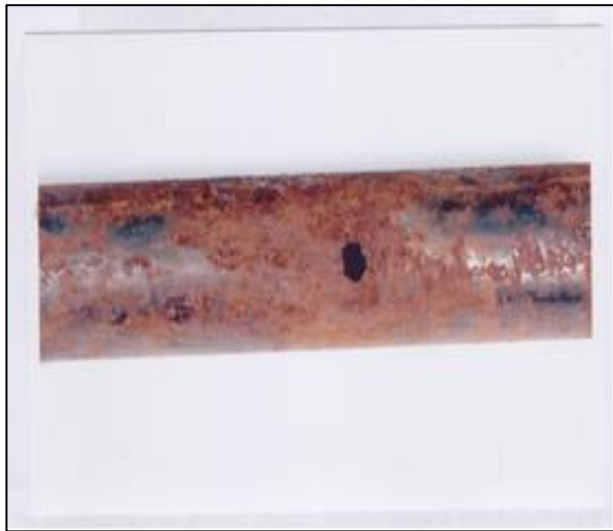
Fig 1: Macrograph of Sample 1

Sample 1 is collected from re-heater [Fig. 1]. A hole from fireside but no material loss is visible. After cutting tube along axis localized corrosion around the failure is visible that is due to oxygen pitting. In pitting corrosion small area is attacked because it becomes anodic to rest of surface or because of localized concentration of corrosion contamination in water. Pitting that occurs at relatively few and scattered sites can result in rapid perforation because of large ratio of cathode to anode area.

The causes of failure in the tubes under consideration are of various types as discussed here. The main cause of failure of the sample 1 is corrosion which is further due to oxygen pitting. Due to this localized corrosion the material of the tube is lost and resulted in a perforation.

From above discussion it can be said that the failure in this unit of captive power plant are due to oxygen pitting, steam impingement and the formation of iron oxide. In three out of four samples collected the main cause of failure is corrosion. Improved material with higher chromium percentage is the replacement for above tubes as presence of more than 10 percent of chromium in steel alloy helps in preventing corrosion.

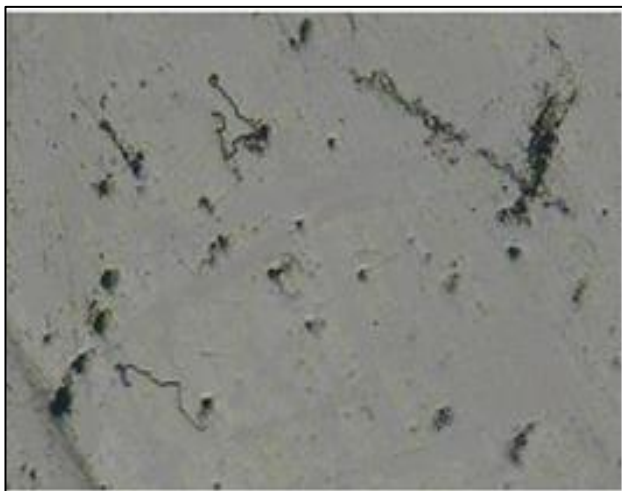
Fig 2: Micrograph of Sample 1

Micrograph and SEM are taken which also suggest presence of corrosion particles [Fig.2 &3].

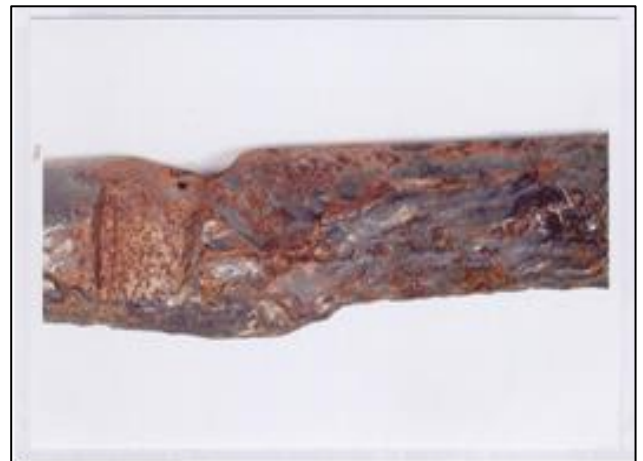
Fig 4: Macrograph of Sample 2

Sample 2 is collected from super-heater. No corrosion products are visible on fireside of the tube but the surface is highly eroded. A large welding patch and two holes are present. On cutting the tube along the axis two holes much bigger in size as compared to earlier ones beneath the weld patch are clearly visible. Around all these perforations protective oxide layer is washed away. The macrograph of tube is presented in Fig. 4 and cut section is shown in Fig 5.

Sample 2 is failed due to the impingement of steam on the hot outer surface of the tube. The steam had come from some parallel tube due to leakage. The four perforations i.e. point of failure in a short length of 2.5 inches suggests that usual failures are there in this region of Super-heater. The failure in this sample is due to steam erosion.

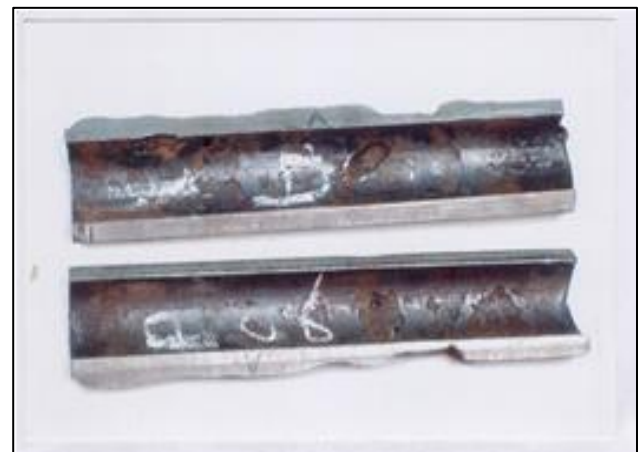
Fig 5: Cut Section of Sample 2

In the tube length of about 2.5 inches there are four points of failure which suggest that failure in the regions of super heater from where sample is collected usually occurs and steam leaked from these perforations strikes on the hot outer surface of other tubes and damage the same. This type of erosions is due to steam impingement. Erosion involves impact of large numbers of small solid or liquid particles against the surface or is caused by gas filled bubbles in a cavitating liquid. Liquid impingement erosion occurs chiefly in components that are subjected to high velocity flow of wet steam. Among the components most susceptible to liquid impingement erosion is steam piping condenser and heat exchanger tubes

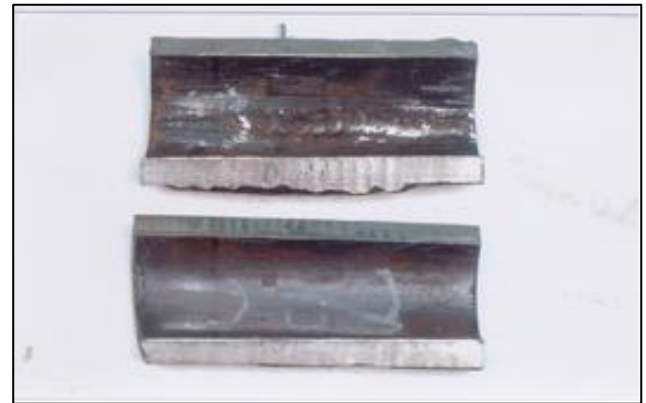
Fig 6: Cut Section of Tube 3

Sample 3 is collected from platen super heater which makes the part of ceiling of the boiler. Very small erosion and welding patch are present on outer surface of tube. From this it can be inferred that the failure does not occurred from fireside of the tube. The cut section of the tube is presented in Fig 6.

An oval hole, which was earlier welded from outer side and narrow longitudinal splits can be seen. These longitudinal splits are scale of some oxide of iron. The failed

tube has minimal swelling and longitudinal splits that are narrow. For this type of symptoms the cause of failure is long term overheating occurred for a period of months or years. To confirm the presence of oxide of iron in the scale present on the inner side of the tube, the X-Ray Diffraction Analysis is performed, which is presented in Fig. 7. The presence of Fe_2O_3 as revealed by XRD is further evidence of formation of corrosion products.

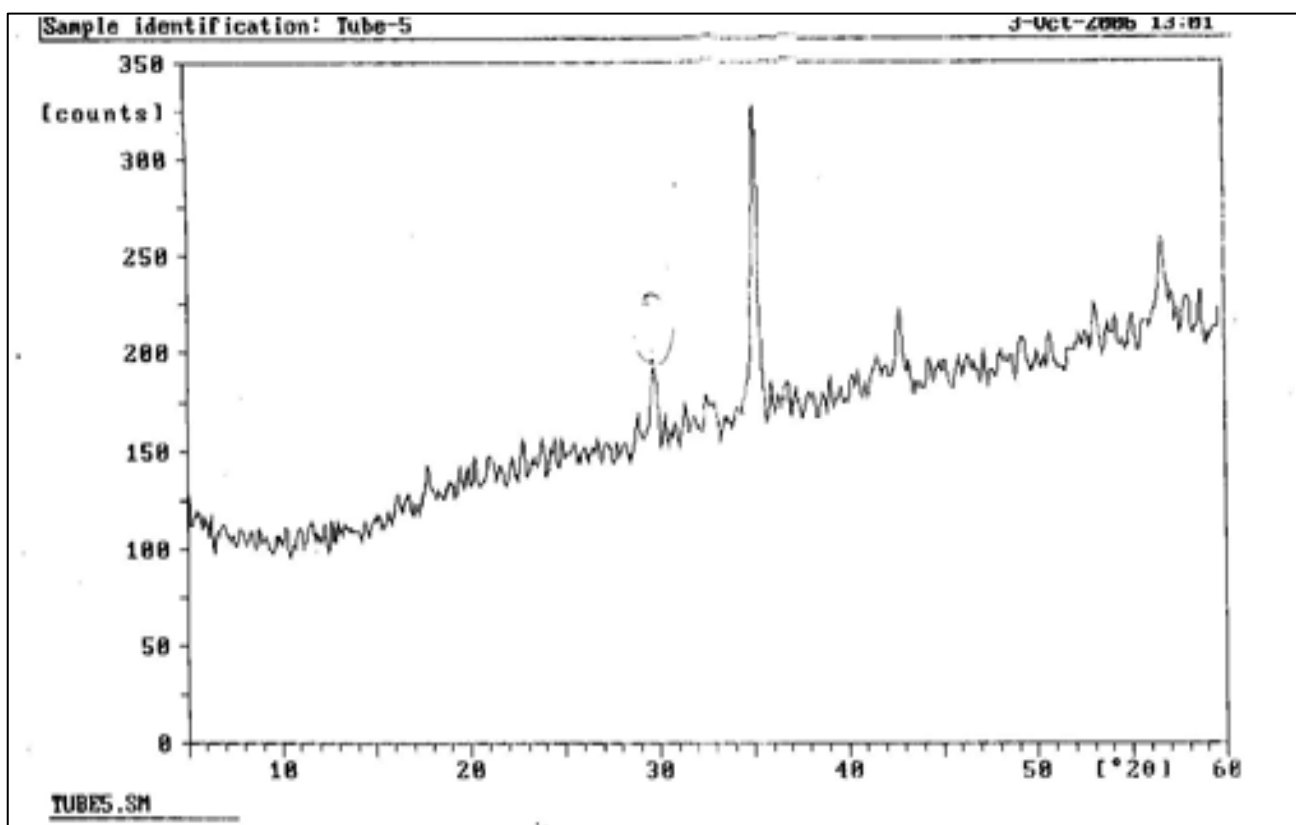
Fig 7: XRD Plot of Sample 3

Sample 3 and 4 are failed due formation of compound of iron and oxygen i.e. Fe_2O_3 . If it were reacted with any other compound to form Fe_3O_4 , the protective oxide of iron then the life of the sample may have increased.

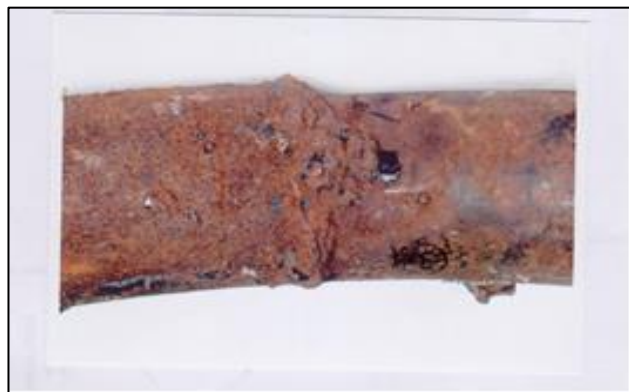
Fig 8: Macrograph of Sample 4

Sample 4 is collected from water wall section of captive boiler. A small hole and a weld patch are clearly visible. The presence of weld patch means earlier failure of tube. Near the point of failure erosion of tube material is visible due to which thinning of wall took place but no thinning is present around the fracture surface. The material removal from fireside may be due to erosion by hard unburnt coal particles

along with silica from furnace bed, which strikes the wall along with flue gases. The macrograph of tube 4 is presented in Fig. 8.

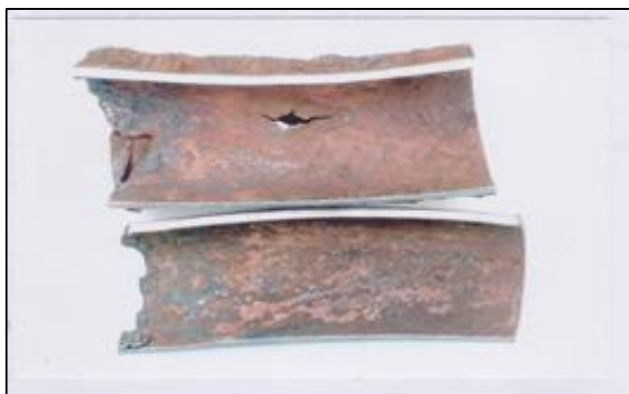
Fig 9: Cut Section of Sample 4

The tube is now cut along the axis. After cutting the tube a fracture is visible on which steel plate was earlier welded from fireside of tube. The crack is about 30 mm along the axis of tube and is having maximum dimension of 7 mm along lateral axis of tube. The cut section of sample is presented in Fig. 9

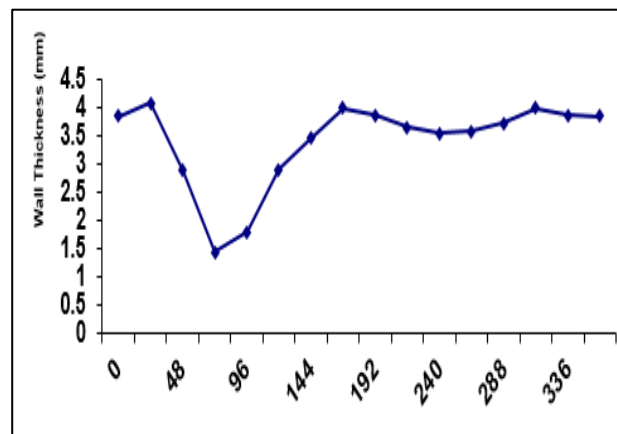
Fig 10: Plot of Wall Thickness versus Circumferential Angle

The plot of wall thickness versus circumferential angle is presented in Fig. 10.

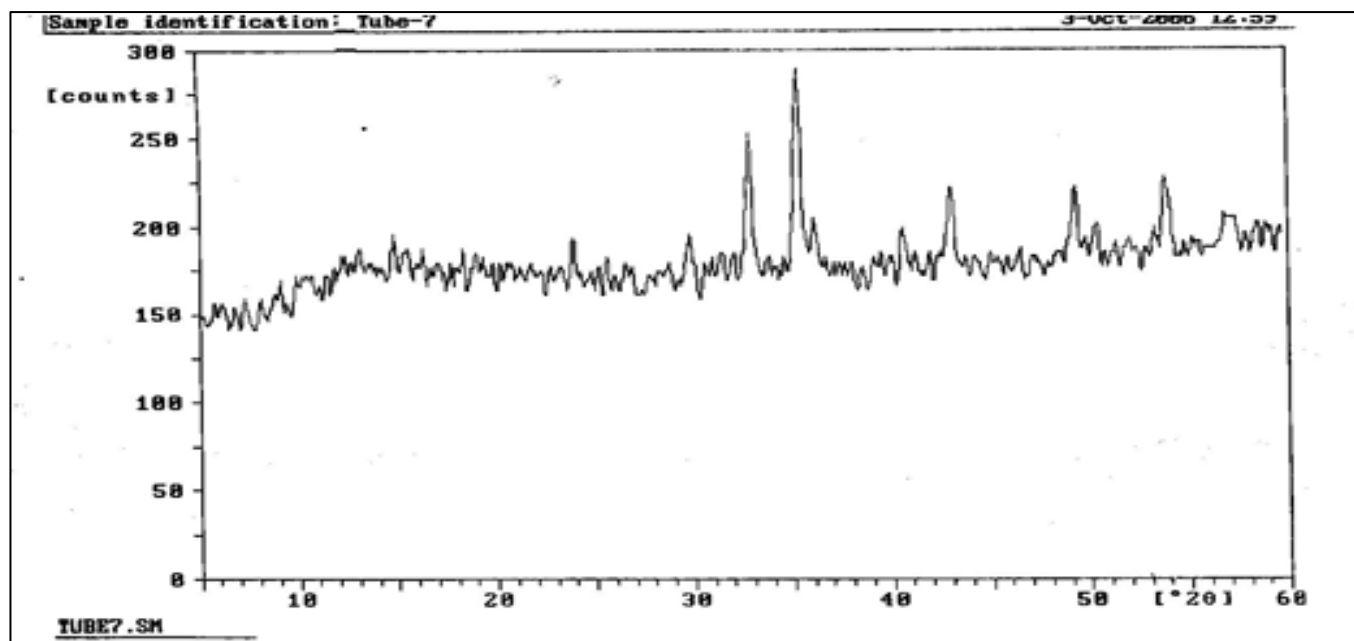
Fig 11: XRD Plot of sample 3

The dark brown coloured oxide is scratched from the inner side of the tube for X Ray Diffraction analysis.

The presence of Fe_2O_3 as revealed by XRD is further evidence of formation of corrosion products.
