Analisis of the Centrifugal Exhaust Fan Damage on Line Painting

Ahmad Hipni¹, Jimmy Sabar HP Sitanggang², Erry Rimawan³, Humiras Hardi Purba⁴, Choesnul Jaqin⁵
^{1,2,3,4,5}Master of Industrial Engineering Program
 MercuBuana University, Jakarta, Indonesia

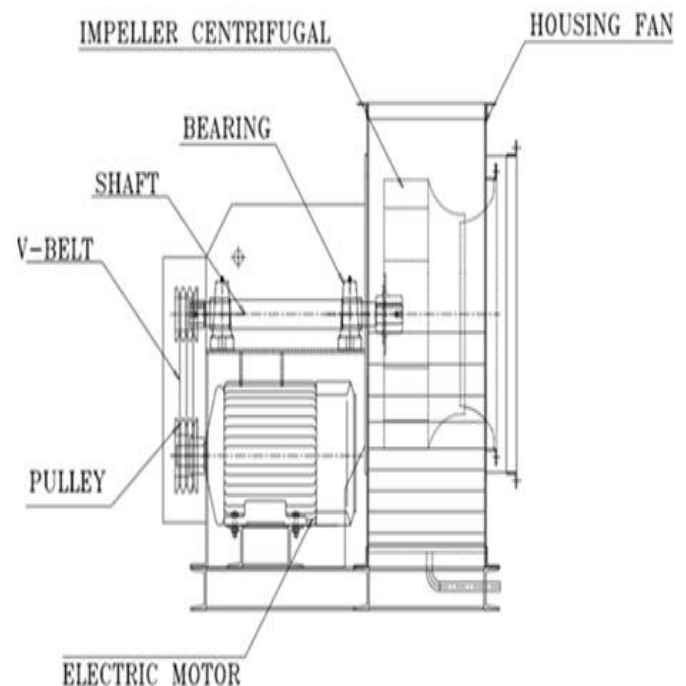
Fig 1:- Components on centrifugal exhaust fan
 (Source : Data Of Drawing Koba Multi Indonesia, PT)

From the above picture, it can be seen that the centrifugal exhaust fan on the line of paintings is often subjected to problems because the impellers are bricks with housing causing the cause of the impeller. In general, if this happens, the replacement of the bearing frequency is made faster than the maintenance schedule of the centrifugal exhaust fan. This study is conducted to improve centrifugal exhaust fan lifetime by maintaining the reliability of the centrifugal exhaust fan from possible damage. The problem discussed in this study is to determine the type of damage that occurs in the centrifugal exhaust fan, analyzing how this damage can occur and provide an accurate solution to the damage.

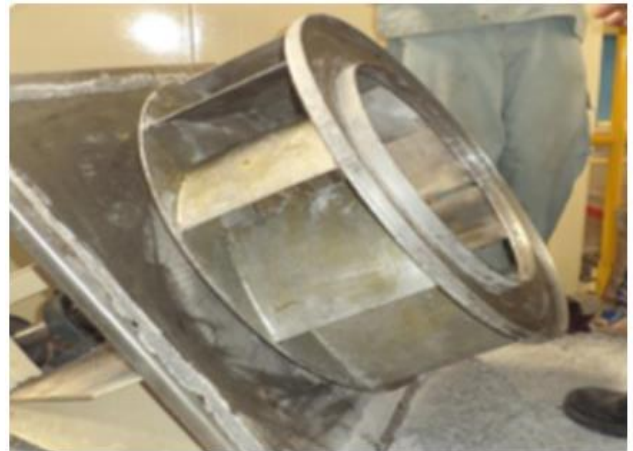
- Impeller damage is usually caused by friction with housing fans and impeller corrosion due to air containing chemicals. This is the flow of noise and vibration on the exhaust fan becomes larger. As can be seen in Figure 5

Fig 5:- Centrifugal impeller

No	Part Item	Repair And Maintenance
1	Impeller	* Clean every 2 weeks * Fix the impeller if the condition is lightly damaged * Replace with the new impeller if the old impeller can not be repaired
2	Bearing	* Lubricate the bearing periodically * Bearing installation follows the instructions
3	Motor	* Check the vibration on the motor regularly
4	Pulley	* Check the pulley condition if there is a crack immediately replaced
5	V-Belt	* Check the condition of V velt, if there is a crack and break immediately replace

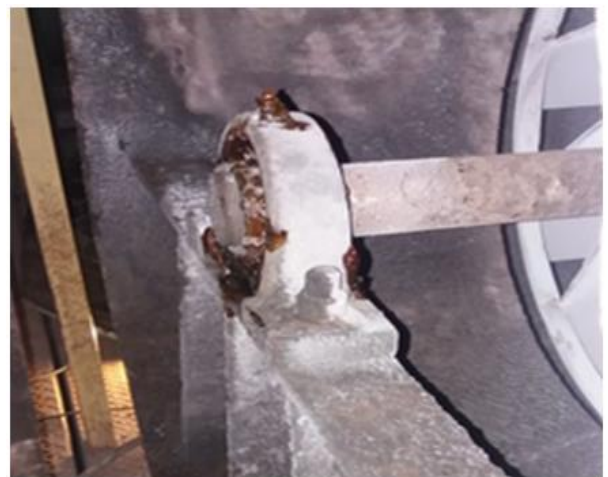
- Damage to the bearing in the form of lubrication in the interior, damage in the form of longitudinal cracks towards the center of the outer bearing, scratches and deformation on the surface due to friction and effect can be seen in Figure 6.

Fig 6:- Fillow Block Bearing

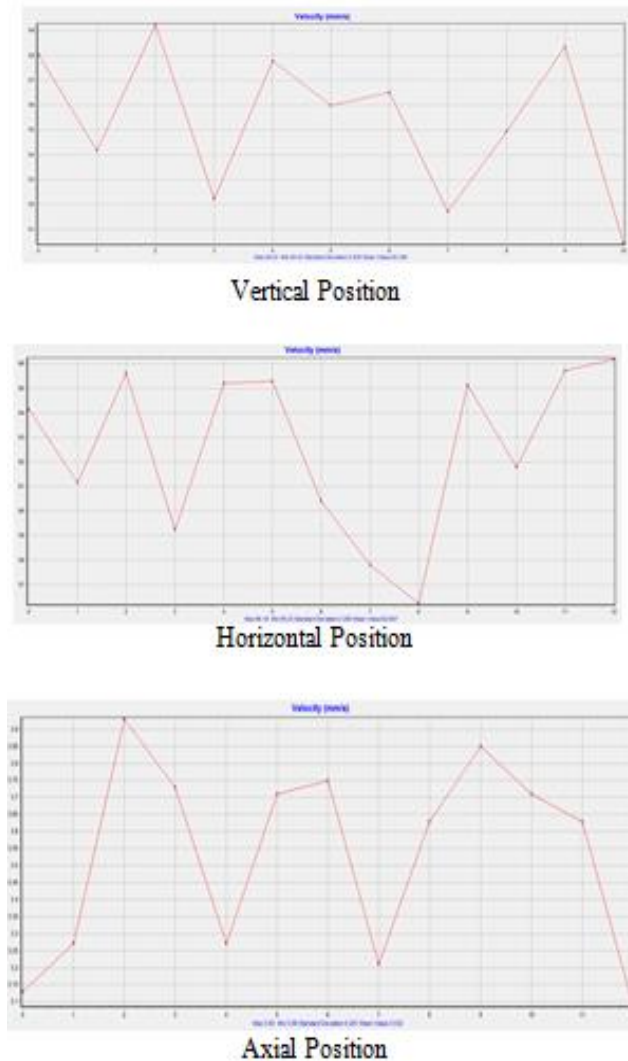
Fig 7:- Vibration chart measurement results

The vibration spectrum graphs on the bearings and motors as shown in Figure 6 show that the position of the vertical velocity vibration is still in the red column with a value of 55.395 mm / s. While in horizontal position also exceeded the permissible safe limit or red column based on ISO 2371 with value 62.607 mm / s. Although the axial velocity vibration position is still in a safe limit with a value of 3,532 mm / s. From the trend chart shows the breakdown of the bearing on the bearings where the large amplitude appears in the vertical position then increases the horizontal position and decreases in the axis. This indicates that there is damage to the bearing and impeller disconscience.

From the above table it can be seen that the exhaust fan has some indication of damage, but the most dominant damage symptom is the bearing that causes vibration and unbalance, where the damage symptoms are seen in the horizontal and vertical position of the bearing exhaust fan that has the highest vibration value compared to axial position, which is 62.607 mm / s. In addition, the signs of damage are damage to the rusty impeller.

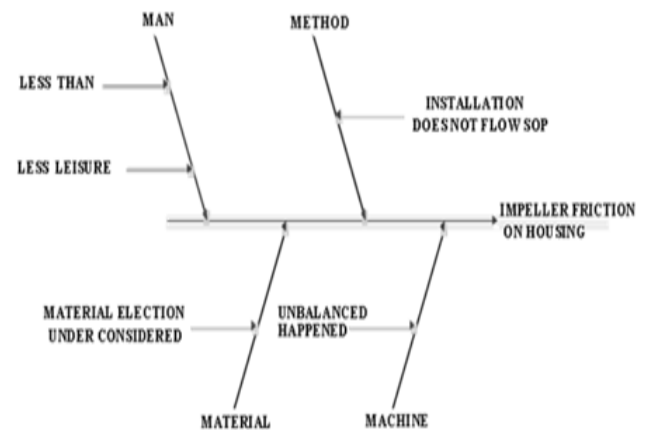
Fig 8:- Ishikawa Diagram Impeller With Housing

Analysis of the root causes of friction between impellers and housing using the Ishikawa diagram as shown in Figure 8, where friction can occur due to several things such as errors in installation, failure of the shaft, failure of the bearing, and unbalance. From the checks that have been done, it is known that friction between impellers and casings is caused by failure of the bearing. This can be seen when the disassembly of the exhaust fan turns out that the bearing is damaged and corroded due to lack of lubrication in the bearing .. Damage to this bearing causes the shaft to move forward at high speed and results in rotation of the impeller on the housing.

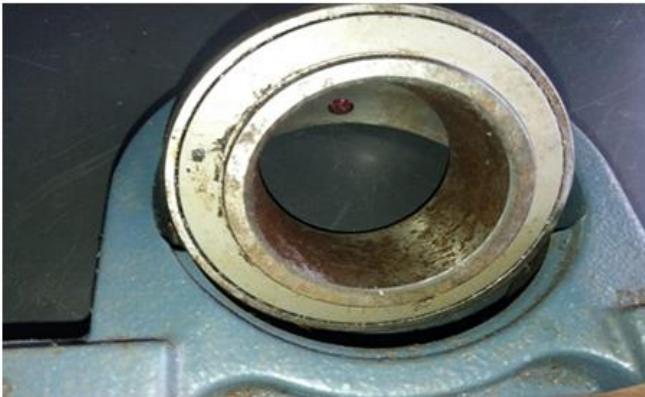
Fig 9:- Damage to Bering

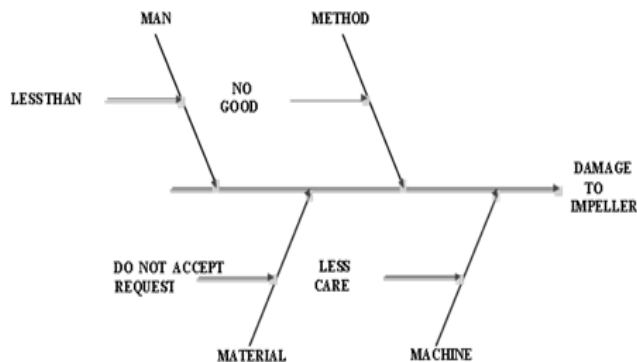
Fig 10:- Ishikawa Damage diagram on the impeller

From the inspection, it is known that impeller damage is caused by imbalance, this can be seen in the result of vibration checks where there is an indication of imbalance in the centrifugal exhaust fan that has the highest vibration value compared to other damage symptoms which causes the most dominant damage effect. An imbalance causes vibration and causes relaxation at the base, so that the bolt is damaged and released.

Based on the type of damage that occurs and the source analysis of the damage, appropriate improvement strategies can be formulated using FMEA to prevent further damage. Preparation of FMEA is focused on faulty components, bearings and propellers. For unbalanced problems, it can be done after changing the bearings while damage to the impeller can still be fixed if the damage is not too severe.

To determine the type of imbalance, you can check the value of the vibration when the motor is loaded. The vibration value is taken and recorded when the motor is controlled so that the motor load is stopped. If the vibration value decreases slowly then this indicates that the imbalance is mechanical imbalance, while electrical imbalances occur if the motor vibration value decreases dramatically as the load is stopped. From an unbalanced problem, the most important step to overcome this problem is to offset the rotor with mass repayment mass or reduce the rotor mass (drilling).

If the problem is an electric unbalance due to the motor stator coil, the rewind is done. If the imbalance problem is solved, the next step is to repair the base, and tie the bolt. This is important because these components also work to make the rigid motors also function as vibration dampers.
