Kaben Location Lagam Landslides and Preparedness Measures, Kenya

Abstract:- The Kaben Location Lagam escarpment landslides of Elgeyo-Marakwet County, Marakwet East in Kenya, are not only recurrent but are highly cataclysmic and destructive. They cause mayhem whenever they occur. The first known landslides on the Lagam escarpment of the Kaben location, occurred during the 1961 El-Nino, when a major rainstorm hit the area (Kiptungu). The landslides denudated Embosumer River and left huge boulders scattered over many farmlands. Four decades later, on the night of 12th April 2010, a catastrophic landslide once again hit Kaben location. Embosumer River was again the perpetrator, having broken its banks due to excessive water inflow from Lagam escarpment. Fourteen (14) people lost their lives, others were badly injured and lots of property was destroyed. A decade later, on Sunday, 19th April 2020, in the afternoon, heavy rains pounded the area, once more, causing massive mudslides that involved many rivers and streams. Thus, twenty six (26) people lost their lives and homes, schools and farmlands were washed away and several bodies trapped in the mudslide material. This preliminary stud

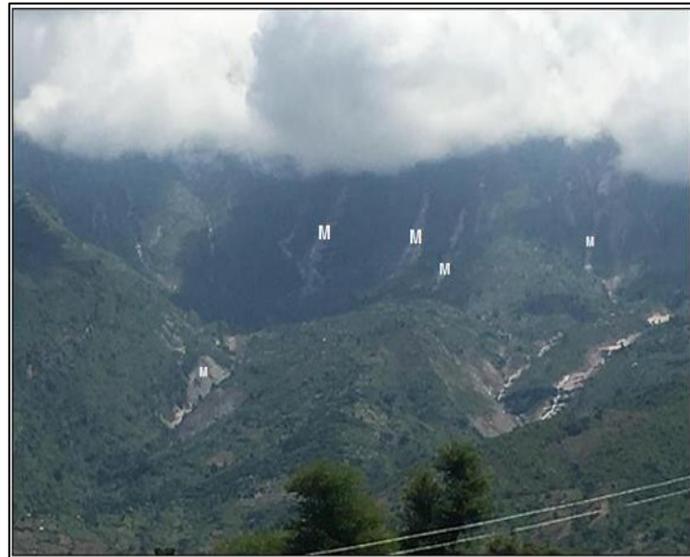
Plate 1: Embosumer and Emboreberwo Rivers on their upper sections and at source, as well as mudslides (M) paths of the Lagam escarpment (April, 2020).

The mudslides left massive scars on the escarpment and rock trails, on the river valleys and farmlands from which local residents draw their livelihood. As a result, twenty six (26) people lost their lives, when the Liter and Chesegon areas of Marakwet East and West Pokot and on the Kerio Valley floor were washed away (Plate 1).

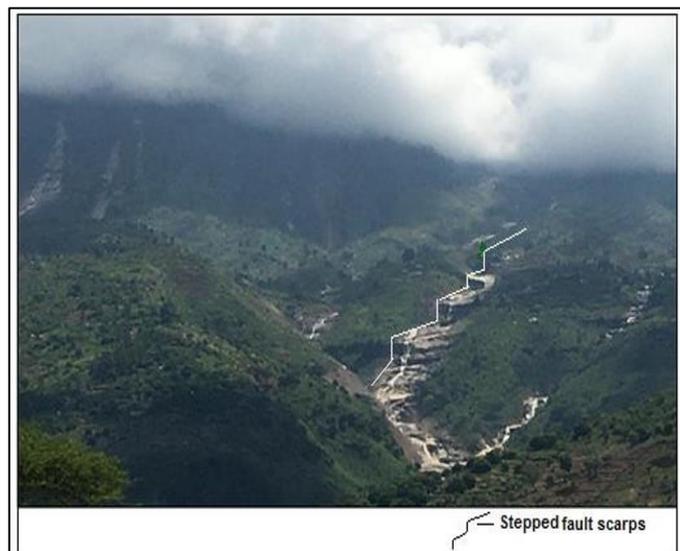
Plate 2: Emboreberwo and its post-landslide flow (April 2020).

The Rock that makes up the escarpment can be clearly seen from Plate 2.

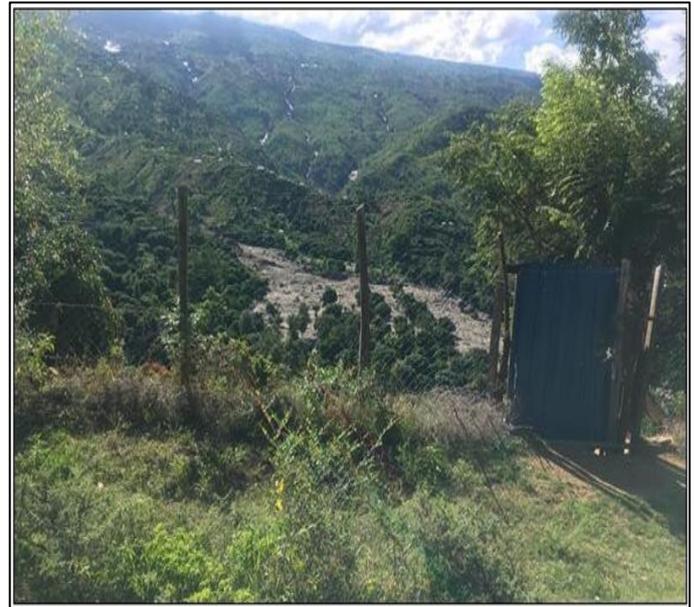
Plate 3: Farmlands washed away by the Lagam escarpment mudslides and Emb

Embosumer River on its lower section (April 2020).

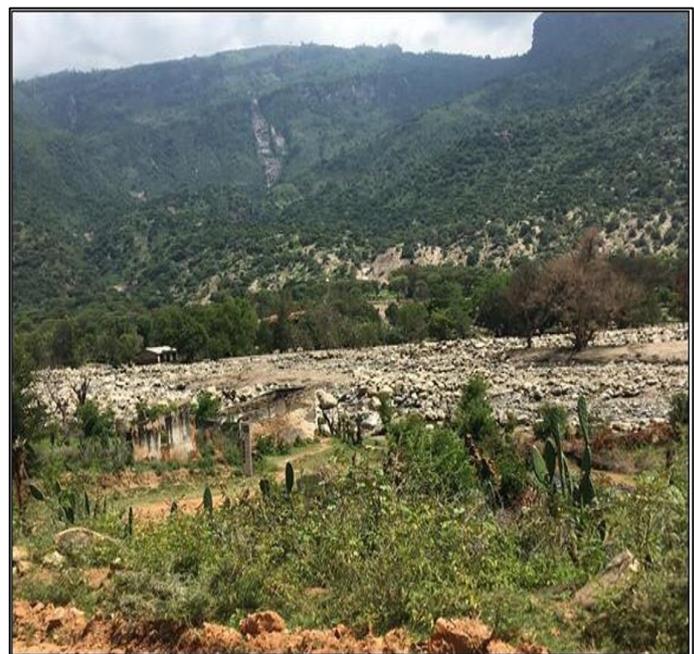
Plate 4: A rocky river Chesegon, at the border of Marakwet East and West Pokot-on the Kerio Valley floor (April 2020)

There were some mudslides at Kipchumwa location as well. Cracks have been reported on parts of Katilit and Kipchumwa, indicating that the landslide problem in the Lagam escarpment may not be over but could be spreading to other areas, outside Kaben location. Furthermore, step faulting may have affected the landslide area, as shown by the pictures presented, especially in Plates 2, 3 and 4.

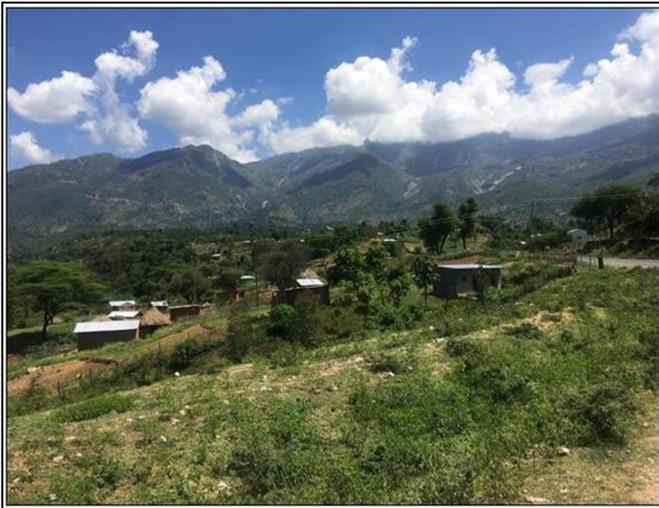
Plate 9: The landslide areas, Wewo Hill and Katilit -viewed from Sambalat (April 2020)

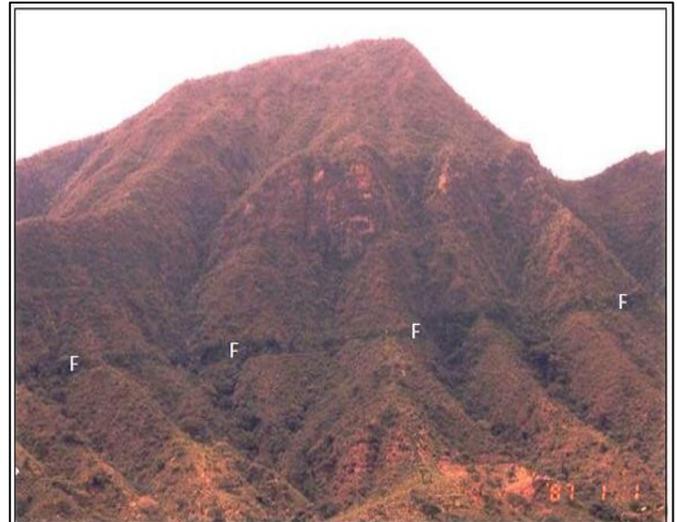
Plate 12: Kapchapai Hill with the ancestral water canal/furrow (F) on it (Kowow water furrow).
Picture adapted from [2].

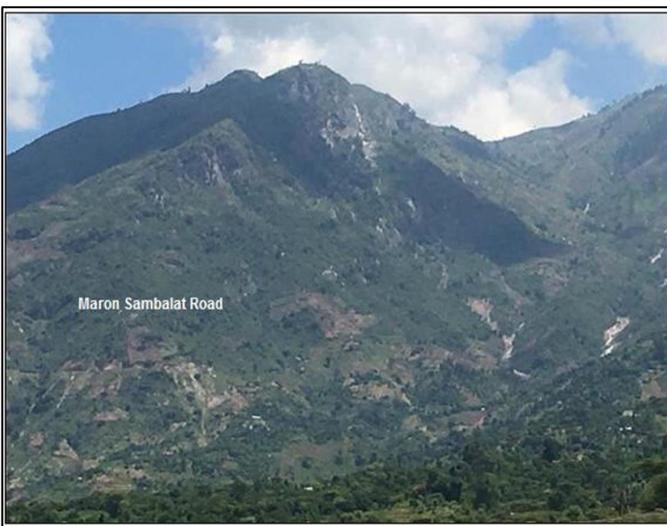
Plate 10: Wewo Hill and a section of the escarpment below it. The picture also shows a section of the Maron-Sambalat road (April 2020).

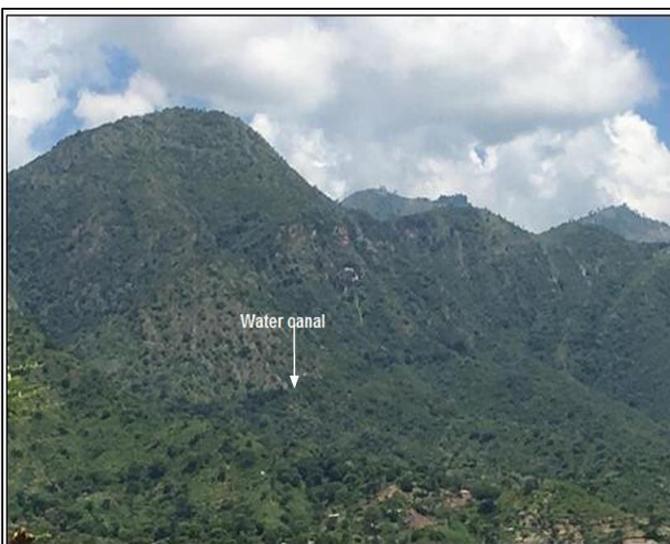
Plate 11: Kapchapai Hill with an ancestral water canal/furrow cutting across its northern slope (April 2020).

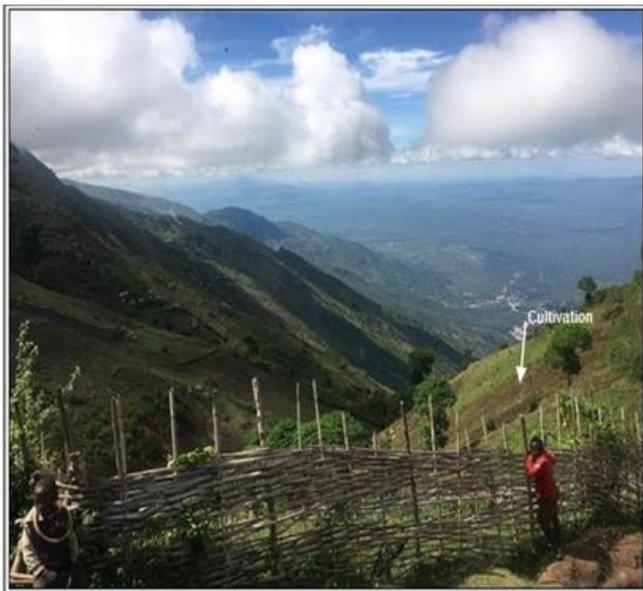
The photograph below (Plate 16), which was taken from near Wewo primary school, on the upland plateau, shows a section of the Embobut forest that has been mowed down, to pave way for agricultural land.

Plate 16: A section of the Embobut forest, adjacent to the Lagam escarpment (April 2020).

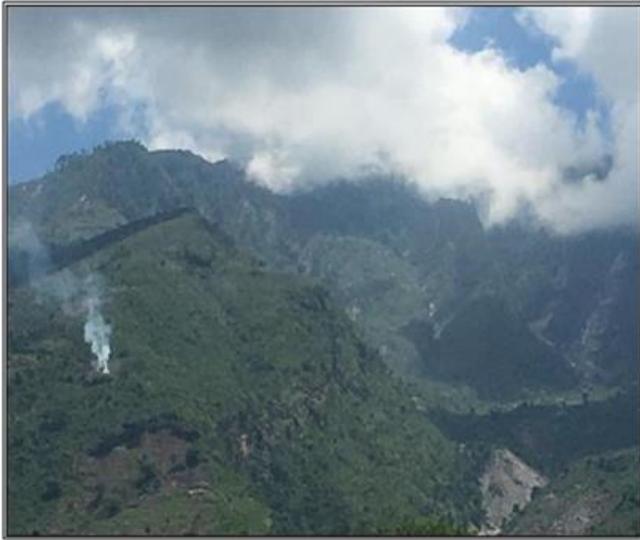
Plate 18: Slash and burn farming on the Lagam escarpment together with cultivation on riverbanks (April 2020).

In the quest for extra farmland, riverbanks, on the Lagam escarpment, are cultivated. This encourages undercutting of the banks by water hydraulic force and easy collapse during flood seasons. The steepness of the riverbanks adds to the quandary of collapsing land, along the rivers, during the rainy season (Plates 17 and 18).

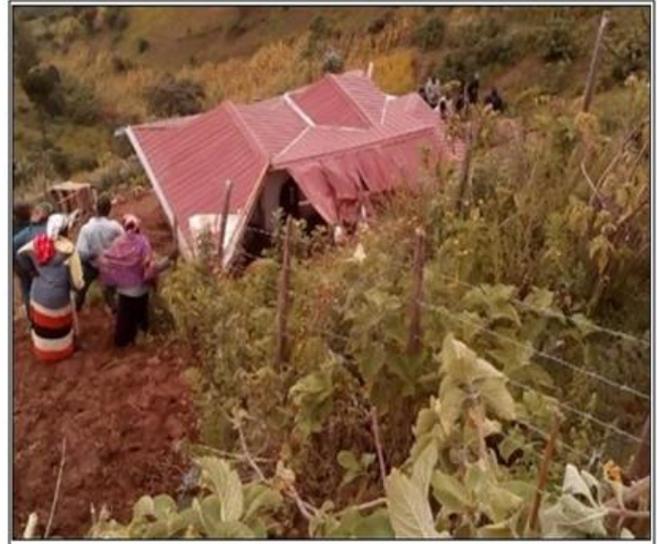
Plate 20: The family house where four family members perished in 2019 in Marakwet East. Source: Standard digital news-Kenya (2019).

In 2019, a family of four were killed by a landslide that originated from a road above their house, when heavy rains hit Tuturung area of Marakwet East (Plate 20).

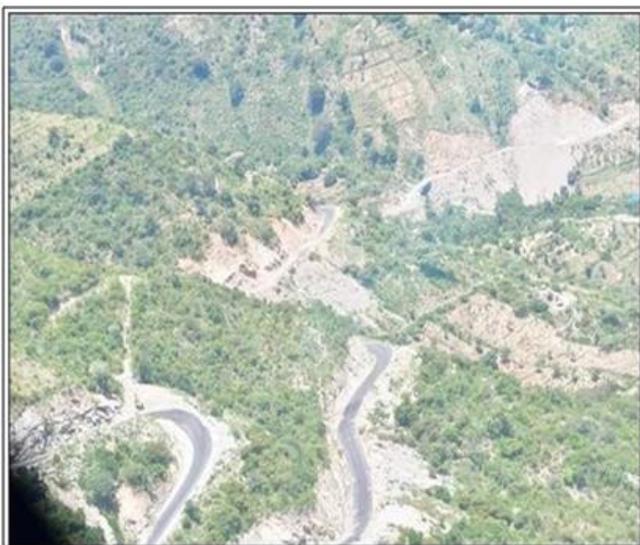
Plate 19: A section of a road on the Lagam escarpment affected by landslides (LS). Source: Unknown

Landslides on the Lagam escarpment are also experienced in areas where roads cut deep into the slopes. Road network, in the area, is still on high demand but the hanging road shoulders should be effectively steadied and stability measures applied so as to guard against landslides. The escarpment road shoulders slide onto the road or down the escarpment, from the road surfaces at several localities. Plate 19, shows a road section on the Lagam escarpment. The road shoulders are not only steep, but loose. Deforestation and dangerous farming, on the escarpment, is also evident on the upper parts of the area shown by the photograph. The photograph also shows road instigated landslides.

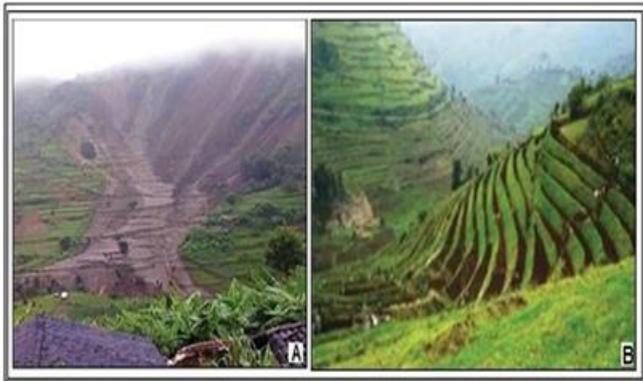
Plate 22: Landslides (A), Karongi, Western Province and Terracing efforts in Nyabihu district (B), Rwanda [8]. (Photo: Rwanda Red Cross).

- Encouraging agro-forestry in the area.
- Zoning of hill slopes, evacuation of steep areas by residents to less steep areas [8]; and creating terraced surfaces for cultivation purposes. This is well implemented in Rwanda as a remedial measure of landslides (Plate 22).

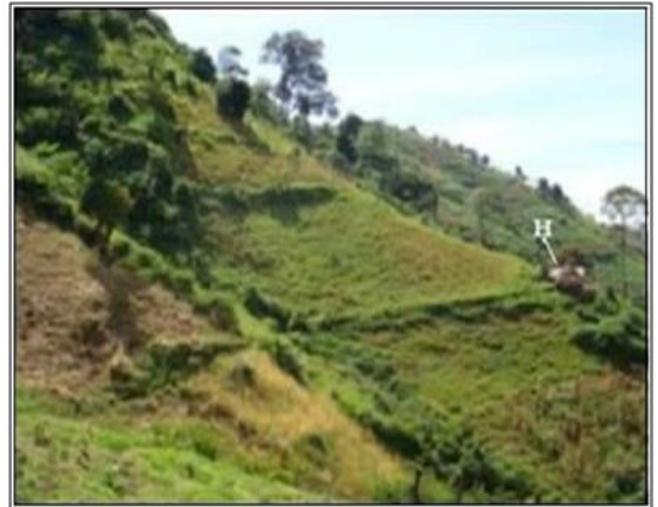
Plate 24: A homestead (H) built on land slide debris, Kapkese, Kipkelion District in Kenya [6].

scree slope material, such as illustrated by Plate 24. The loose material can easily lose shear strength on saturation, thereby resulting to land sliding [6].
