# Assessment of Road Conditions Using Road Lab Pro and Daily Road Voyager

**Abstract:-**This work described and analyzed the roughness of the surveyed road using two applications- Road Lab Pro and Daily Road Voyager. These phone applications are entirely different in work and function based on their configuration to enable the user carry out specific task in checkmating the road abnormalities.

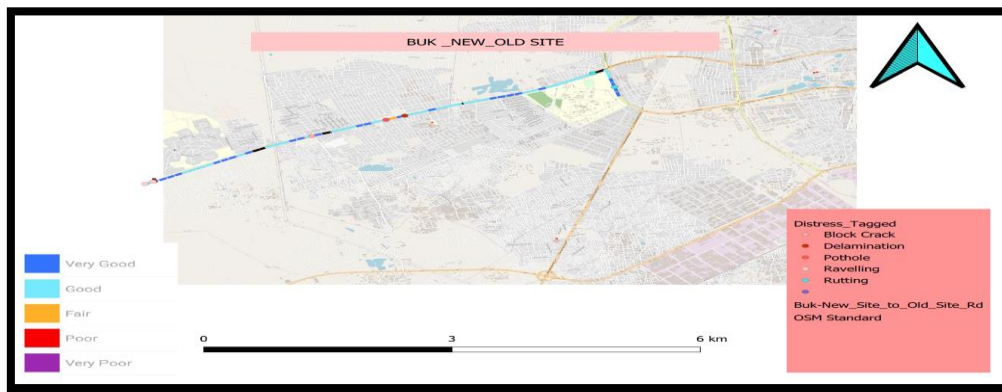
Fig. 4: BUK New Site Main to BUK Old Site Old Gate

The road is dual carriageway and comprises of asphalt paved on both the carriageway. The total surveyed length of the route is approximately 6.5km with an average speed of 42km/h from the data collected from the road lap pro, the average IRI of the road is 3.0; classified as good. From visual observation some sections of the road were identified with block crack, potholes, ravelling and rutting.

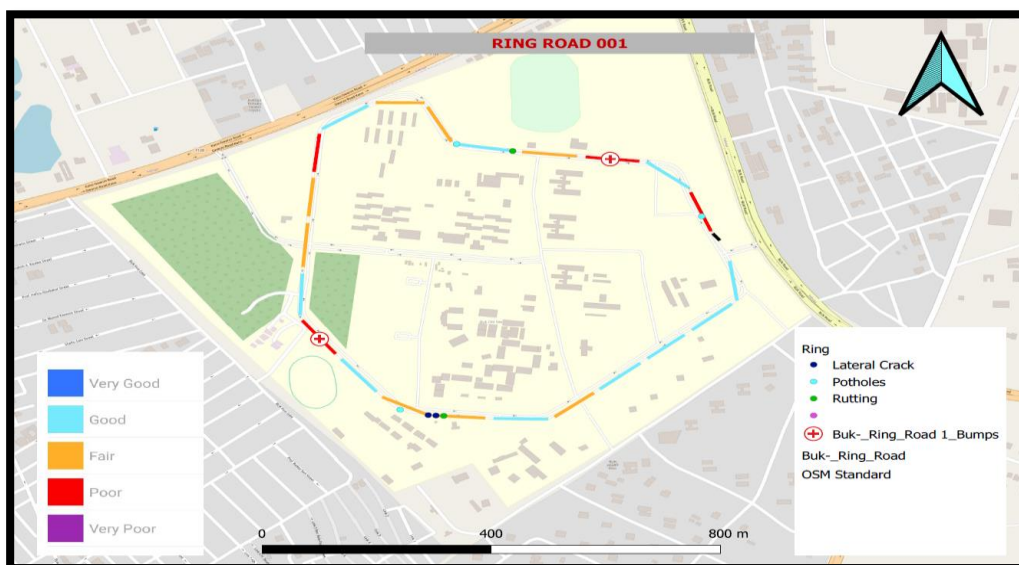
Fig. 5: BUK old Site Ring Road

The road is dual carriageway and comprises of asphalt paved on both the carriageway. The total surveyed length of the route is approximately 2.5km on both directions with an

average speed of 47 km/h and average IRI with roughness of 3.94; classified as fair. From visual observation, some sections of the road were identified with block crack, potholes, ravelling and rutting.

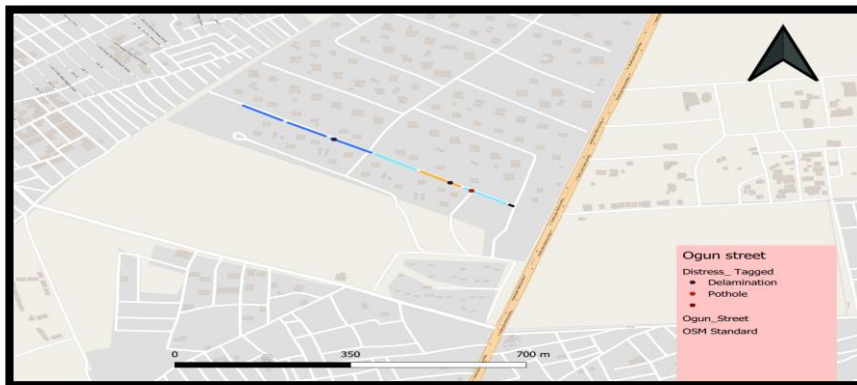
Fig. 7: Ogun Street

The road is asphaltic paved single carriageway. The total surveyed length of the route is approximately 0.75 km with an average speed of 38 km/h and average IRI with

roughness of 3.64; classified as good. From visual observation, this routesome sections of the road were identified with deterioration and potholes.

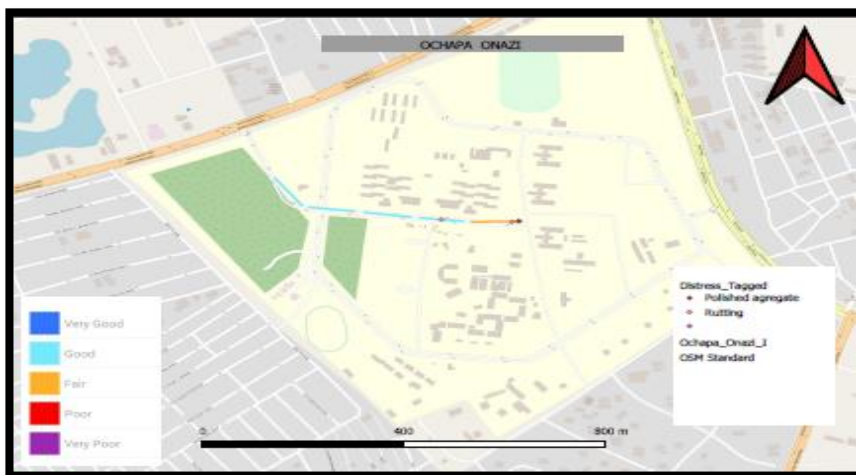
Fig. 8: OchapaOnazi Street

The road is dual carriageway and comprises of asphalt paved on both the carriageway. The total surveyed length of the route is approximately 0.75 km on both clockwise and

anticlockwise direction with an average speed of 42 km/h and average IRI with roughness of 3.41; classified as good. From visual observation, the route is identified with polished aggregate and rutting on several sections.

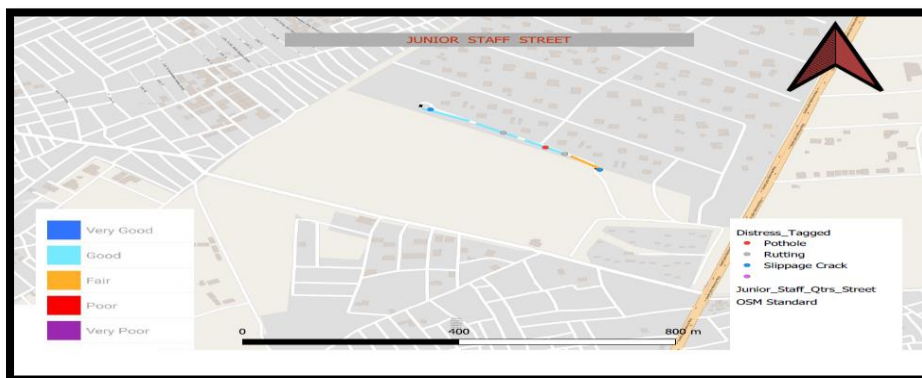
Fig. 12: Junior Staff Quarters Street

The road is asphaltic paved single carriageway. The total surveyed length of the route is approximately 0.5 km with an average speed of 38 km/h and average IRI with

roughness of 3.41; classified as good. From visual observation, this route was identified with several distress such as potholes, rutting and slippage crack.

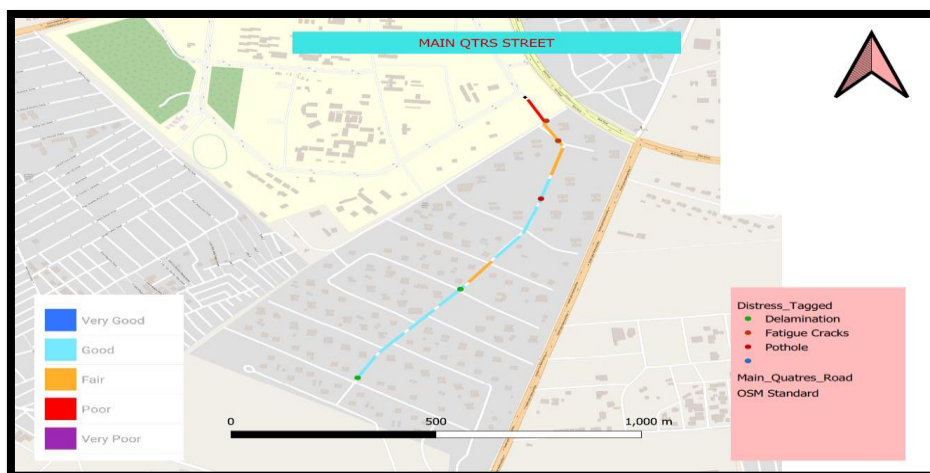
Fig. 16: Main Quarters Road

The road is asphaltic paved single carriageway. The total surveyed length of the route is approximately 1.2 km with an average speed of 48 km/h and average IRI with

roughness of 3.9; classified as good. From visual observation, the route is identified with delamination, fatigue cracks and potholes in some sections.
