# Hydraulic Capacity, Drainage Performance and Flood Risk of New Amsterdam, Guyana

Michael L. Hackett<sup>1</sup>; Bibi Sherriza Ali<sup>2</sup>; Jason Phillips<sup>3</sup>

**Abstract:** New Amsterdam, the capital of Region 6, Guyana, experiences recurrent flooding during periods of intense rainfall despite the presence of gravity drainage sluices and recently installed drainage pumps. However, unlike Georgetown, no published study has quantitatively evaluated the hydraulic capacity and drainage performance of the municipality's drainage system. This study addresses that knowledge gap through field investigations, hydraulic analysis, and examination of historical rainfall and flood records. Field measurements were obtained at the town's five gravity sluices and two permanent drainage pumps, including sluice dimensions, water depths, operating conditions, and evidence of siltation. The hydraulic capacity of each sluice was calculated using a unified Sluice Drainage Coefficient Equation derived from the Chezy-Manning equation and the rainfall drainage coefficient relationship. The five sluices were estimated to provide a combined theoretical discharge of 7.06 m<sup>3</sup>/s, corre

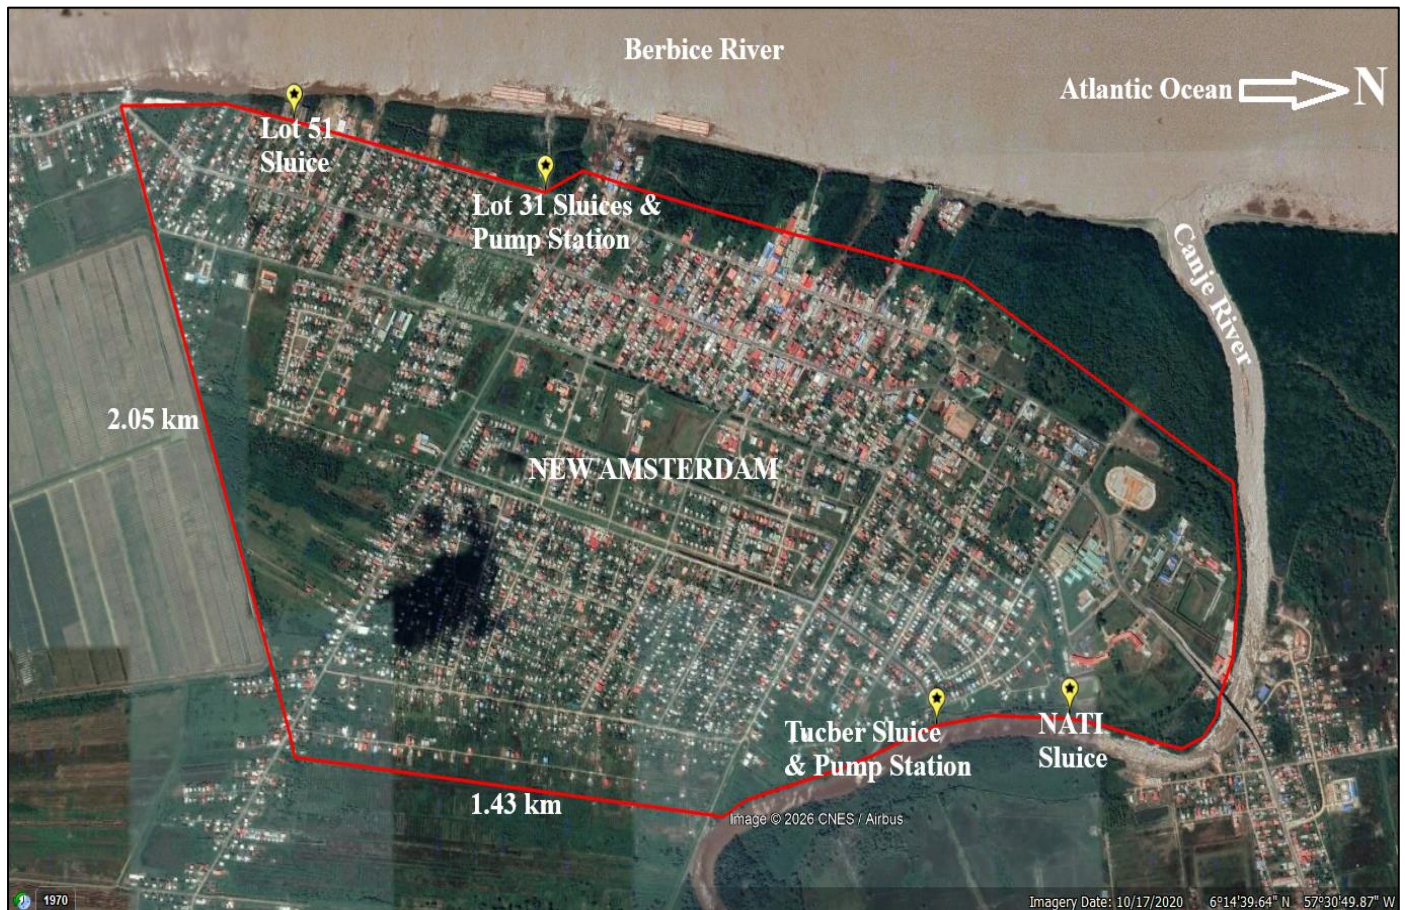
Figure 1 shows a map of the study area and the locations of the five sluices and two pump stations investigated during this study. The figure also illustrates the road network, and the layout of New Amsterdam. Most canals and internal drains run alongside the roads.

Fig 1 Map of New Amsterdam Showing Locations of Sluices and Pump Stations Where Field Data Were Collected. Base Map from Google Earth Satellite Imagery (Google, 2026), October 17, 2020. Field Data and Annotations by the Author (2016–2026).

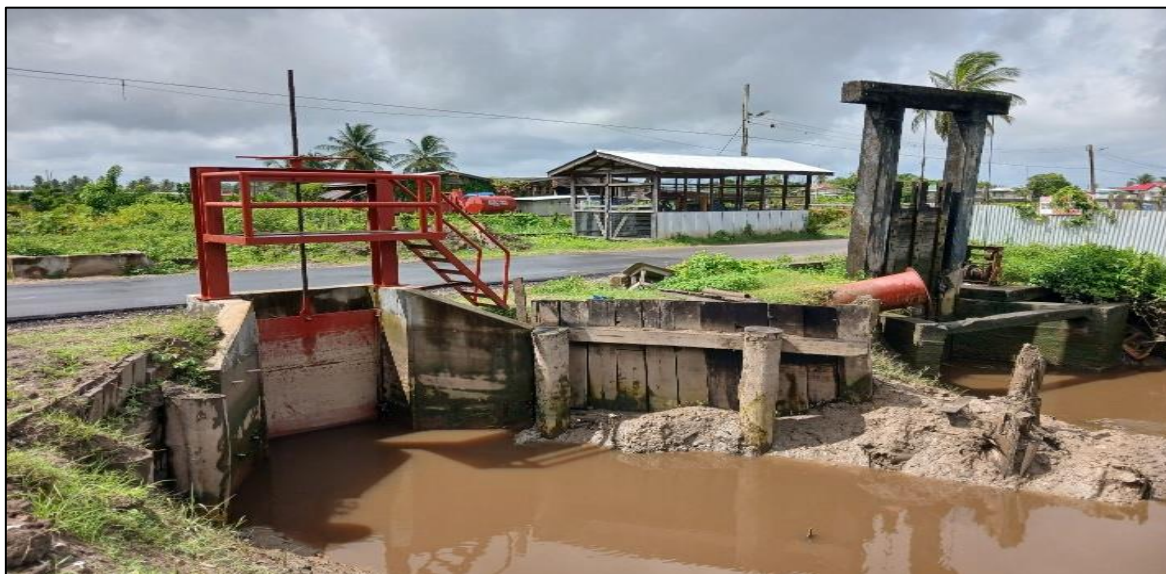
Figure 2 shows the old gravity sluice, the newly constructed vertical-screw-operated sluice, and the nearby 40-cusec drainage pump with discharge pipeline installed at the Lot 31 site.

Fig 2 Lot 31 Old (Right) and Newly Constructed (Left) Lot 31 Sluices and Pump Station in Background.

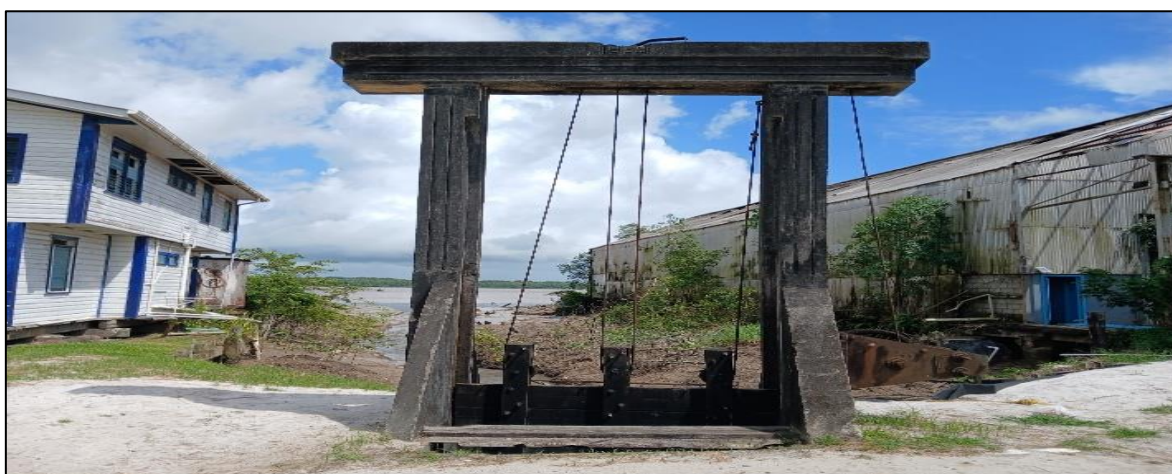
Figure 3 illustrates the Lot 51 sluice, where field observations showed free discharge under submerged-gate (orifice flow) conditions during low tide on one occasion and raised gate (free open channel flow) on another occasion.

Fig 3 Lot 51 Sluice Discharging by Gravity During Low Tide.

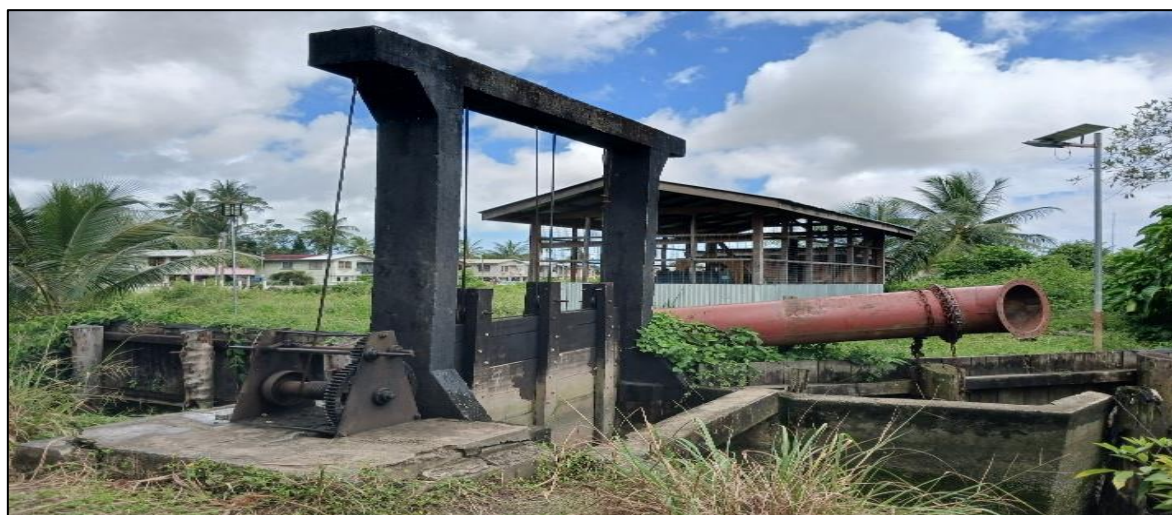
Figure 4 shows the Tucber sluice together with the adjacent 40-cusec drainage pump and discharge pipeline.

Fig 4 Tucber Sluice and Pump Station on the South Bank of the Canje River

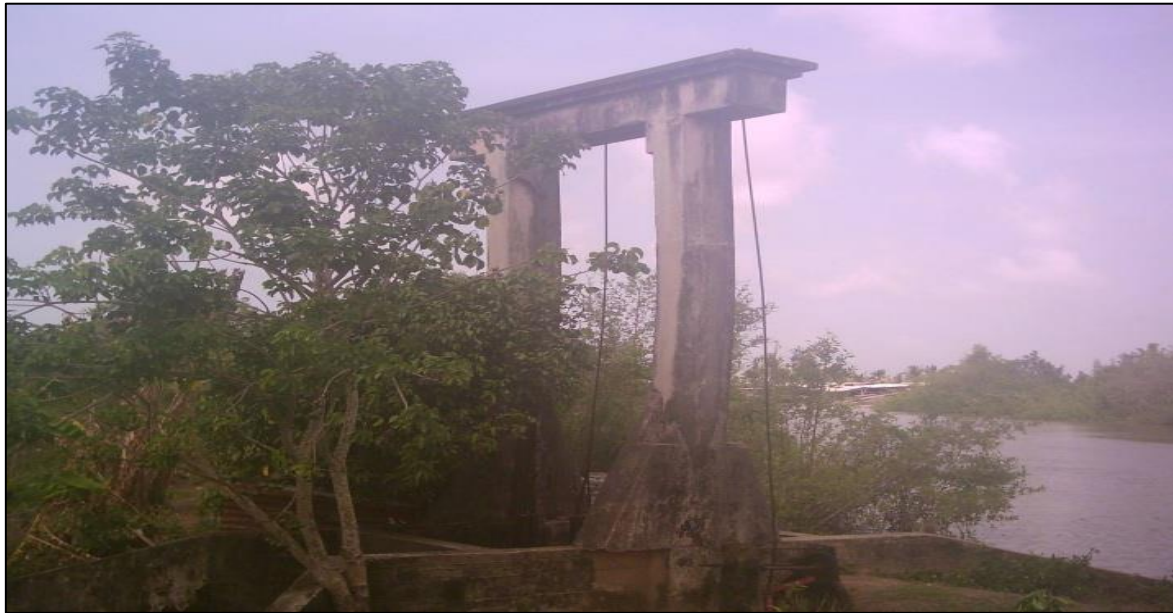
Figure 5 shows the NATI sluice, located approximately 160 m east of the New Amsterdam Technical Institute (NATI) on the south bank of the Canje River, from which the sluice derives its name.

Fig 5 NATI Sluice on the South Bank of the Canje River
