# Enhancing Reliability of an Industrial Blower Through Bearing Design Modification: An Industrial Case Study

<sup>1</sup>Assistant General Manager Plant Health Services Department, Rashtriya Chemicals & Fertilizers Ltd., Trombay Unit, Mumbai-400074, India

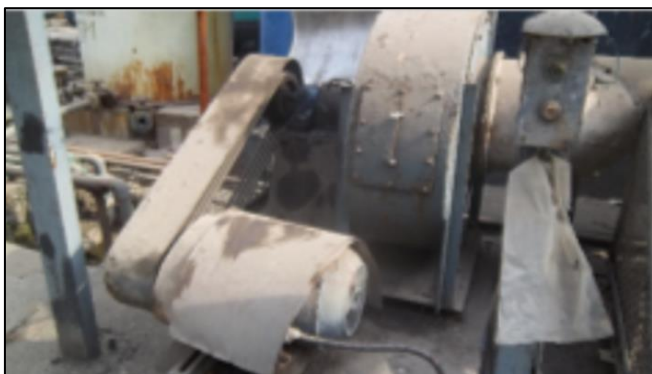
Photograph1 Degasser Blower Arrangement

Two blowers are installed in the water treatment section of the new steam generation plant at RCF Trombay Unit. Both blowers are driven by electric motors through belt drives. Under normal operating conditions, one blower remains in service while the other is kept on standby. Photograph 1 shows the machinery arrangement of the deaerator blower.

The degasser blower is a cantilever-type, belt-driven blower operating at 1635 rpm. It is equipped with a 2309 EK bearing mounted on an H2309 adapter sleeve, supported in an SN 609 Plummer block. The blower shaft diameter is 40 mm. Photograph 1 shows the machinery arrangement of the degasser blower.

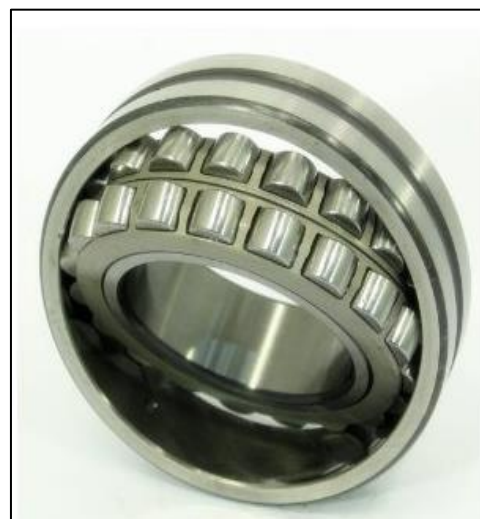
Fig 3 Spherical Roller Bearing

After evaluating various bearing options, the 22309 EK spherical roller bearing was selected. This bearing provides the same self-aligning capability as the existing bearing while offering substantially higher dynamic and static load-carrying capacities, with identical principal dimensions. Spherical

roller bearings are preferred for heavy-duty applications[8], such as industrial blowers, where high bearing life and reliability are essential. Consequently, the new bearing could be installed without requiring any major modifications to the blower assembly. Photographs of the 2309 EK self-aligning ball bearing and the 22309 EK spherical roller bearing are shown in Photographs 2 and 3 respectively.

As shown in Table 3[8], the 22309 EK spherical roller bearing has the same bore, outside diameter, and width as the existing 2309 EK self-aligning ball bearing, allowing it to be installed without altering the existing blower arrangement. The bearing can be mounted using the same H2309 adapter sleeve and SN 609 Plummer block, thereby eliminating the need for any major mechanical modifications.

Spherical roller bearings are designed to accommodate heavy radial loads and can withstand bidirectional axial and combined loads. Owing to their robust internal geometry, they provide significantly higher load-carrying capacity than self-aligning ball bearings. In contrast, self-aligning ball bearings are primarily designed to carry radial loads and light axial loads in both directions. However, they are not suitable for carrying pure axial loads. Furthermore, the 22309 EK spherical roller bearing provides nearly three times the dynamic load capacity and almost ten times the static load capacity of the existing 2309 EK self-aligning ball bearing, making it a suitable and reliable solution for improving blower performance, extending bearing service life, and enhancing overall equipment reliability.

and abnormal noise was identified. The investigation revealed that the problem was caused by the insufficient load-carrying capacity of the existing 2309 EK self-aligning ball bearings. Therefore, it was recommended to modify the bearing design by replacing the self-aligning ball bearings with 22309 EK spherical roller bearings, which possess the same self-aligning capability but offer significantly higher dynamic and static load-carrying capacities.

After implementing the bearing design modification, the blower vibration and abnormal noise were reduced to normal operating levels. The blower has been operating smoothly with normal noise level and stable vibration levels since the modification. The blower casing vibration measurements recorded before and after the bearing design modification are presented in Table 4.

The blower bearing design modification reduced the blower casing vibration from a maximum of 20.7 mm/s rms to 0.7 mm/s rms, bringing the vibration level within the normal operating range and resulting in acceptable noise levels. The frequent abnormal noise originating from the blower bearings was eliminated, thereby significantly reducing environmental noise pollution within the plant.
