Analisis of the Centrifugal Exhaust Fan Damage on Line Painting

Ahmad Hipni¹, Jimmy Sabar HP Sitanggang², Erry Rimawan³, Humiras Hardi Purba⁴, Choesnul Jaqin⁵
^{1,2,3,4,5}Master of Industrial Engineering Program
 MercuBuana University, Jakarta, Indonesia

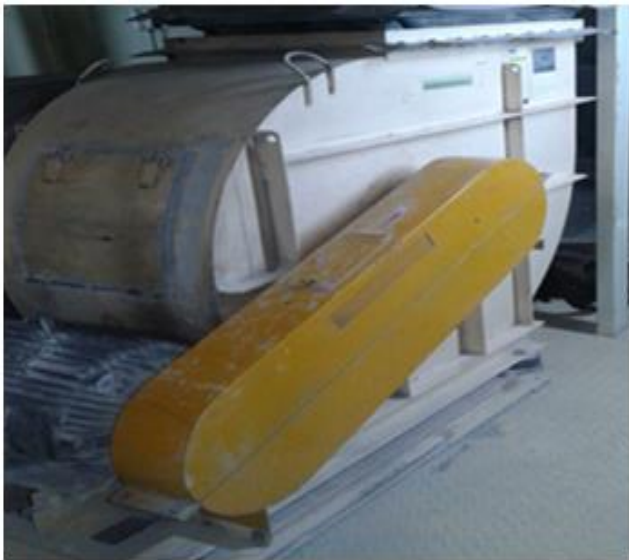
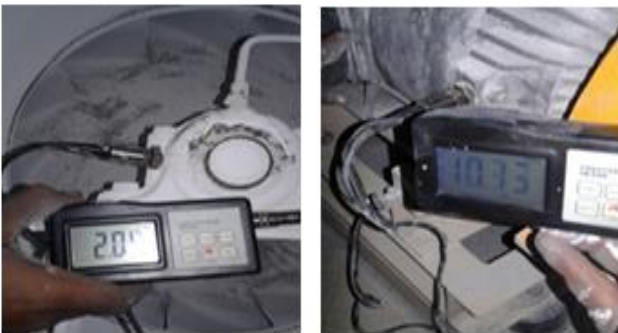
Fig 2:- The vibration data retrieval position

Visual observation is performed on an exhaust fan or a faulty motor component when the disassembly occurs. As for vibration data capture, it is done on 2 parts, one side of the measurement on bearing 1 (one) bearing 2 (two) and one side once again the measurement is made on the electric motor. On each side data is collected 3 times, ie on the vertical, horizontal and axial sides. Location and direction of vibration data capture as shown in Figure 2
