Sustainable Design Strategy for Single-Family Housing in Bosnia and Herzegovina

Keywords: Sustainable design, single-family home, passive design, energy efficient, sustainable construction, environment.

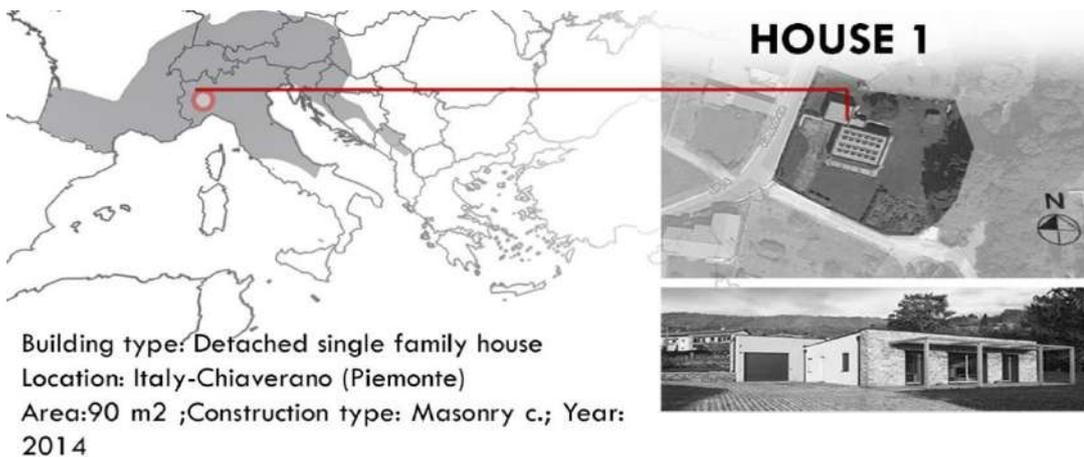
Figure 3. location and picture of house

The orientation of the house is positioned so that the surface of the walls is directly facing the sides of the world (**Figure 3**).

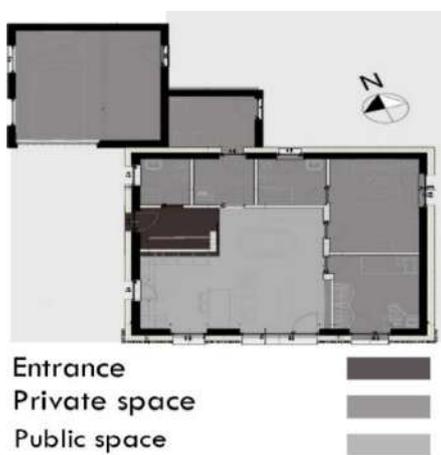
Figure 3.1 Floor plan of house

The organization of the rooms in the house is graphically shown (**Figure 3.1**) and shows where the entrance, private space and public space in the house are located.

The private space includes bedrooms, pantries, dressing rooms and garage and orientation with openings faces east and west, while the public space, which includes the living room and dining room, is oriented south.

The south side has 25% openings, which is a drastic difference from the north. The fact is that the house uses a huge amount of solar energy to illuminate the rooms, in this case, the public space of the house (**Figure 3.1**) where the living room and dining room are located and that it uses the sun's heat to heat these rooms, which are the largest in the house.

The east and west sides are almost identical with respect to the south and north sides, and private rooms such as bedrooms and pantries are positioned there (**Figure 3.1**) and on these sides, a smaller amount of solar energy is required and winds are weaker on those sides than on the south and north so that the percentage of openings is moderate and in line with the position of the house and the organization of the rooms in it.

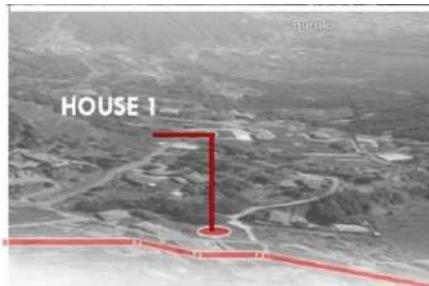
Figure 3.2 Graphical presentation of topography and position of the house 1 on the site

The house is made in a mountainous area where the alpine climate is represented. An overview of the wider picture of the site (**Figure 3.2**) shows that there is a huge fall in the terrain, north of the mountain and south of the slope. The place and the smaller circle on which the house is located are quite flat.

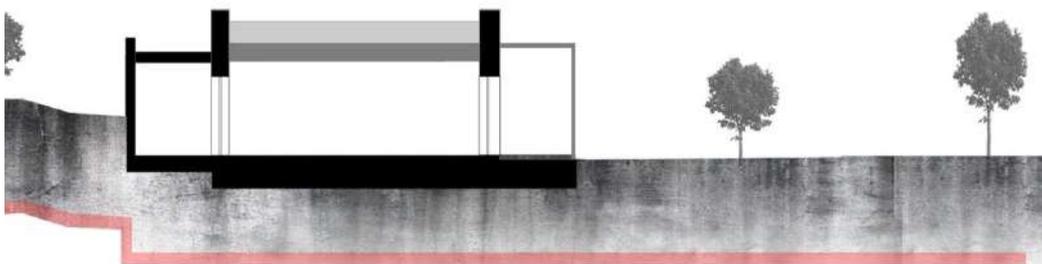
Figure 3.3 Graphical presentation of cross section through the house and the site where the house is located

ne part of the house on the north side is totaled in the ground about 1.5 m deep (**Figure 3.3**) and it is part of the private space of the house, which is not a disadvantage of this house but it is advantageous because in some way it is protected from strong winds from the north side.

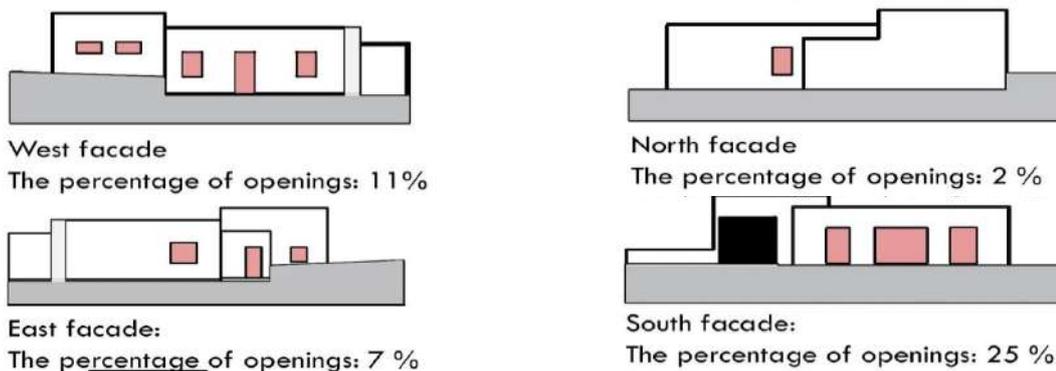
Figure 3.4 Percentage of the openings on facade

As shown (**Figures 3.4**) in the north facade is 2% in the south 25% which is a huge difference while in the east 7% and in the west 11% which is very approximate.

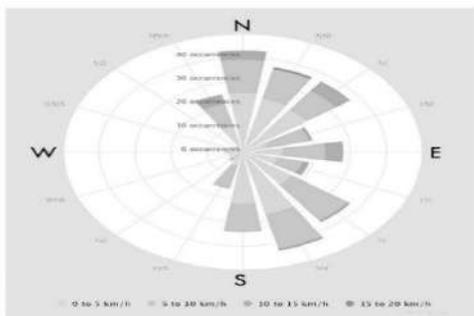
Figure 3.5 Wind rose for Chiaverano

The northern façade has the lowest percentage of openings since the lowest percentage of solar energy is used and the other key thing is that strong winds (**Figure 3.5**) come from the north, which in this case would be difficult to control if the facility had a larger percentage of openings on the north side.

As for the winds on the south side (**Figure 3.5**), they are much milder than the north winds and can be more easily controlled.

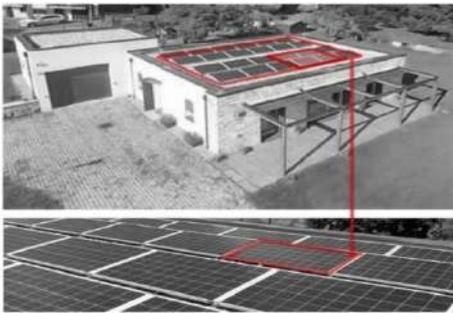
Figure 3.8 Solar panels installed on the roof

Above the entrance, public, and part of the private spaces, a flat roof was used to install 5.5 kWp. Photovoltaic solar panels (**Figure 3.8**). These panels are huge benefits for the house to reduce energy consumption, because of this house in such a location that it needs more space heating than houses located in places where it is continental or Mediterranean climate zone.

Installation of photovoltaic solar panels the production of renewable energy is 61 kWh / (m²a) based on a projected surface what is a great result for these conditions.

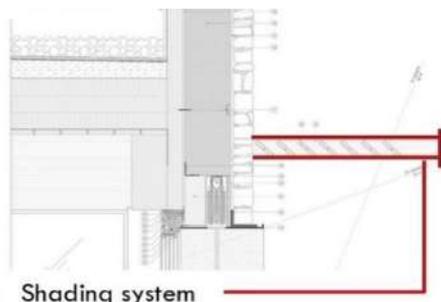
Figure 3.9 Shading system view through cross section

(**Figure 3.9**) shows the type of shading system, which is positioned only on the south side due to the summer weather for easier control of the required sun rays and the second key thing is there is a public space where the users spent a lot of time.

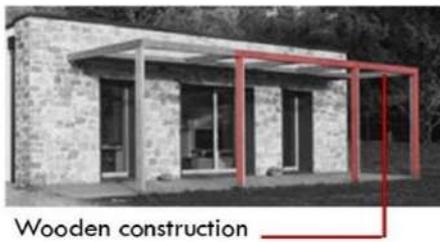
Figure 3.10 Shading system and wooden construction

The construction of this shading system is constructed of wood (**Figure 3.10**) and has the option of opening and closing the roof structure on the shading system as needed because the sun's rays are not at the same angle during summer and winter (**Figure 3.11**)

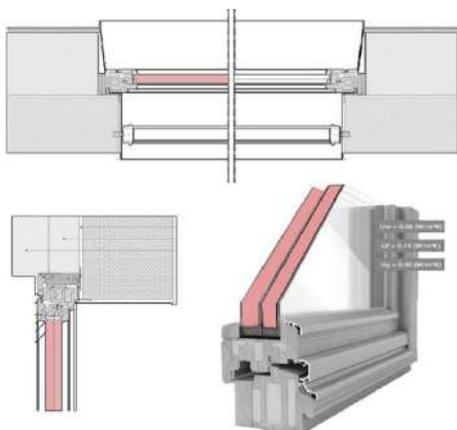
Figure 3.15 Section and picture of the window set

HOUSE 1 features Wood windows with polyurethane inserts [0,024 W / (mK)], with aluminum drips developed by Marles company d.o.o. (MEGA PASIV-P). An important detail in this type of window is glass. Triple glazing with low emissivity glass with high insulation is installed on the windows of this house

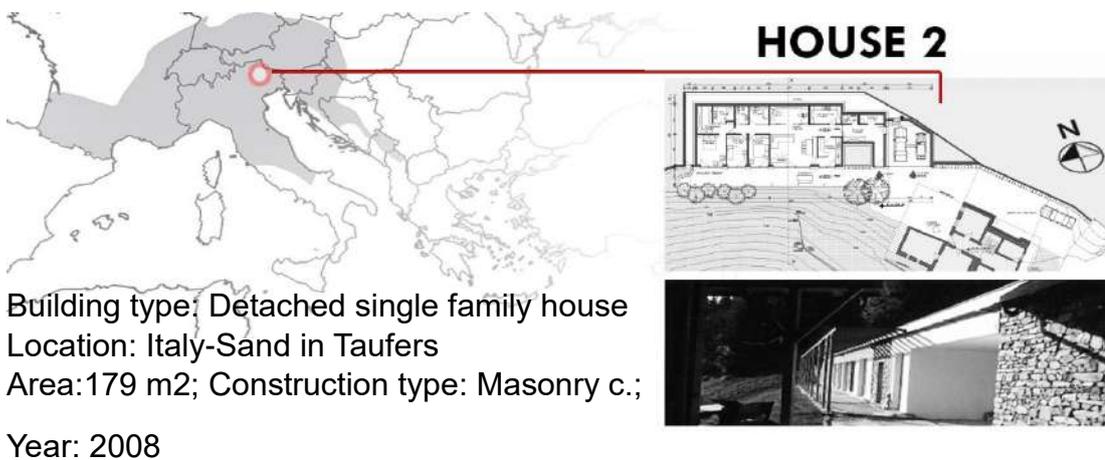
Figure 4 location and picture of house

The specificity of this house is that only one side of the house has openings and is oriented to the northeast, while the other three wall surfaces are buried in the ground. **(Figure 4)**

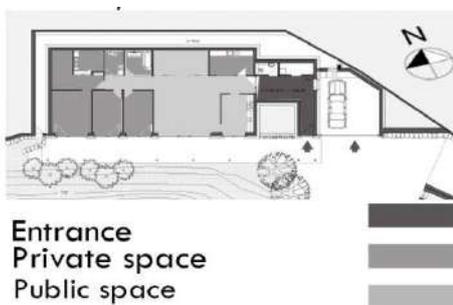
Figure 4.1 Floor plan of house

The living room, kitchen, and bedrooms are all organized to the northeast because there is natural light, while all service rooms, bathrooms, pantries, etc. are in the southern part where the house is underground and there is no natural light. **(Figure 4.1)**

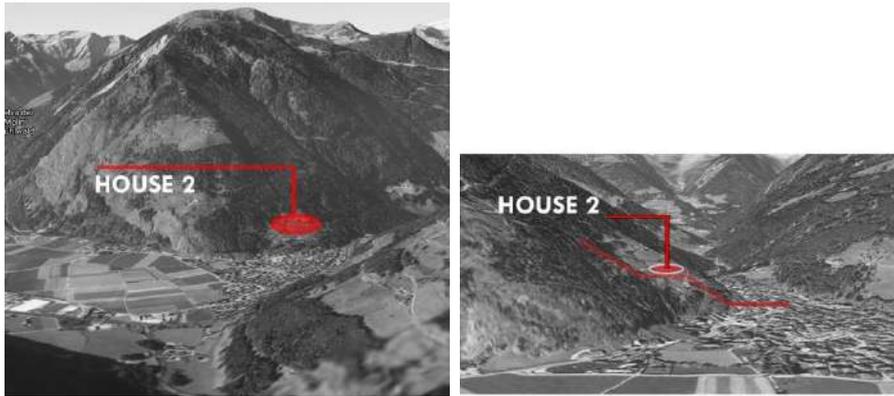
Figure 4.2 Graphical presentation of topography and position of the house on the site

The house is made in a mountainous area where the alpine climate is represented. An overview of the wider picture of the site **(Figure 4.2)**. It can be seen that the huge drop of the terrain from south to north, **(Figure 4.2)** therefore the position of the object towards the terrain can be seen **(Figure 4.3)** the southern, part western, and eastern sides are underground.

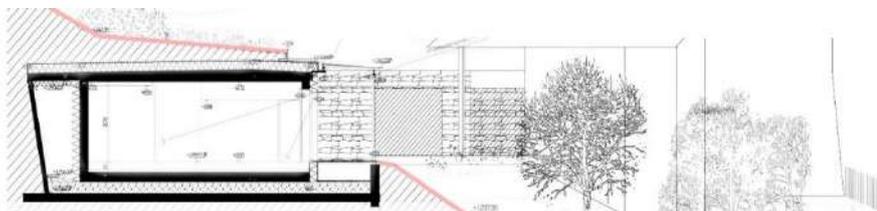
Figure 4.3 Graphical presentation of cross section through the house and the site where the house is located

For the most part, the roof surface is covered with earth in a different thickness as can be seen in the cross-section **(Figure 4.3)**

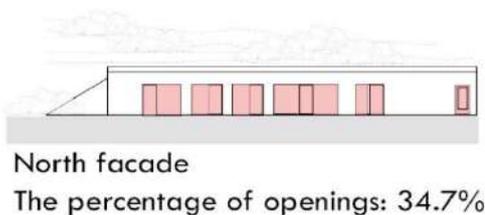
Figure 4.4 Percentage of the openings on facades

By analysis and calculation of house 2, as already mentioned, the openings are located only on the northeast side, while the rest is in the ground. The number of openings on the north-east side is estimated at 34.7%, (**Figure 4.4**) which is quite large and represents a huge challenge to protect the building from cold winters, given the alpine climate. Another very important factor is the flow of strong winds from the north-east side (**Figure 4.5**), which additionally bears the costs of high-ranking openings (windows and doors with multi-layer insulation).

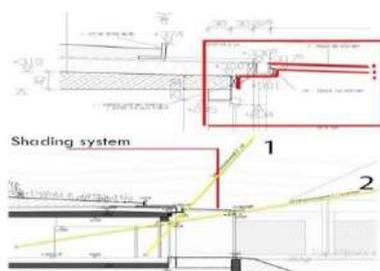
Figure 4.7 Shading system view through cross section

The construction of this shading system is made of metal structures that are fixed.

Covering the roof structures with canvas on the system shaded as needed because the sun's rays are not at the same angle (yellow line 1&2) in summer and winter (**Figure 4.7**)

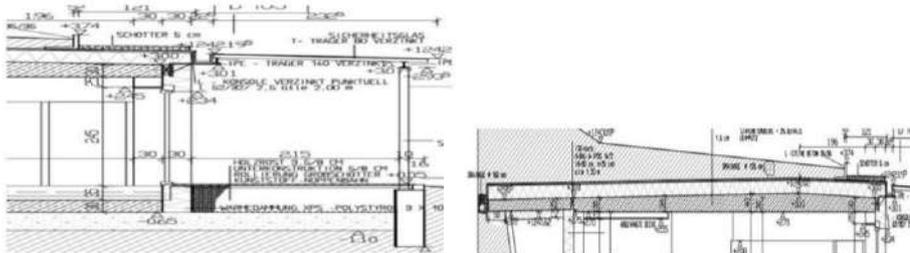
Figure 4.8 Cross section -slab, wall and roof

Detailed technical section (**Figure 4.8**)

building a house 2 are shown were through the cross-section we can see the construction strategy that has met all the conditions of a passive house.

Basement floor / floor slab: Parquet, 4 cm insulation board (Screed), 10 cm insulation EPS, 10 cm bulk (Base plate),50 cm insulation
 U-value = 0.1 W/(m2K)

Roof: Abdichtung ins. ,30 cm XPS insulation, Vapor barrier, 30 cm reinforced concrete ceiling
 U-value = 0.12 W/(m2K)
 Air tightness: n50 = 0.47

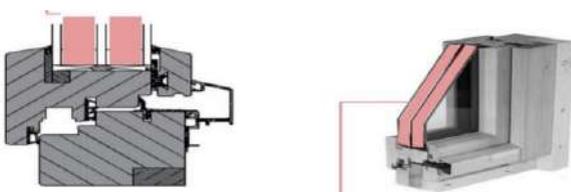
Figure 4.9 Section and picture of the window set

This house has windows of the company OPTIWIN, (**Figure 4.9**) which has a certificate of passive design that their products meet the criteria of a passive house.

U g-value = 0.6 W / (m2K)

Energy efficiency: Window system certified by the Passive House Institute PHI Darmstadt: A-component

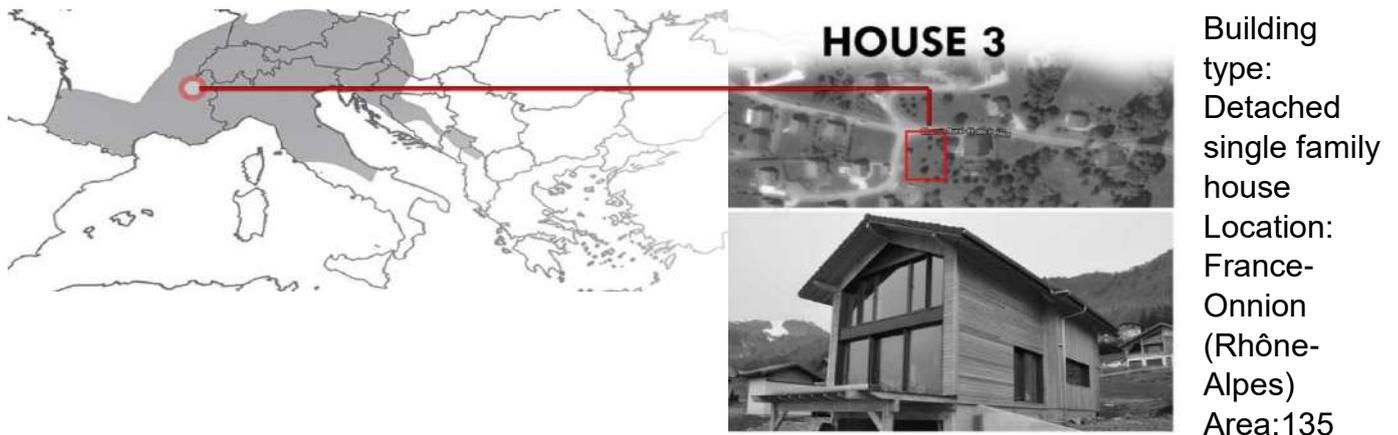
m2 ;
 Construction type: mixed construction.; Year: 2016
Figure 5 location and picture of house

The position of the house is purposefully resolved according to the orientation to the sides of the world and harmonized according to the terrain (**Figure 5**).

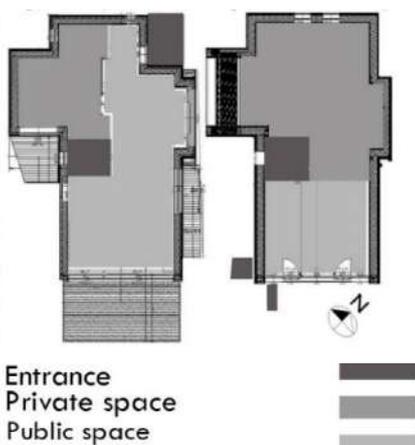
Figure 5.1 Floor plan of house

The house is properly oriented and that benefits from nature such as solar energy and airflow. The organization is solved so that all public spaces (living room and dining room are positioned on the south-east side where the highest concentration of sunlight. While private and service space is positioned on the north-west side which can be concluded that the correct way of organizing space according to the system of passive houses.

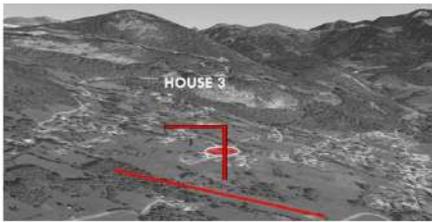
Figure 5.2 Graphical presentation of topography and position of the house on the site”

The terrain is sloping from the highest point in the northwest to the southeast where the lowest point of the terrain is (**Figure 5.2**). Space on which the house 3 positioned had to be excavated, taking into account the percentage of the slope of the terrain.

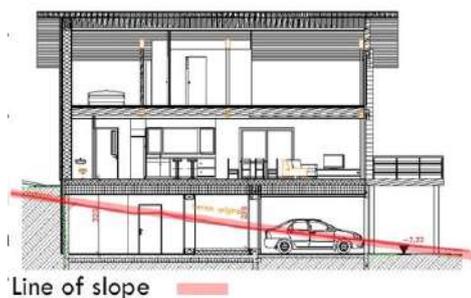
Figure 5.3 Graphical presentation of cross section through the house and the site where the house is located”

About 50% of the facility is underground under a slope where the highest ground level is more than 2 m where it descends to the zero points as can be seen in the technical cross-section through the terrain and the house. (**Figure 5.3**)

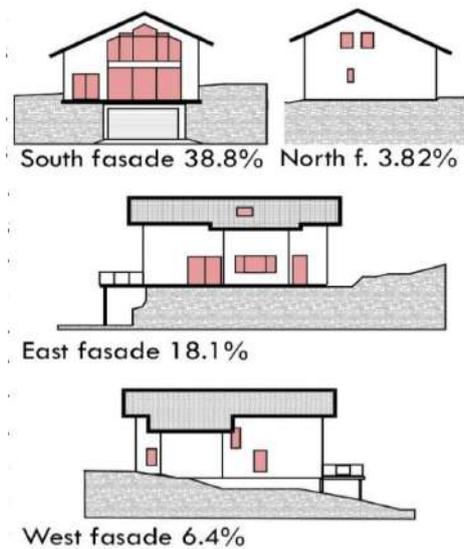
Figure 5.4 Percentage of the openings on facades

Open are positioned on all 4 sides of the building. The largest percentage of openings is on the southeast side, about 38%, of course with the intention of the designer to use as much sun energy and natural light on that side, as already mentioned on that side are positioned public spaces (living room dining room).

On the east-north side, the total area of the opening is 18.1%, which is quite enough for optimal natural lighting where part of the kitchen and bedrooms are positioned. northwest side 3.82% which is the lowest percentage of wind and there are positioned bathrooms. the south-south side is 6.4% and the bedrooms are positioned (**Figure 5.4**). The wind circulation is strongest on the east side and the west side (**Figure 5.5**) we can conclude that according to the total area of the opening on these sides it is properly distributed with minimal risk of air leakage.

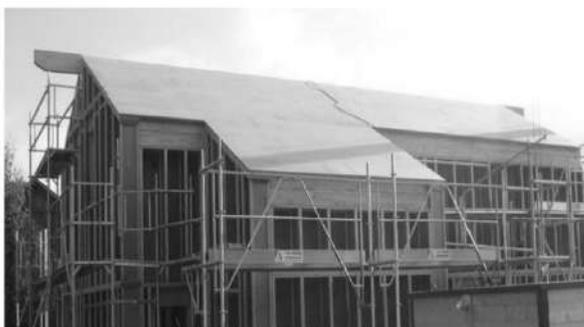
Figure 5.7 Roof-Method of construction

built of wooden construction (**Figure 5.7**). The roof is falling by 26%, which is better compared to the previous two houses where the roofs are flat, because when it comes to the alpine climate, a huge amount of snow falls annually, which often stays on the roofs and it requires strengthening structures, as well as additional insulation which is not an economic plus, and is needed for many years to be cost effective.

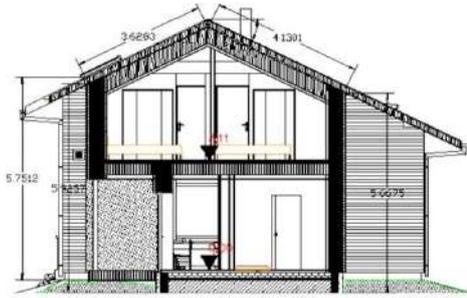
Figure 5.6 Roof cross section through the house

House 3 has a gabled roof (**Figure 5.6**)

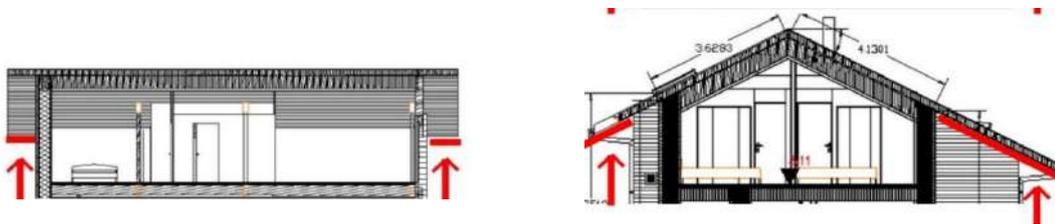
Figure 5.8 Shading system view through cross section

As already mentioned, the roof of house 3 is gabled, with it being let over the walls of the house 50-60 cm (**Figure 5.8**). Such a system has been common in construction for a long time. The reason for leaving 50 60cm is exactly how much it takes to cover the sidewalk around the whole house so that the users can take shelter during the rain. As a sun protection system in the case of house 3 there is no significant effect.

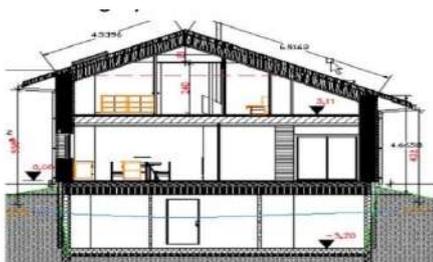
Figure 5.9 Cross section -slab, wall and roof

Through a detailed section, (**Figure 5.9**) we extracted all types of layers from the roof, walls, and floor and their value, presented in U-value, which is according to the regulations of passive houses. (It refers to the permeability of warm air and the lower the U-value the material is the better insulator).

Basement floor / floor slab: Carrelage, Screed, Screed insulation, Concrete slab, Polystyrene U-value = 0.124 W/(m2K)

Roof: Gypsum board, Air layer, OSB, Cellulose wool, Wood structure, Wood fibres U-value = 0.105 W/(m2K) Air tightness: n50 = 0.61/h

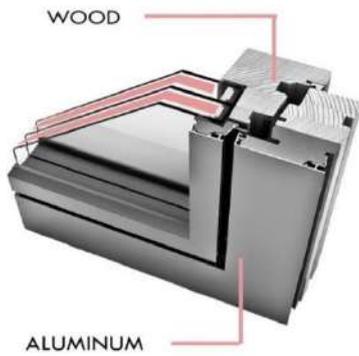
Figure 5.10 Section and picture of the window set

This house has windows of the company INTER-NORM. The window is made of a combination of wood and aluminum and thermal insulation foam in between, which is far high quality and corresponds to the system of passive houses. It is very resistant to all weather conditions; a very important detail is that it is a three-layer glass (**Figure 5.10**)

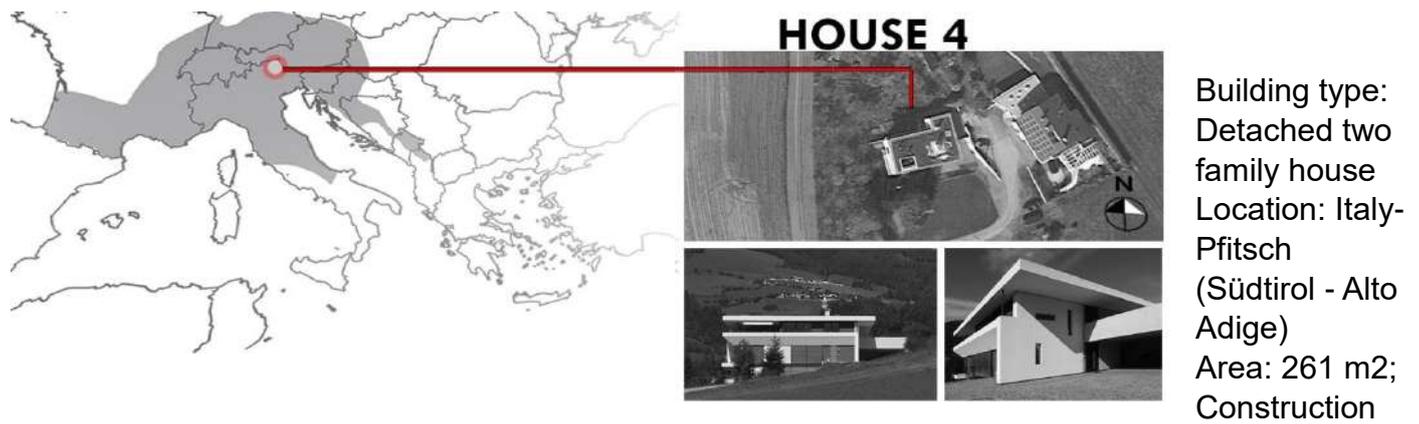
Figure 6 location and picture of house

According to the terrain and area where house 4 is (**Figure 6**), it can be said that the orientation of the house and as a room organization is almost perfect to what is required by the institute for passive houses.

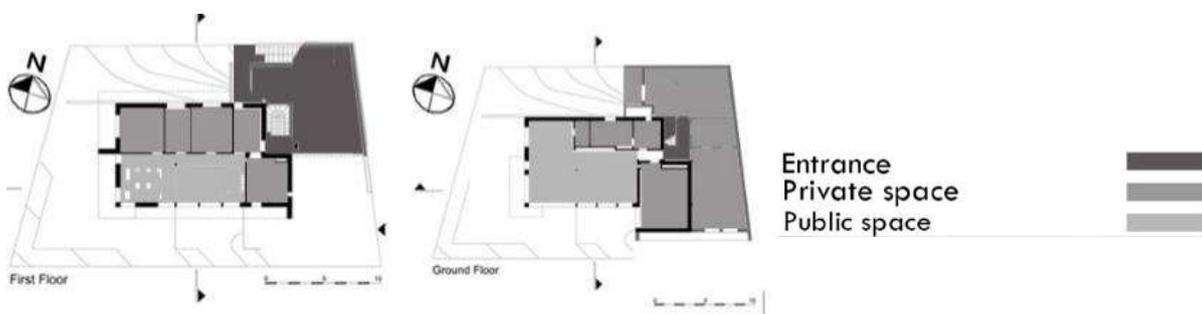
Figure 6.1 Floor plan of house

A more detailed analysis of the organization of space in the house shows that the greatest importance was given to the public space (living room and dining room). The position of the public space is south and west so that it uses the most solar energy and natural light, after which the north side and part of the east were used for private and service rooms (**Figure 6.1**).

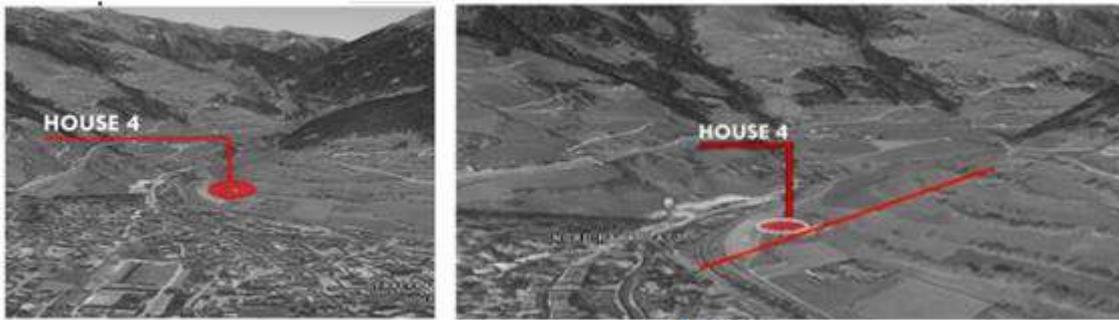
Figure 6.2 Graphical presentation of topography and position of the house 4 on the site.

The terrain on which house 4 is positioned is under a slight slope (**Figure 6.2**).

In relation to the position of the house, the slope of the terrain (highest point) is from east to west (the lowest point of the terrain), where it was necessary to bury two floors of the house on the east side. Cross-section through the terrain and the house (**Figure 6.3**) presented clearly that more than 50% of the house is underground, which is not economically profitable at the very beginning of construction, but in a slightly longer time benefit is that House is protected from strong alpine winds.

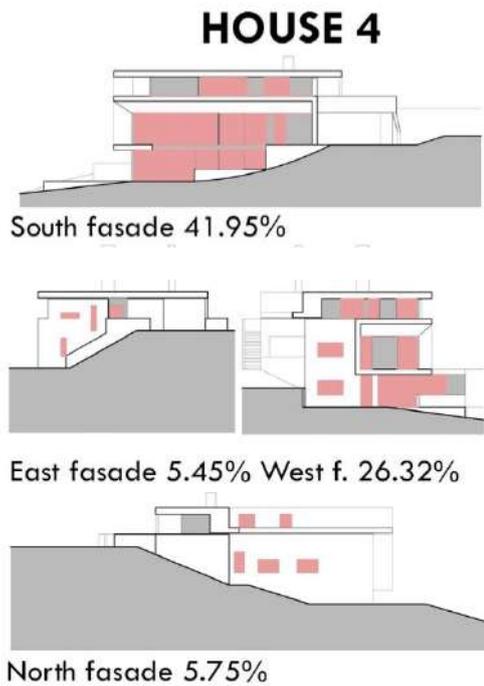
Figure 6.4 Percentage of the openings on facades

Detailed technical drawings of the façade of house 4 presented all the surfaces of the openings. According to detailed drawings (**Figures 6.4**), it can be clearly seen that on the south side of the building, the highest percentage of openings is 41.95%, which is the highest percentage of all 4 houses in the Alpine climate so far. After which the second largest percentage of openings is borne by the west side 26.32%.

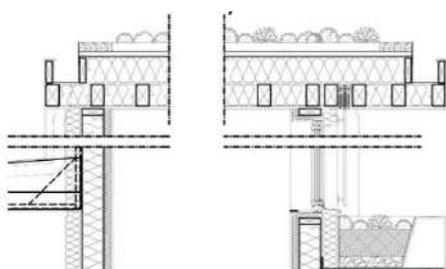
Figure 6.6 Cross-section of the roof

The roof of house 4 is flat with multi-layer insulation, and the last layer is the soil on which the grass is sown (**Figure 6.6**).

Strengthening the wooden structure was necessary in order to accept all the load of the last layer (earth), as well as the load that will cause snow during the winter, with an emphasis on the alpine climate in which the winter is long with a lot of precipitation.

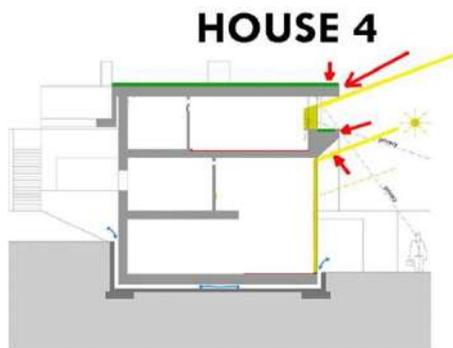
Figure 6.7 Shading system view through cross section

Detailed cross-section through the house with the presentation of the sun's rays

(Figure 6.7) as they affect the building during the summer is a clear indicator of what kind of shading system it is. The shading system was done on the top floor by letting the roof over the walls while on the floor below it was made at an angle prefabricated from a wooden structure over which the facade was done. As a whole, it aesthetically met the needs, however, and the efficiency is quite good, and it is useful only during the summer at the highest temperatures when the sun is in angle over 60° relative to the ground.

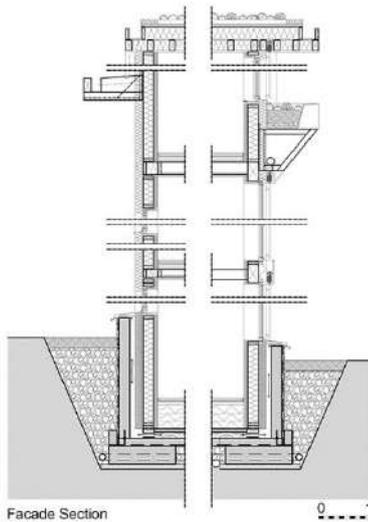
Figure 6.8 Cross section -slab, wall and roof

U-value = 0.12 W/(m2K)

Air tightness n50 = 0.59/h

(Figure 6.8) through all floors and analysis of the structure, we get the strategy followed by the architect's how did this project to make this house pass all the criteria of a passive house.

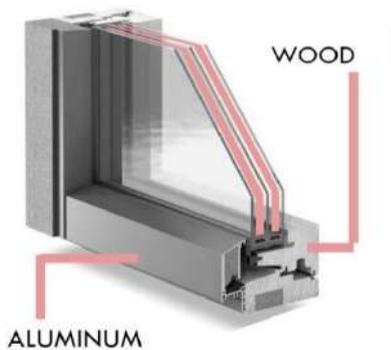
Figure 6.9 Section and picture of the window set

It was done with combinations of tested materials such as in the category’s timber, timber-alu, alu and vinyl

Wood-aluminum window (Triple glazing with lowemissivity glass)

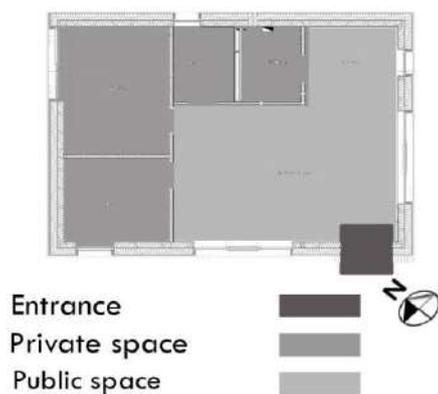
Figure 7.1 Floor plan of house

The graphic display (**Figure 7.1**) shows the organization of space in the house towards the sides of the world, so it is evident that public areas are oriented to the southeast, which is too much in passive houses to use solar heat and daylight. With relatively small openings, the bedrooms as a private space, positioned to the northwest, which is a very common occurrence in passive houses.

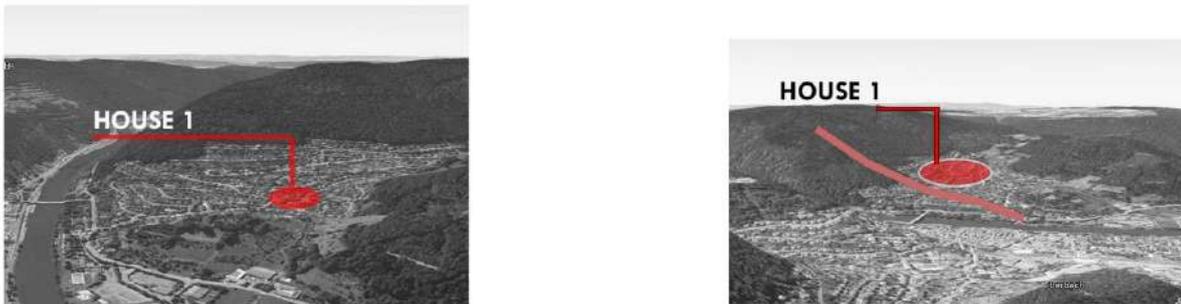
Figure 7.2 Graphical presentation of topography and position of the house 3 on the site

The position of the house is in a relatively hilly part of town where the continental climate is represented (**Figure 7.2 & 7.3**)

In this case, the building is not buried in the ground as in previous cases, but is raised by one floor on poles, which saves on digging and also on additional insulation needed when the building is in the ground.

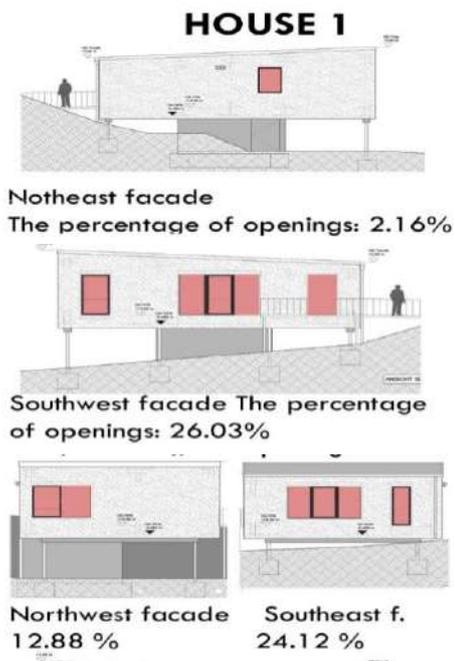
Figure 7.4 Percentage of the openings on facades

Therefore, as shown (**Figure 7.4**), the Southwest side has the highest percentage of openings 26.03% and as we have already pointed out in the description of the orientation, there are positioned public areas such as the living room and dining room where most natural light is needed because users – are usually most, they spend time there.

Southeast 24.12% where part of the public areas is positioned so that the percentage of openings is increased so that the house receives as much natural light as possible.

Northwest 12.88% is the part to which they were opened used for private rooms such as bedrooms and study rooms, while on Northeast there is a bathroom and there is an opening of 2.16% according to the minimum need of that space.

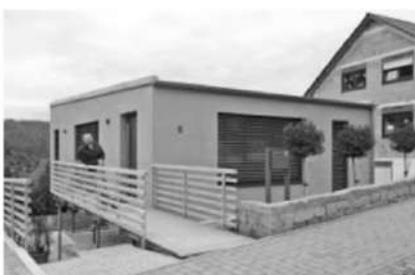
Figure 7.6 Pictorial representation of the roof surface finish

The architect predicted that the entire roof surface would be covered with sheet metal, to avoid additional insulation when the House has a This move saves a lot of money and the roof has been done adequately green surface or stone.

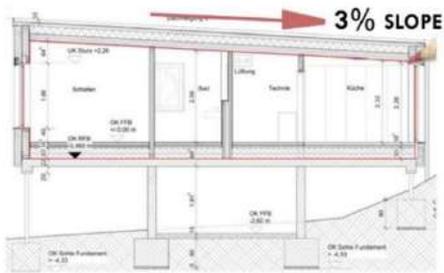
Figure 7.7 Cross-section through the house

The type of roof is flat with a slope of 3%, the slope starts from the northwest side to the southeast side as can be seen in the cross-section (**Figure 7.7**)

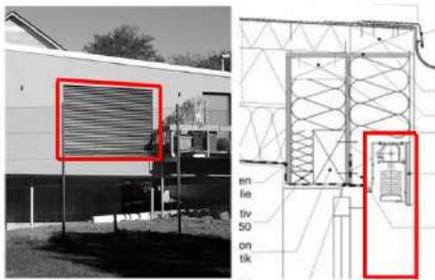
Figure 7.8 Section cross wall and shading system

The shading system on this house is done in the form of blinds, which are hidden in the facade and the descent down covers the glass surface of the opening according to the needs of the user. (Figure 7.8)

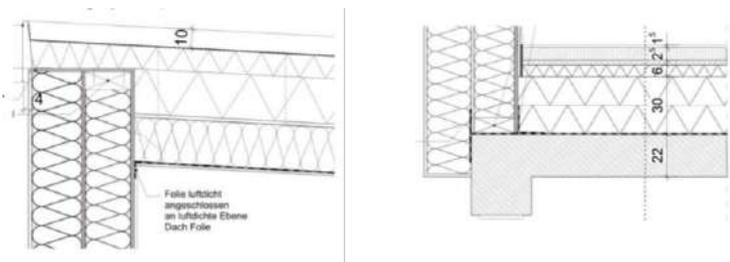
Figure 7.9 Cross section -slab, wall and roof

The detailed technical sections (Figure 7.9) of all layers of protection, structural elements, selection of materials, insulation, and method of building a house 1 is shown. Through the cross-section, we can see the construction strategy that has met all the conditions of a passive house. (A very important value for this research is U-value it is the process of measuring how effective a material is as an insulator. It refers to the permeability of warm air and the lower the U-value the material is the better insulator. The value of Airtightness is also important in passive houses and refers to the speed of air leakage through a building the value of it is usually 50 Pascals).

U-value = 0.076 W/(m²K)

Air tightness: n₅₀ = 0.4/h

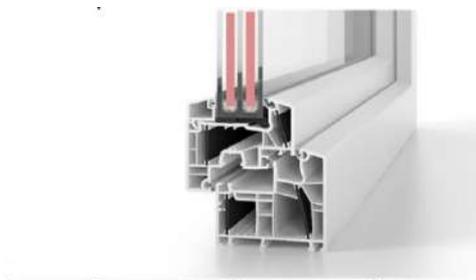
Figure 7.10 Section and picture of the window set

PVC, energeto® 8000 85 mm construction depth. **(Figure 7.10)**

Glazing

U g-value = 0.5 W/(m²K)

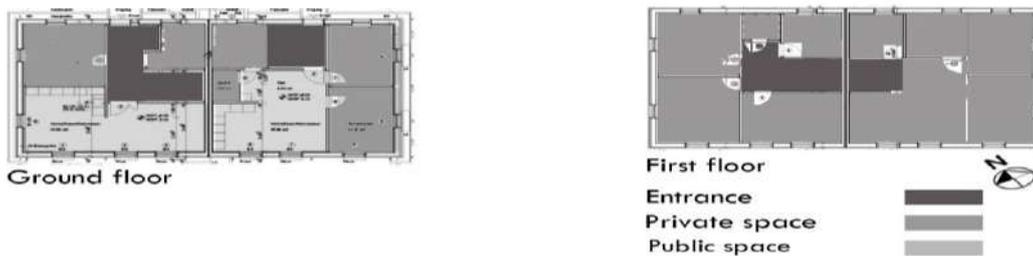
Figure 8.1 Floor plans of house

The Orientation house is positioned towards the urban plan (**Figure 8**) and as a result, the facade surfaces are not parallel to the sides of the world and it is at a slight angle so that it does not adversely affect the proper orientation of this house. The organization of the ground floor is that all public areas are oriented south and a small part to the west, while all private areas in the north are a large part east and in one part and west, the entrance is positioned in the north. On the second floor, as shown (**Figure 8.1**), the central part is the communication, while the other is all private space (bedrooms).

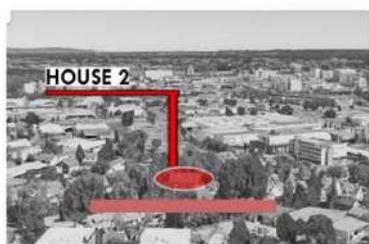
Figure 8.2 Graphical presentation of topography and position of the house 3 on the site

The terrain on which the house is located is relatively flat in a circle of about 5 to 10 km after which the terrain is hilly. The house is on a flat surface so no additional digging was required. The only excavation was for the base concrete slab.

The place where the house is located is very populated and the continental climate is present in this area. (**Figure 8.2**)

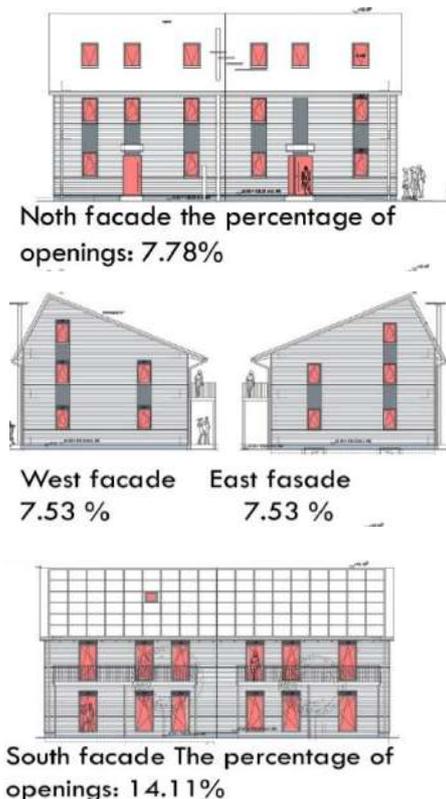
Figure 8.4 Percentage of the openings on facades

The highest percentage is on the Southside of 14.11% and as we could see in the analysis (orientation) that on the south side is positioned public spaces such as living room open kitchen and dining room.

North 7.78%, West 7.53%, and East 7.53% show that there is private and communication space on these sides and that the area of the opening is approximately the same for all three sides (**Figure 8.4**) Wind flow is not as strong as can be seen in the analysis of wind flow (**Figure 8.5**)

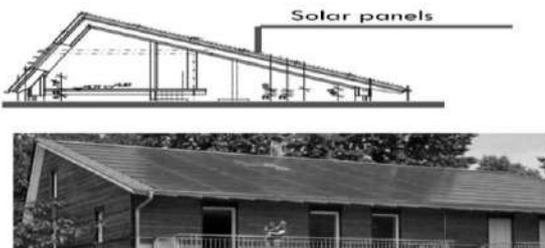
Figure 8.7 Section and picture of the roof

On house 2, which is in the area of continental climate, the architects predicted a gabled roof. The orientation of the roof surface is south-north. The arms of the roof are not at the same angle (**Figure 8.7**), the side facing south is purposely at a slight slope as while the north side is at a sharp angle, to get a larger roof area on the south side. The main reason for this move is to place solar panels (**Figure 8.6**) on a larger area (south), which is a huge contribution to this project, without the roof structure being expensive in practice.

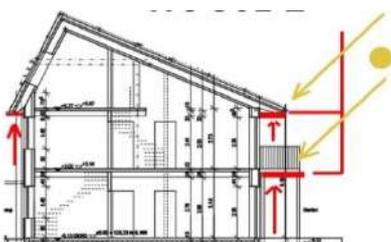
Figure 8.8 Section cross of the house and shading system

The shading system is of the classic type, the first floor is protected by the roof overhang, while the ground floor protects the balcony on the south side, where the public areas are located. (**Figure 8.8**)

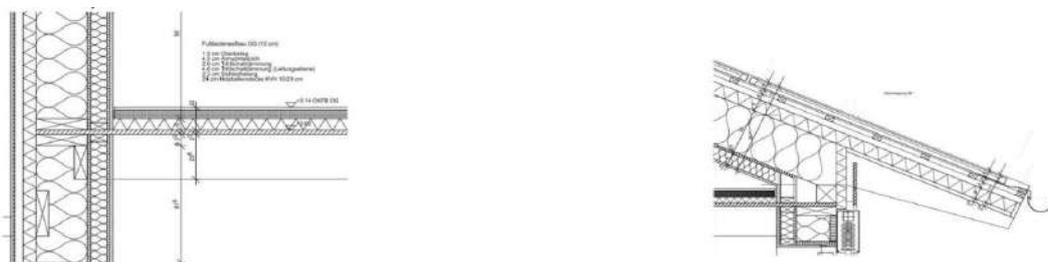
Figure 8.9 Cross section -slab, wall and roof

The detailed technical sections (**Figure 8.9**) of all layers presents the quality of the construction.

U-value = 0.093 W / (m²K)

Air tightness n50 = 0.4/h

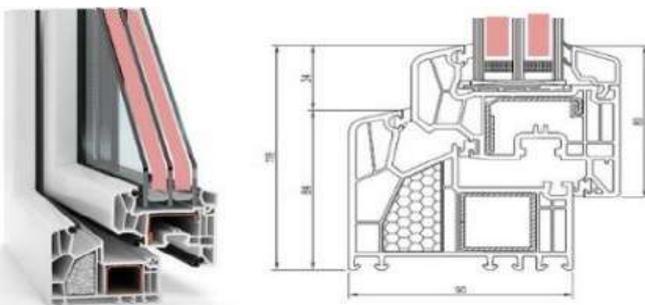
Figure 8.10 Section and picture of the window set

This house has windows of the company VEKA. (**Figure 8.10**) VEKA ALPHALINE 90 MD

WINDOWS-Alphaline is one of the better offers that the company Veka has produced for houses that are energy-efficient, which in most cases has shown very good results, such as on this house.

U g-value = 0.54 W/(m²K)

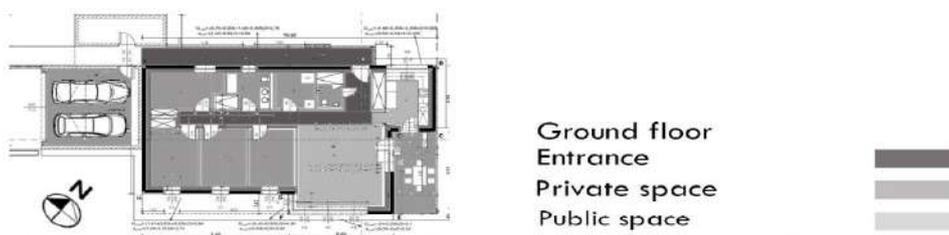
Figure 9.1 Floor plan of house

The orientation of house 3, which is located in a moderately populated place where the continental climate is present, is determined according to the urban plan, but the position of the rooms in it are very well used. As can be seen (**Figure 9.1**) on the southeast side where the highest concentration of the sun is positioned public areas while in the southwest are positioned private spaces such as bedrooms, even part of the bedrooms are located on the northwest where the entrance and horizontal communication. From this, it can be concluded that the position, orientation, and organization are according to what passive houses possess.

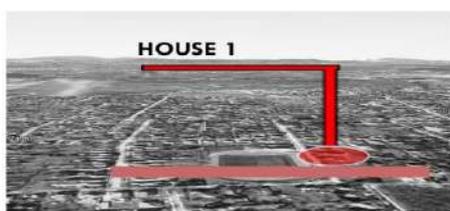
Figure 9.2 Graphical presentation of topography and position of the house 3 on the site

The area where house 3 is located is flat even in a district of a few tens of kilometers (**Figure 9.2**). The area is heavily populated and urbanized. The advantage is that the base is extremely flat and there was no need to bury the house, except for the excavation provided for the concrete foundations, which support the entire house. In such terrains, a problem in the wind flow can often occur, where the mountainous winds descend towards the flat part uncontrolled from all sides.

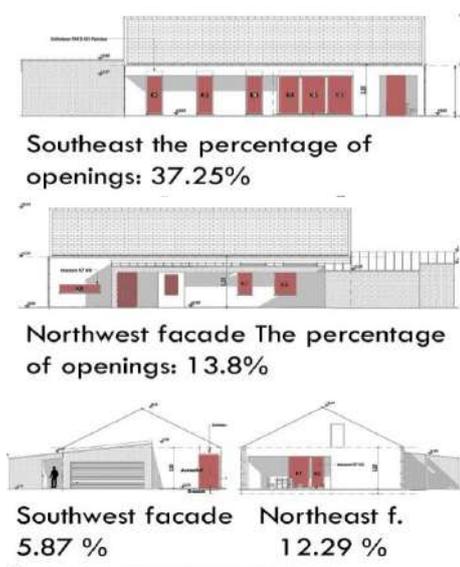
Figure 9.4 Percentage of the openings on facades

According to the given analysis (**Figure 9.4**), it is clear that the southeast side has drastically the highest percentage of openings 37.25% because as we have already analyzed on that side are located public spaces such as the living room and a large part of the bedrooms. While Northeast 12.29% and Northwest 13.8% are pretty much up to the standard of the area of openings that these rooms need. on the southwest, there is an entrance and it is 5.87% of the total area of the facade. Another thing is very important to mention that the analysis of wind (**Figure 9.5**) currents showed that the strongest wind flow comes from the Northwest, however, even if there is a budget of 13.8% openings along the dimensions are small. According to the project, two toilets and storage were positioned in the northwest, which required that the size of the opening be smaller and thus reduce the risk of air leakage.

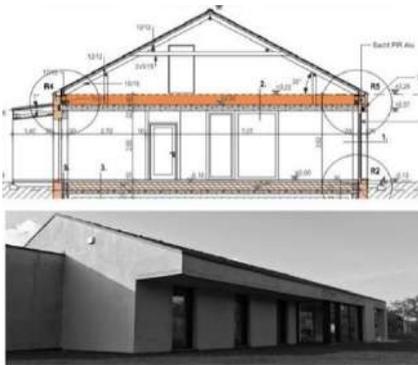
Figure 9.6 Section and picture of the roof

On house 3, which is located in the area of continental climate, the architects envisioned a gabled roof. The orientation of the roof surface is northwest-southeast. The arms of the roof structure are made symmetrically at the same angle. An interesting detail that can be seen in the cross-section (**Figure 9.6**) is that the architects did not plan to let the roof over the walls and make a shading system but did it in another way. Solar panels

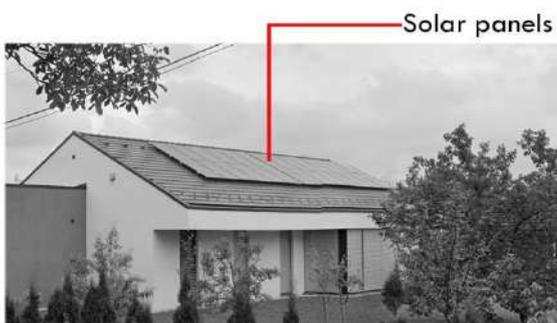
Figure 9.7 Solar panels over the roof tiles

(**Figure 9.7**) are placed on the surface of the roof structure facing south-east.

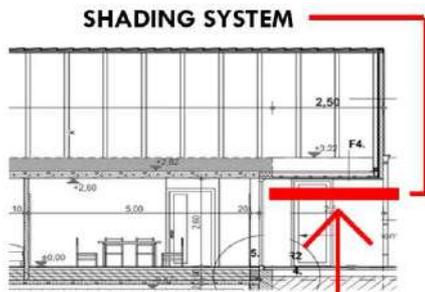
Figure 9.8 Section cross of the house and shading system

As already mentioned, the highest concentration of sun and solar heat is reflected on the southeast facade, especially during the summer. The architects have indented one part on the south-east side so that the roof slab and roof are over that space if we look through the cross-section (**Figures 9.8**) and with this step protection is gotten for the public space in the house from strong sunlight and heat.

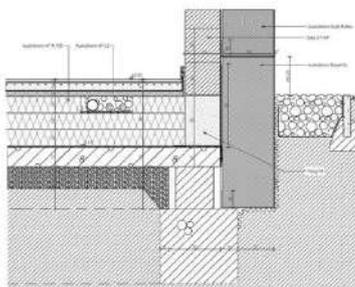
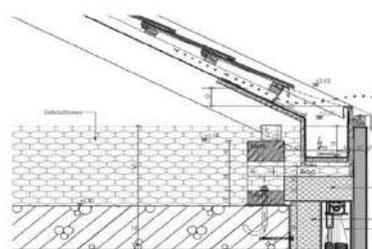
Figure 9.9 Cross section -slab, wall and roof

The detailed technical sections (**Figure 9.9**) of all layers presents the quality of the construction. (A very important value for this research is U-value it is the process of measuring how effective a material is as an insulator. It refers to the permeability of warm air and the lower the U-value the material is the better insulator. The value of Airtightness is also important in passive houses and refers to the speed of air leakage through a building the value of it is usually 50 Pascals)

U-value = 0.095 W / (m²K)

Air tightness: n50 = 0.26/h

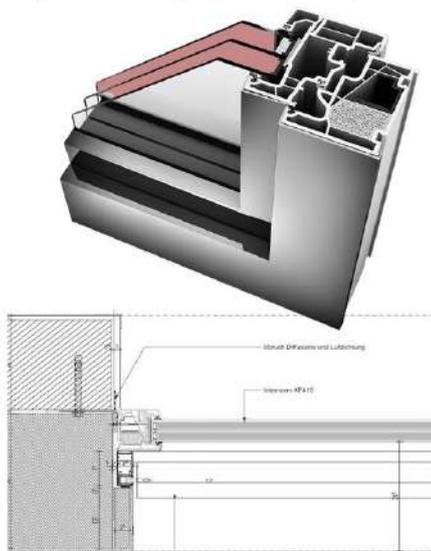
Figure 9.10 Section and picture of the window set

This house has windows of the company Internorm, KF 410 (**Figure 9.10**). Plastic-aluminum windows,

Whether in classic white plastic or with a weatherproof aluminum shell - with KF 410 right decision. The angular design of the frame and sash is coordinated with the construction of the home pure design style. Thanks to the new I-tec Insulation technology, the frame is completely insulated and the thermal insulation is significantly improved. If required, the I-tec ventilation can be integrated into this window. This innovative ventilation system ensures sufficient fresh air and a perfect indoor climate for 24 hours.

Glazing U g-value = 0.57 W/(m²K)

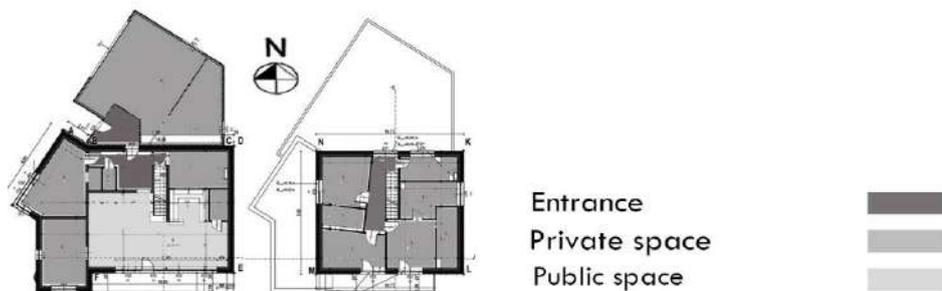
Figure 10.1 Floor plan of house

House 4 is made in an area where the continental climate is represented. The shape of the house as can be seen in the picture (**Figure 10**) is very specific and useful. One part of the house follows the line of the road to follow the urban plan, while one part is oriented so that the walls are parallel to the sides of the world, which is an ideal solution when it comes to passive houses. As with the others passive house, house 4 is planned: the public space (living room and dining room)are positioned to the south, while the private spaces as bedrooms face north and east on the ground floor, and on the first floor there is one bedroom or study on each side, with different number and size of the openings. Communication (entrance) is central and north which is ideal for these conditions.

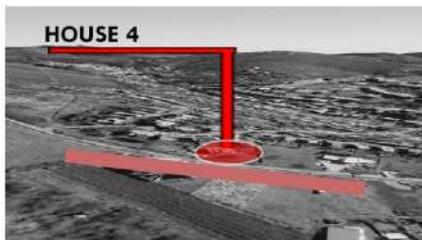
Figure 10.2 Graphical presentation of topography and position of the house 3 on the site

The location where house 4 is located is slightly hilly, (**Figure 10.2**) the position where the house is located is slightly sloping, so it was necessary to bathe and level the part where the house is positioned. No part of the house is total in the ground except the concrete structural ground floor slab that accepts the load of the whole building.

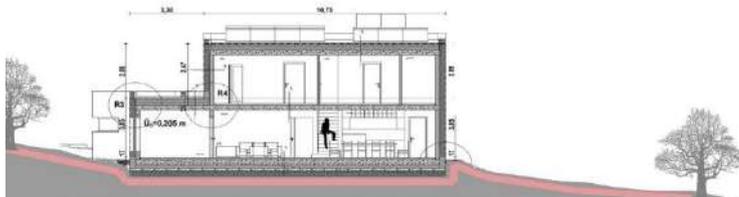
Figure 10.3 Graphical presentation of cross section through the house and the site where the house is located.

(**Figure 10.3**)

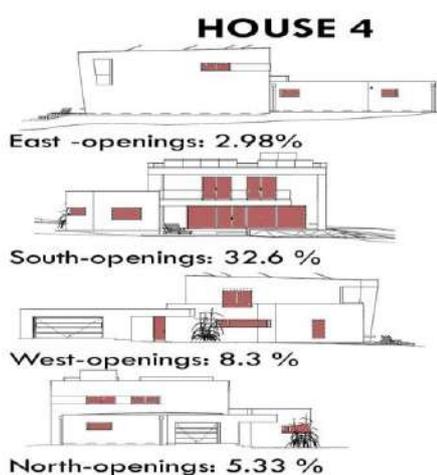
Figure 10.4 Percentage of the openings on facades

By calculating the area of facades (**Figure 10.4**), we obtained that the highest percentage of openings on the South Facade is 32.6%, which we saw in the orientation analysis that the position of public spaces is in the south so that the area of openings is properly distributed and the area of openings is ideal. Westside 8.3% the second largest area of the opening, according to analysis number 1, the orientation there are positioned private space (bedrooms, pantry, as well as garage space). Northside 5.33% are positioned entrances and horizontal communication between the spaces. Eastside 2.98% also have private rooms such as bedrooms, and study rooms which is not the practice to have the lowest percentage of openings on that side, however, House 4 is still with quality and the way it is made passive.

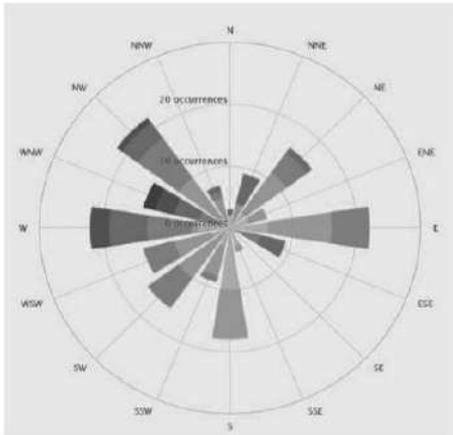
Figure 10.5 Wind rose for Hungary-Eger

Through the analysis of wind rose (**Figure 10.5**)

, we can see that the strongest winds flow from the east and west, which is not common as in other houses, and thus we can conclude that the main reason why architects reduced the area of openings on the east side to avoid air leaks through windows.

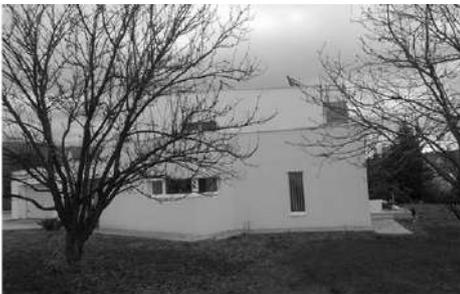
Figure 10.7 Solar panels over the roof tiles

According to the area where house 4 is, it is positioned as we have already stated the continental climate. The sun's heat reaches about 300 degrees, which the architects used for energy purposes. The roof is flat with multi-layer insulation and solar panels are positioned on the roof surface (**Figure 10.7**), which is of great benefit if take into account the summer temperature we have stated.

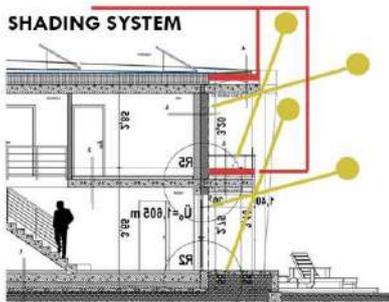
Figure 10.8 Section cross of the house and shading system

The biggest influence of the sun is on the south side. An architect on that side let the roof over the wall and protect the private rooms upstairs, also on the ground floor protection is the terrace from the first floor and all this is a shading system that is effective during summer heat and strong sunlight. However, in winter this shading system does not affect (**Figure 10.8**)
