Sustainable Design Strategy for Single-Family Housing in Bosnia and Herzegovina

Keywords: Sustainable design, single-family home, passive design, energy efficient, sustainable construction, environment.

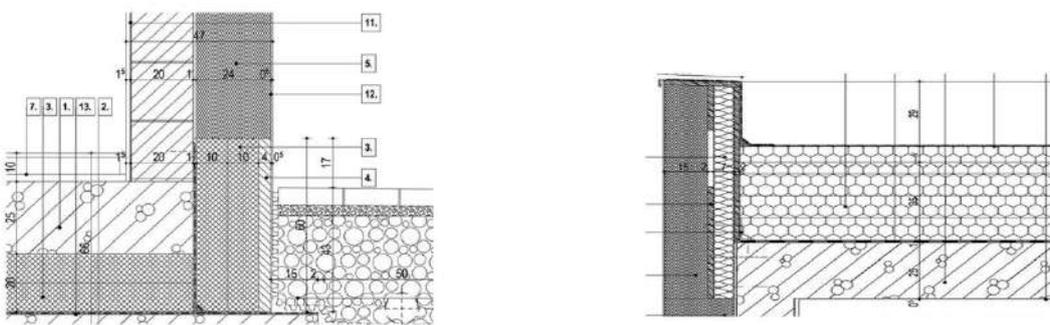
Figure 10.9 Cross section -slab, wall and roof

The detailed technical section (**Figure 10.9**) of all layers presents the quality of the construction. (A very important value for this research is U-value it is the process of measuring how effective a material is as an insulator. It refers to the permeability of warm air and the lower the U-value the material is the better insulator. The value of Airtightness is also important in passive houses and refers to the speed of air leakage through a building the value of it is usually 50 Pascals)

Exterior wall: Lime-gypsum plaster, sand-lime brick masonry, Bachel, mineral external plaster
 U-value = 0.097 W / (m2K)

Basement floor / floor slab: Ceramic, screed, footfall sound insulation, reinforced concrete floor slab, insulation
 U-value = 0.159 W / (m2K)

Roof: Thermal insulation, reinforced concrete ceiling
 U-value = 0.097 W / (m2K) Air tightness: n50 = 0.22/h

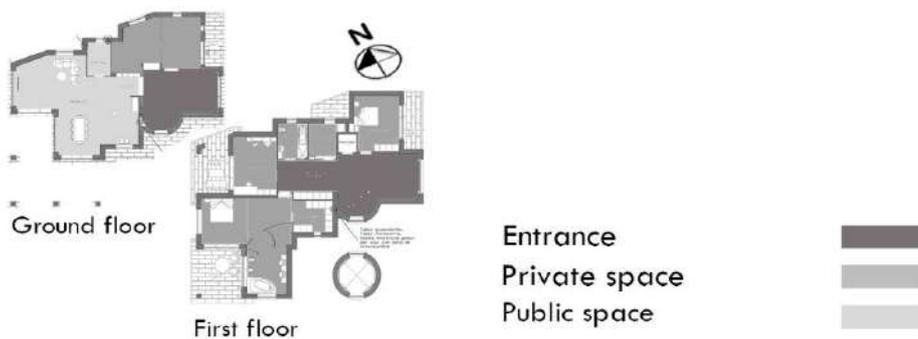
Figure 11.1 Floor plan of house

1.ORIENTATION Since House 1 is located in a very hilly place, the plot has affected the position of the house in relation to the terrain (**Figure 11**). The place is moderately populated, but the landscape is highly mountainous and if the Mediterranean climate is present. Regardless of the circumstances in which the house is located, the architect has organized the space so that the organization is adequate to what the passive system of the house requires. According to the analysis (**Figure 11.1**) on the ground floor on the south and west side is positioned public space as is usual with passive houses to use natural light and sunlight, on the first floor in the same position are private rooms, such as the master bedroom. As for the private rooms (bed-rooms and study rooms), in addition to the south and west sides, they are located in the north of the house. The entrance and communications are positioned to the east because on that side there is a road that leads to the house.

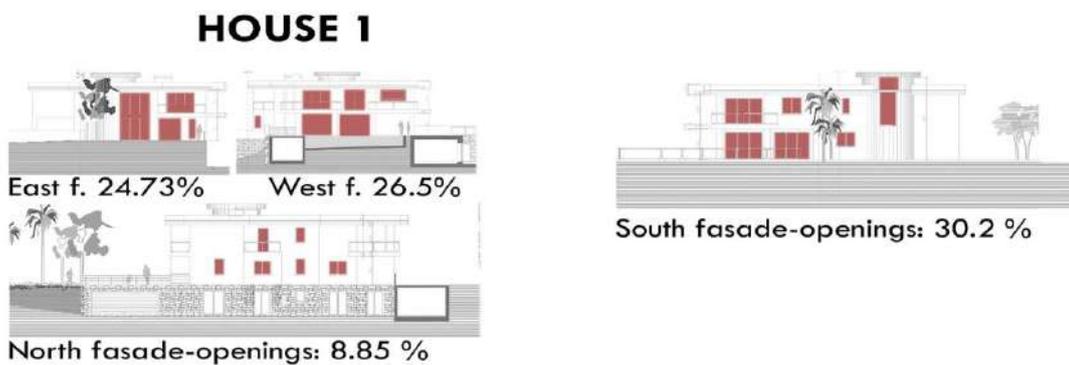
Figure 11.4 Percentage of the openings on facades

As already mentioned in the analysis 1 orientation, the public space (living room and dining room) is located to the south and west, and therefore we see that on that side is the largest percentage of openings so that in house 1 can access as much sunlight, that is, natural light as well as heat from the sun. South facade 30.2% and West facade 26.5%. While in the North it is 8.85% where the bedrooms are positioned. East facade 24.73% purpose of this amount of openings is that on that side is also part of the bedrooms as well as all horizontal and vertical communication.

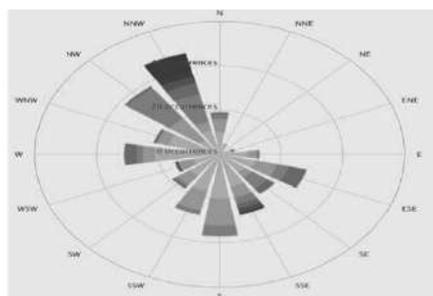
Figure 11.5 Wind rose for Spain-Mijas

Based on the analysis of winds (**Figure 11.5**) for the areas where house 1 is located, we can conclude that winds are present from all sides. The strongest wind currents come from the north. Depending on the climate zone, the winds will not adversely affect the house 1

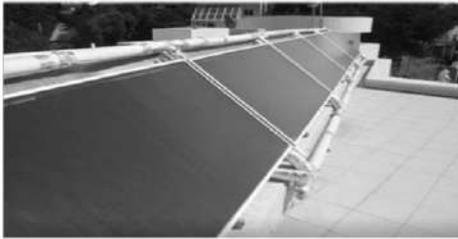
Figure 11.6 Solar panels over the roof tiles.

As already mentioned, that the house is located in a hilly area but with a Mediterranean climate, the architect predicted a flat roof, which is recommended for this area. What should be emphasized is that the roof area is about 140 square meters, which is quite large, and with vertical communication, it is always possible to access the roof. An architect decided on an energy-efficient step. As can be seen in the picture (**Figure 11.6**) on the roof surface are positioned solar panels, which make a huge contribution to energy savings, especially when it comes to the Mediterranean climate where there are many sunny days during the year.

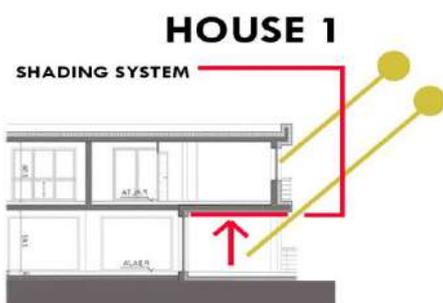
Figure 11.8 Section cross of the house and shading system

The strongest impact of the sun is on the south side. The architect on that side lets the roof slab over the wall to cover the bedrooms upstairs, the terrace from the first floor also covers the ground floor, and all this is a shading device that is efficient during summer heat and strong sunlight. However, this shading system does not impact in winter (**Figure 11.8**)

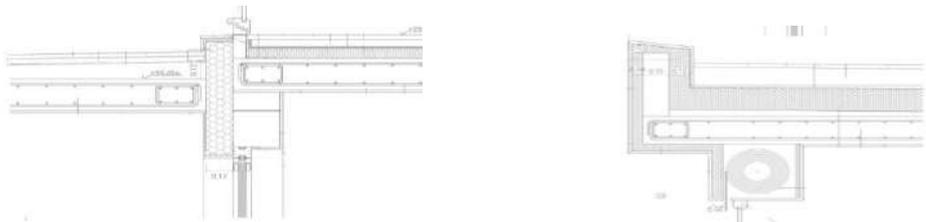
Figure 11.9 Cross section -slab, wall and roof

The detailed technical section (**Figure 11.9**) of all layers presents the quality of the construction. (A very important value for this research is U-value it is the process of measuring how effective a material is as an insulator. It refers to the permeability of warm air and the lower the U-value the material is the better insulator. The value of Airtightness is also important in passive houses and refers to the speed of air leakage through a building the value of it is usually 50 Pascals)

U-value = $0.23 \text{ W / (m}^2\text{K)}$

Air tightness: n50 = 0.469/h

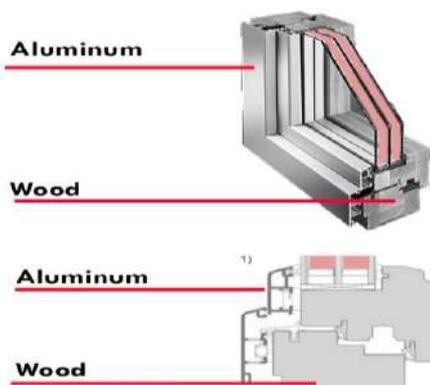
Figure 11.10 Section and picture of the window set

This house has windows of the company

GUTMANN MIRA (Figure 11.10)

U g-value = $1 \text{ W/(m}^2\text{K)}$

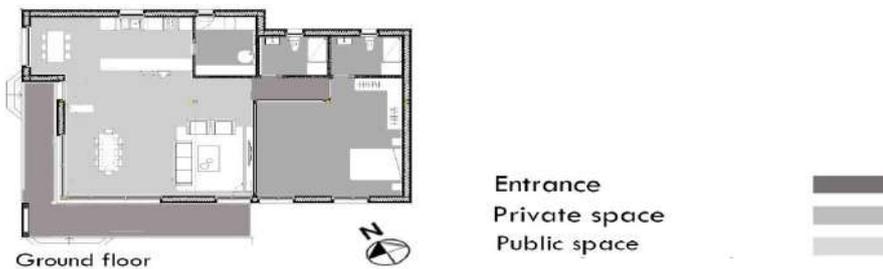
Figure 12.1 Floor plan of house

(Figure 12.1)

The entire space on the west and half of the building on the south is designed to be a public area (living room, dining room). The other half of the southern part of the house is designed for private space, ie the master bedroom. The northern part of the house was used for service rooms (bathrooms and kitchen)

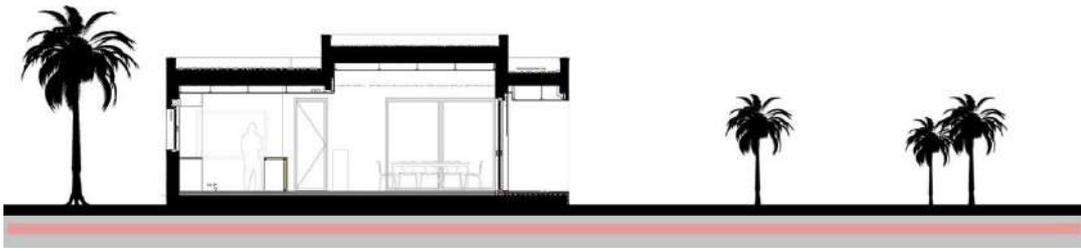
Figure 12.3 Graphical presentation of cross section through the house and the site where the house is located.

As already mentioned, the terrain is absolutely flat, which is analyzed by the technical cross-section through the terrain and through the house (**Figure 12.3**), the financial advantage is that it is not necessary to bury the part of the house, as is the case with houses on hilly terrain.

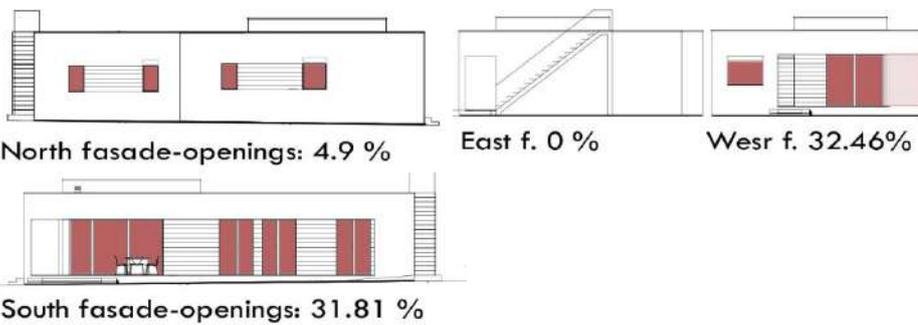
Figure 12.4 Percentage of the openings on facades

On the south side, there is also a master bedroom so a certain percentage of the openings on the south side is divided into public and private space. As we have already mentioned, there are service rooms on the north side and on that side, the percentage is 4.9%, which is in line with the needs of that area. However, it is important to mention that we do not have openings on the east side, so the percentage is 0% (**Figure 12.4**)

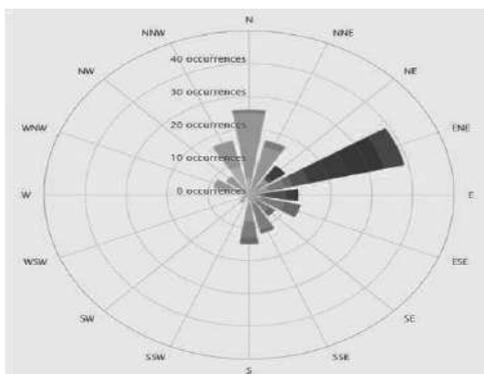
Figure 12.5 Wind rose for Spain-Torrellano

Analysis of the winds (**Figure 12.5**) showed that the strongest current comes from the east, and the premise of this study is that the architects did not design openings on that side, to avoid air leakage through the openings due to strong winds.

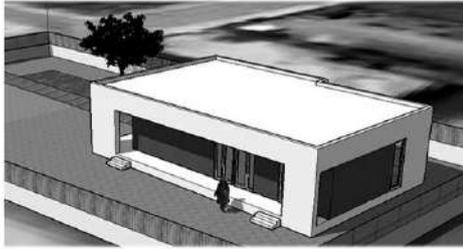
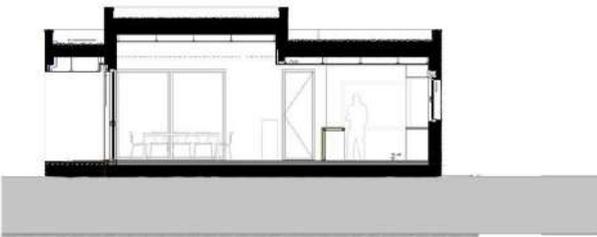
Since the house is located in an area where the Mediterranean climate is presented, the architects designed a flat roof, which is common for such an area. **(Figure 12.6 & 12.7)**

Along the east side on which we have mentioned that there is no opening, stairs have been built leading to the roof. All things considered, the only drawback is that no solar panels are installed on the roof surface, as we have found that access to the roof is possible and that the area is ideal for solar panels.

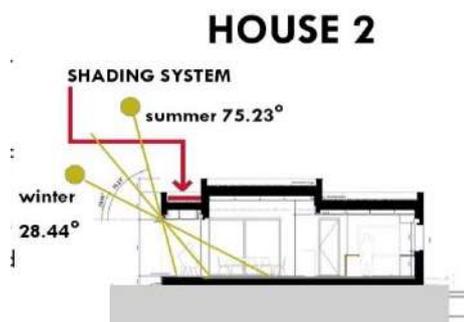
Figure 12.8 Method of the shading system

As has already been stated, the highest concentration of sun and solar heat is reflected on the south-eastern facade, particularly during the summer. Architects have indented one portion of house on the south and east side so that the roofing slab and roof are over that space if we look through the cross-section **(Figures 12.8)** and with this step security the public space in the house is shielded from strong sunlight and heat.

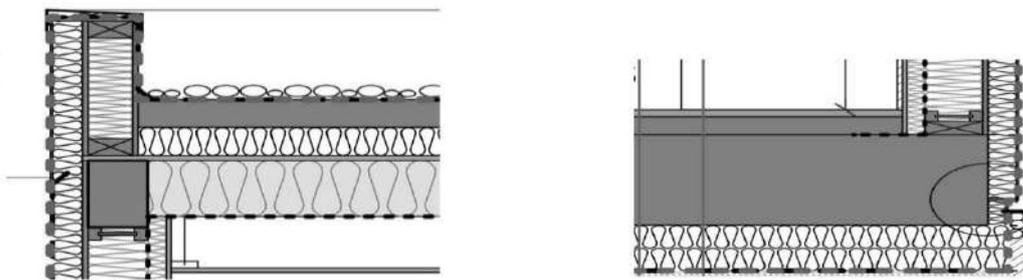
Figure 12.9 Cross section -slab, wall and roof

The detailed technical section **(Figure 12.9)** of all layers presents the quality of the construction. (A very important value for this research is U-value it is the process of measuring how effective a material is as an insulator. It refers to the permeability of warm air and the lower the U-value the material is the better insulator. The value of Airtightness is also important in passive houses and refers to the speed of air leakage through a building the value of it is usually 50 Pascals)

U-value = 0.122 W/(m²K)

Air tightness: n50 = 0.5/h

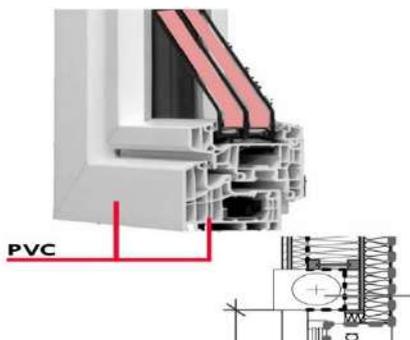
Figure 12.10 Section and picture of the window set

Hoco (**Figure 12.10**)

HOCO H671 PVC entrance door

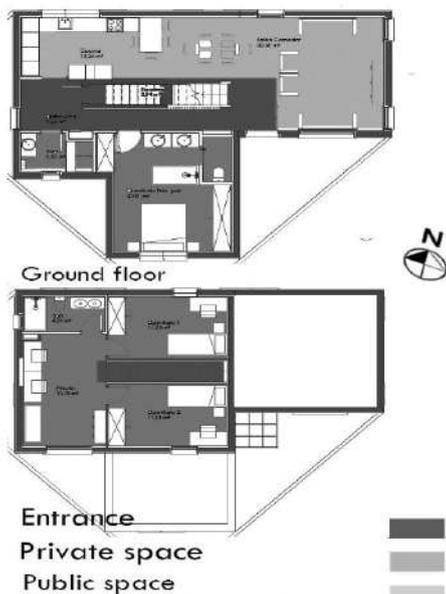
Figure 13.1 Floor plans of house

where house 3 (**Figure 13**) is located is populated, and it can also be said that the terrain is slightly hilly. In this area where the house is positioned, the Mediterranean climate is represented. How the house is oriented and the positions of the rooms have not been a practice in previous analyzes of passive houses. The architects placed the public areas (living room, kitchen and dining room) on the north side and the private rooms on the south. However, a more detailed analysis of the terrain and topography (**Figure 13.2**) concludes that the architects opted for the north side because of the view of the city, because it is a public space (living room, kitchen and dining room) where users spend most time in the house. Upstairs, the organization is such that all private rooms, service and communication, are positioned. (**Figure 13.1**)

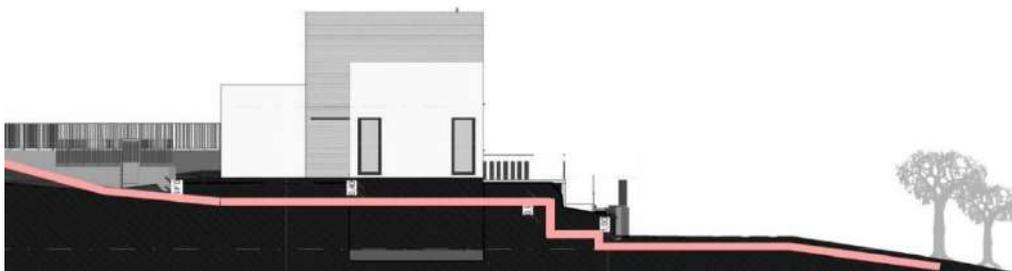
Figure 13.3 Graphical presentation of cross section through the house and the site where the house is located.

As we have already mentioned the house is positioned on slightly hilly terrain. as shown in the detailed technical section (**Figure 13.3**) one part of the ground floor had to be underground, due to a slight drop in terrain. The fall of the terrain starts from the south side as the highest altitude and descends towards the northern part, and that is how we stated the reason why the architects did not turn the public spaces towards the south.

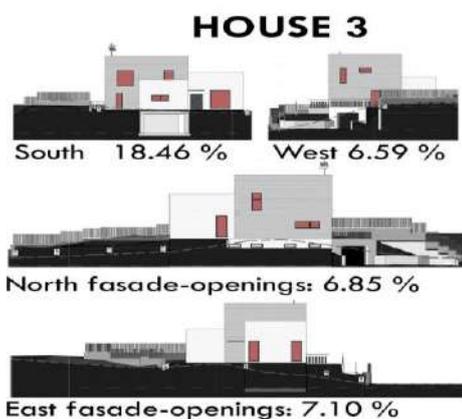
Figure 13.4 Percentage of the openings on facades

Through the analysis of the surfaces of the facades from house 3, the percentage of openings will be separated and analyzed. According to the surface calculation, the South Facade has the highest percentage of openings to the façade surface, 18.46%. According to the analysis (orientation), it was concluded that all private rooms, such as study and bedrooms, are located in this position, and the reason given is that due to the hilly part of the plot on the south side. After the south, the eastern façade has the highest percentage of 7.10% and then the northern 6.85% where it is emphasized that there are public rooms (living room, bedroom, and kitchen), however, given that these are public areas where the greatest amount of natural light is needed, the architects did not take a risk but design with a minimal percentage. The western facade of 6.59% has the smallest area of the opening and according to the first analysis (orientation), we see that the communication and service rooms are positioned. As for wind analysis (**Figure 13.5**), wind currents come from three sides, north, south, and east with the strongest intensity from the east, and this is one of the reasons why the architects.

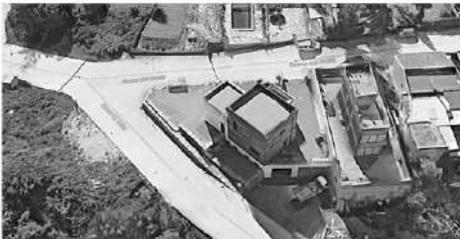
Figure 13.6 Picture of the roof

At house 3 the case is identified as at house 2. Both locations have a Mediterranean climate and a flat roof, which is as we mentioned in this study that is a practice in the Mediterranean climate, but house 3 has an even larger roof area, and as in house 2 is not used for energy-efficient step (installation of solar panels) which is a very large contribution to the facility given that it is located in such an area.

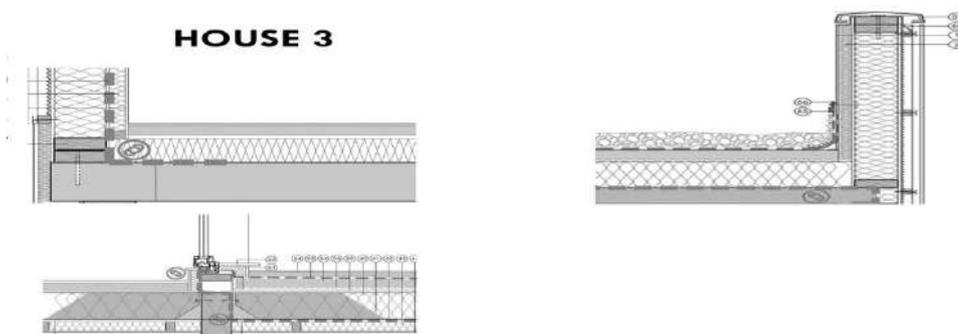
Figure 13.8 Cross section -slab, wall and roof

The detailed technical section (**Figure 13.9**) of all layers presents the quality of the construction. (A very important value for this research is U-value it is the process of measuring how effective a material is as an insulator. It refers to the permeability of warm air and the lower the U-value the material is the better insulator. The value of Airtightness is also important in passive houses and refers to the speed of air leakage through a building the value of it is usually 50 Pascals)

U-value = 0.221 W/(m²K)

Air tightness: n50 = 0.22/h

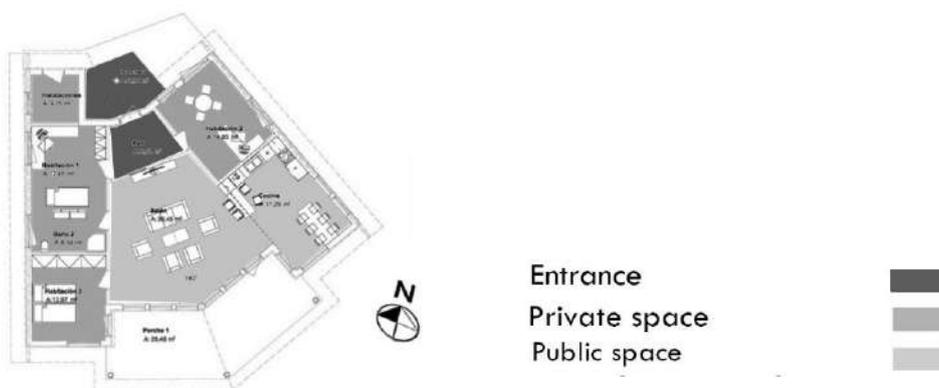
Figure 14.1 Floor plan of house

The location of house 4 is moderately populated, so to speak, in the development of population settlement. **(Figure 14)** The area is slightly hilly, and the Mediterranean climate is represented. By analyzing the orientation and organization of the space, it can be said that the architects, as is usual with passive houses, positioned the public space to the south and the part of the east where the highest concentration of the sun is. Private rooms (bedrooms and study rooms) are positioned to the west and a lesser extent to the north, Horizontal communication is central and north. From this analysis it can be concluded that the position, orientation and organization of space in house 4 was done correctly and following the requirements of passive houses **(Figure 14.1)**

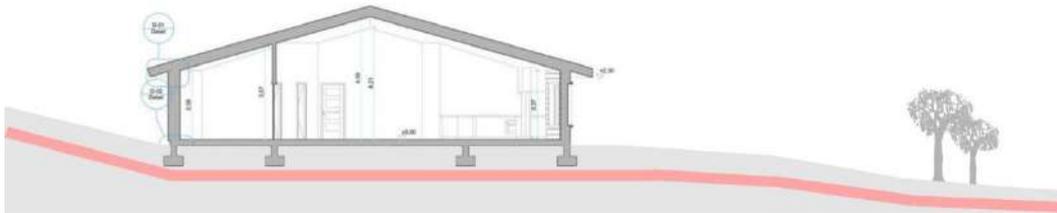
Figure 14.3 Graphical presentation of cross section through the house and the site where the house is located

The terrain on which the house is built was in a very small slope so excavation was needed only for the foundation.

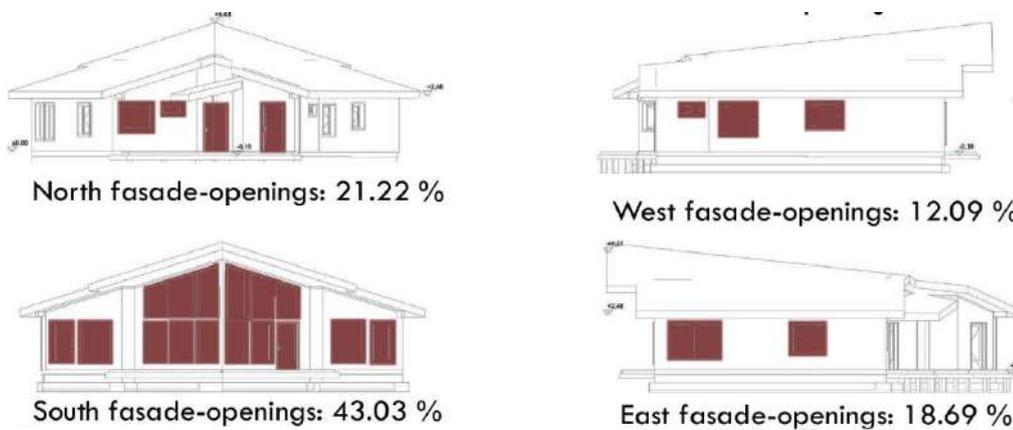
Figure 14.4 Percentage of the openings on facades

The percentage of the opening to the entire surface of the facade is seen in this study of the experiments, and what the intention is (**Figure 14.4**). The estimate reveals that 43.03 % is the highest percentage on the south facade.

On the south side, as we have already mentioned, there is an organized public space where users spend most of their time, and on that side is the highest concentration of sun, which is why it has the highest percentage of openings.

After the southern highest percentage of openings, it has the northern side of 21.22%, on which the central entrances and the horizontal communication between the spaces are positioned. East side 18.69%, on that side there are bedrooms and working rooms (private space). With the lowest percentage of openings, the east side is 12.09%, and the kitchen and dining room are positioned on that side, which can be concluded that it is in line with the needs of the positioned space. Analysis of winds (**Figure 14.5**) shows that the strongest current comes from the eastern side, which is an assumption that on that side is the smallest percentage of openings.

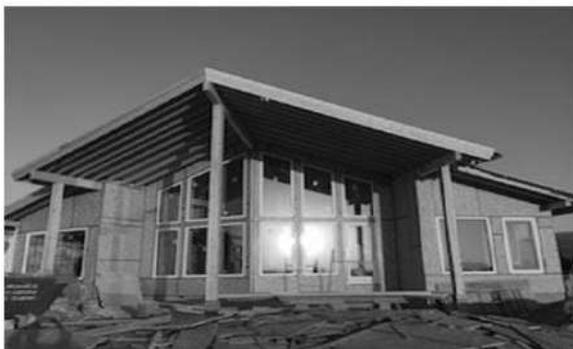
Figure 14.6 Picture of the roof

On the house 4 type of roof is gabled, with a slope of 15.70 % (**Figure 14.6 & 14.7**), the assumption is that the classic roof structure, which is one of the cheapest types of roofs. It should be emphasized that a drop of 15.70% is not common, in places where there are heavy rainfall and snow, but it is a Mediterranean climate so it is not problematic. It is also important to emphasize that in the western part of the roof are installed several solar panels, which is not a huge contribution, but it is useful for smaller needs of the house.

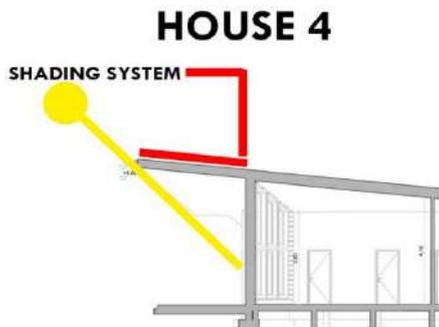
Figure 14.8 Shading system

By overhanging the roof structure over the walls on the south side where, as we analyzed, the highest percentage of openings and where the highest concentration of the sun is, was obtained a shading system which is effective during the summer period (Figure 14.8).

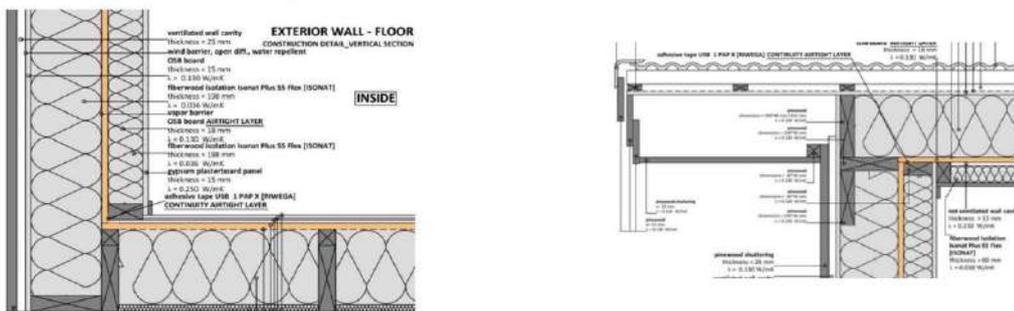
Figure 14.9 Cross section -slab, wall and roof

The detailed technical section (Figure 14.9) of all layers presents the quality of the construction. (A very important value for this research is U-value it is the process of measuring how effective a material is as an insulator. It refers to the permeability of warm air and the lower the U-value the material is the better insulator. The value of Airtightness is also important in passive houses and refers to the speed of air leakage through a building the value of it is usually 50 Pascals)

Basement floor / floor slab: Floor surface, Anti-impact layer, Gypsum plasterboard, OSB board, Fiberwood isonat plus, Fiberwood sylvactis HD
U-value = 0.164 W/(m2K)

Roof: OSB board, Fiberwood Isonat plus, OSB board, Wall cavity, Fiberwood isonat plus Wood shuttering,
U-value = 0.138 W/(m2K)
Air tightness: n50 = 0.6/h

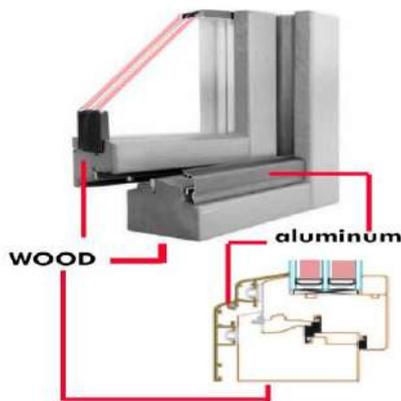
Figure 14.10 Section and picture of the window set

This house has windows of the company Carinbisa V92 (**Figure 14.10**)

U g-value = 0.55 W/(m²K)

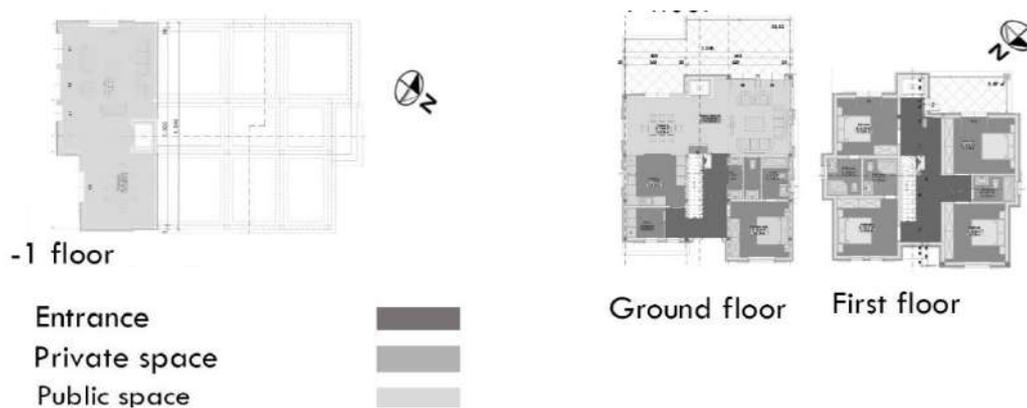
Figure 16.1 Floor plan of house

The orientation of house 1, which is located in a moderately populated place (Figure 16) where the continental climate is present, is determined according to the urban plan, but the position of the rooms in it is very well used. As can be seen (Figures 16.1) On the entire Southside as well as half of the east and west on the floor -1 and ground floor is located a public space such as a living room dining room, with huge balconies for outdoor seating. On the ground floor on the east side of the house is the kitchen and pantry. In the west, there is one bedroom with a bathroom, while in the north there is a central entrance and communication. Upstairs are the layout of 4 bedrooms, each of which shares openings on two sides - one-bedroom divides with south and east another with south and west third with north and east fourth with north and west in the central part there are communications and, on the west, and east there are toilets.

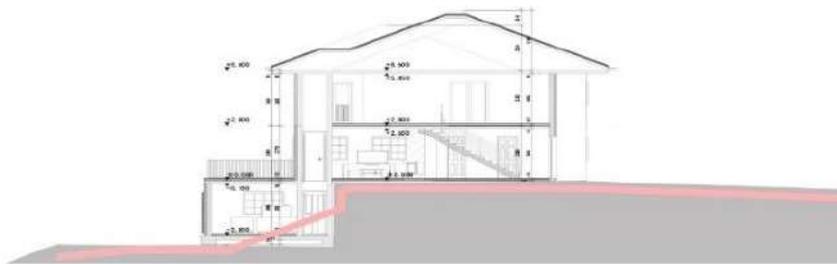
Figure 16.3 Graphical presentation of cross section through the house and the site where the house is located.

The area where house 1 is located is slightly hilly, which is shown by the analysis of the technical cross-section (**Figure 16.3**) through the house and the terrain. Considering the terrain, one part of the house is in the earth (north side of -1 floor), in this case, the public area on the -1st floor faces south, and the ground floor is zero with the access road to the house on the north side.

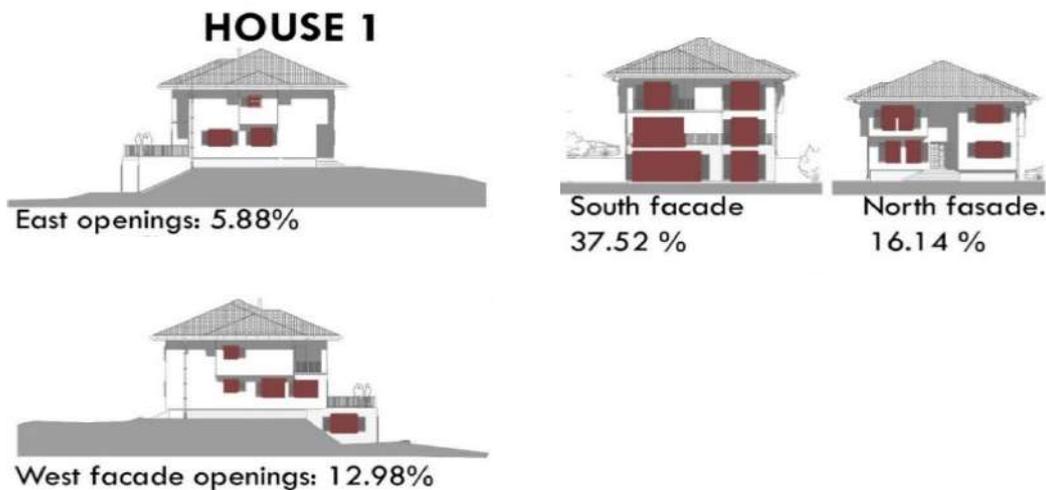
Figure 16.4 Percentage of the openings on facades

According to the analysis (**Figure 16.4**), it is clear that the south side has drastically the highest percentage of openings 37.52% because as already analyzed on that side are located public spaces such as the living room and a large part of the bedrooms at the first floor. After the south, the north side has the highest percentage of 16.14%, which is not the practice when it comes to passive houses. Communications and the entrance to the house are positioned on the north side, and bedrooms are positioned on the first floor, and consequently, there is more than enough area of the openings, which is not an advantage, but a disadvantage. The western part of the façade has 12.98% of the area of the opening and the western part has a part of public and sleeping spaces, which is in line with the needs of these rooms.

The eastern part of the façade has 5.88% of the area of the opening, in these parts the kitchen and bedrooms are positioned, and consequently, it isn't enough for this type of spaces. Analysis of winds for this area (**Figure 16.5**) shows that the strongest winds come from the southeast, and thus indicate another shortcoming in the surface of the openings, that on these sides there is a huge percentage which increases the risk of air leakage through the openings

Conclusion-The organization of the opening as well as the surface is not adequate and following the requirements of passive houses. Proposal-Change the position and area of the openings per the needs of the spaces.

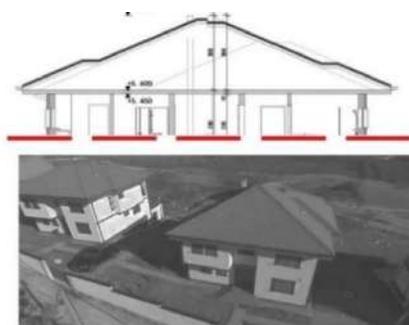
Figure 16.6 Cross section of the roof and picture of the roof

On house 1, which is located in the area of continental climate, the architects envisioned a hip & valley roof. The slope of all roof surfaces is 25°. (Figure 16.6) The roof surfaces are not used for solar panels and if the roof position is ideal for that.

Impression The roof surfaces are broken into several parts, which is an additional cost for the construction of the roof structure.

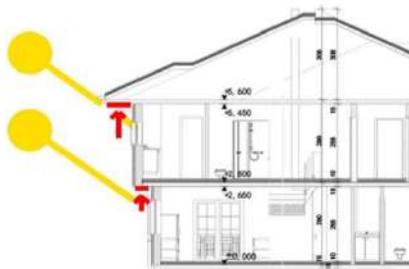
Figure 16.7 The influence of the sun rays on the house

As already mentioned, the highest concentration of sun and solar heat is reflected on the southeast facade, especially during the summer. As seen in the technical cross-sectional analysis (Figure 16.7) The roof surface crossed the walls, but not so much as to shield the openings

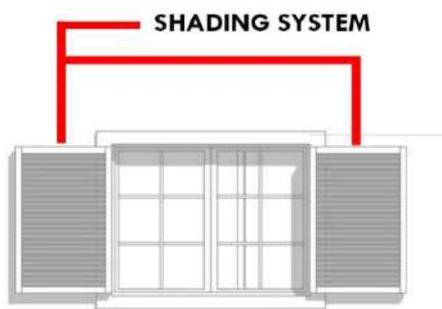
Figure 16.8 Method of the shading system

Let the roof surface over the walls, so much that it can cover the openings (windows) during the summer heat, and a larger overhang of the terraces in the south would protect the public space on the floors -1floor and ground floor.

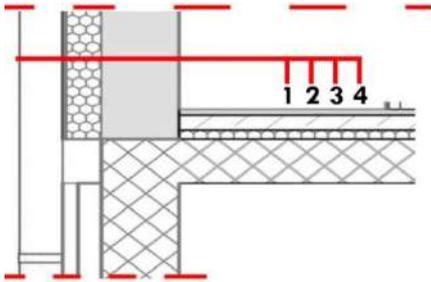
Figure 16.9 Cross section through the wall

Comparison of passive houses 1 and houses 1 in BiH with the area where the continental climate is represented has identified that a mistake is being made at the very beginning. Constructive walls are made of energy-inefficient materials.

Changing the material at the beginning of construction is a key solution.

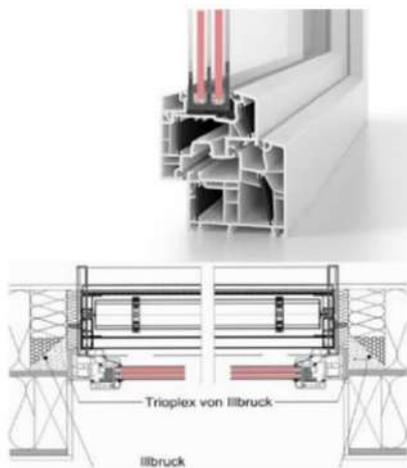
Figure 16.17 Section and picture of windows installed on a passive house

By analyzing the detailed cross-section (**Figure 16.17**) of the window that was installed in the passive house, the study concludes that it has triple glazing and that the coefficient U_g meets the

needs of passive houses. By replacing the windows on the house with 3 windows that have a better coefficient U_g and triple glazing, it would significantly increase energy efficiency.

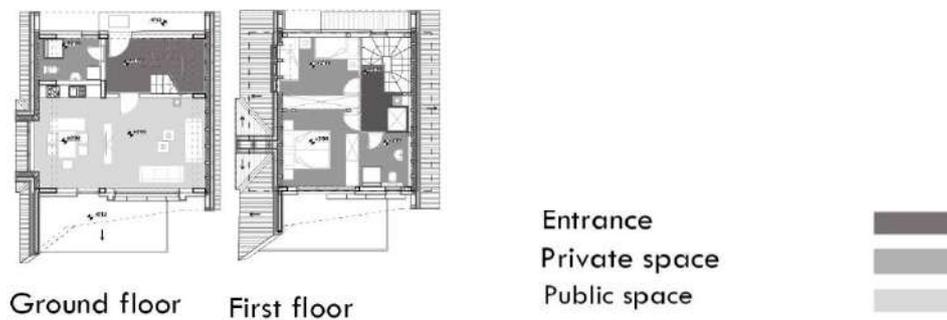
Figure 17.1 Floor plan of house

The area where house 2 in Bosnia and Herzegovina is located in mountainous where the alpine climate zone is represented (**Figure 17**). A more detailed analysis of the orientation and organization of space (**Figure 17.1**) by the analysis study concluded: On the ground floor, the entire south side is used for public space (kitchen, dining room, and living room), which is a great advantage, on the north is a bathroom and entrance to the house. On the first floor of the house, there are bedrooms with orientation north, west, and south, while on the east side there are communications and service rooms.

According to this analysis, it can be concluded that house 2 is oriented and the rooms are organized as is the case with passive houses. It must be emphasized that house 2 is not designed to be passive.

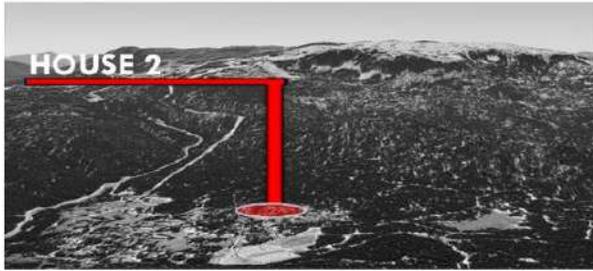
Figure 17.2 Graphical presentation of topography and position of the house 3 on the site.

As already mentioned in the analysis, the area is mountainous and according to the topographic analysis (**Figure 17.2**), it is evident that the terrain is hilly and uneven. A more detailed analysis of the technical cross-section of house 2 (**Figure 17.3**) concluded that it was necessary to dig deeper foundations and perform a cascade method of foundation construction. The study concludes that this method was used due to the larger unevenness and slope of the terrain starting from the east with the highest peak and altitude of about 1900 m to the west where the slope descends to about 1200 m above sea level.

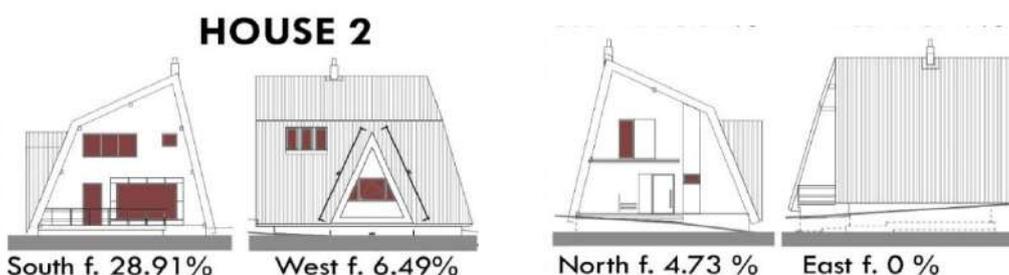
Figure 17.4 Percentage of the openings on facades

According to the analysis (**Figure 17.4**), it is clear that the south side has drastically the highest percentage of openings 28.91% because as already analyzed on that side are located public spaces such as the living room and part of the bedrooms on the first floor. After the south side is followed by the west side of 6.49% and on that side on the ground floor the openings are used for living room, while on the first floor there are bedrooms, and according to the mountain climate situation, the surface of the openings on that side is adequate.

North side 4.73%, the position of communication for house 2, and on the first floor there is one bedroom with an opening on that side. According to the strength of the winds from the north which can be seen in the picture (**Figure 17.5**), it's concluded that it is

an ideal area of openings. The eastern side has no openings, since the analysis of the topography of the study shows that the highest slope and the highest altitude is on the eastern side, it can therefore be concluded that the architects did not make openings on the eastern side.

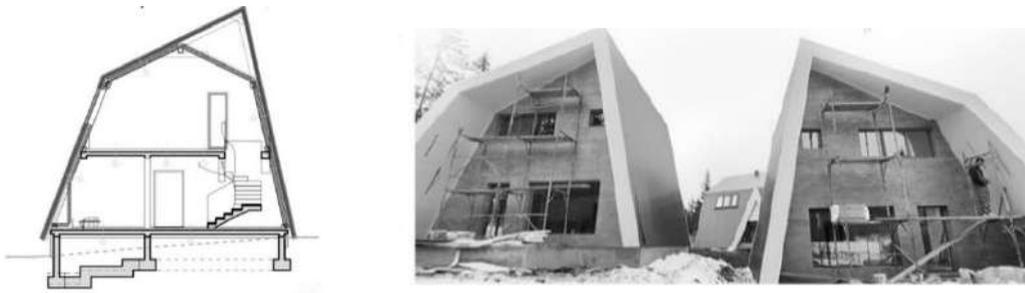
Figure 17.6 Cross section of the roof and picture of the roof

By analyzing the roofs from the case study from the areas of Europe where the alpine climate, the study concluded that there are no rules, that there is a possibility of a flat roof or other types of roofs. In BiH, this is not the case, most roofs are made with a sharp angle, in order to reduce additional insulation and avoid the retention of snow on the roof surface. In house 2, the A-Frame roof has been done, and the roof structure is lowered to the floor (**Figure 17.6**). The east and west sides of the roof surface are the walls of the house 2.

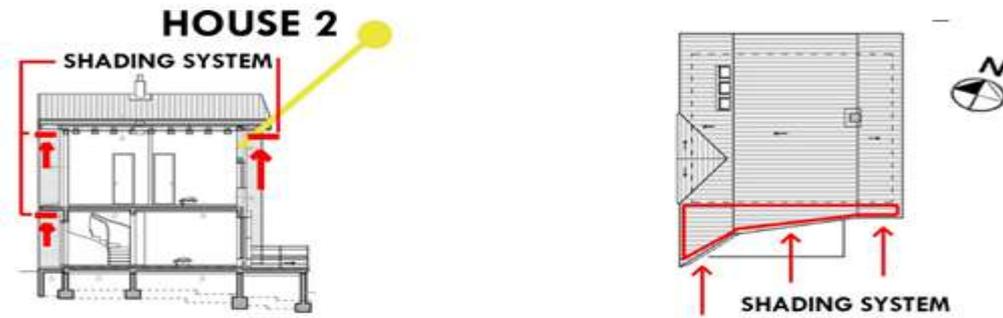
Figure 17.7 Method of the shading system

By analyzing the technical cross-section through the house as well as the plan of the roof structure (**Figure 17.7**), the study concludes that letting the roof structure over the walls in the analysis so far is an indicator that one of the most cheap and effective method. In the case of house 2 on the south side, the roof is unevenly overhanging and the overhang increases from the eastern part of the roof to the western.

Consistent with all analyzes, study introduced that this method is adequate sun protection during the summer period, and protects public spaces on the south side, which are most used by users.

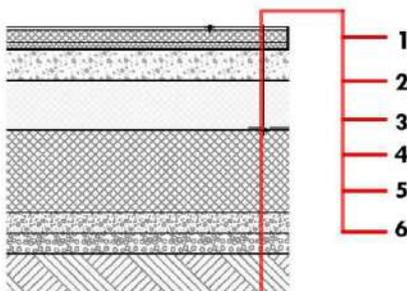
Figure 17.12 Cross section through the slab of the passive house from area where is alpine climate zone

In passive house (**Figure 17.12**), the thickness of the slab is 40 cm, while screed cement is 15 cm and ESP is 24 cm, which is an indicator that in the passive house the thickness of insulation materials is far thicker than house 2 in BiH.

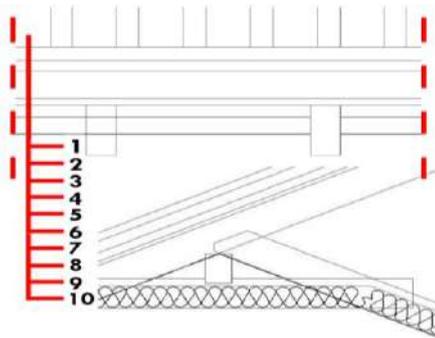
Figure 17.13 Cross section through the roof

By analyzing through the technical cross-section of the roof structure of house 2 (**Figure 17.13**) and comparing the roof structure of passive house (**Figure 17.14**), the study concluded a huge difference in the method of constructing and the type of the roof layers. House 2 in BiH has a traditional roof structure that together with all layers of thermal conductivity U-value of approximately from 1.5 to 2.5 W / m²K, which is a huge loss of thermal energy compared to passive house where U-value = 0.1 W/(m²K) far better result.

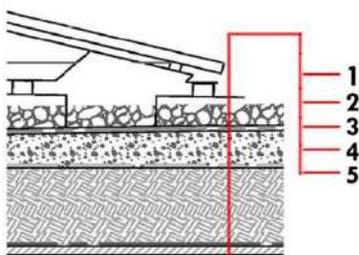
Figure 17.14 Cross section through the roof of the passive house from area where is alpine climate zone.

As we have already mentioned for floors, the situation is similar to the roof. A small number of layers of insulating materials. It is necessary to increase the number of layers of insulation materials that are energy-efficient, their thickness, and set according to the regulations of passive houses

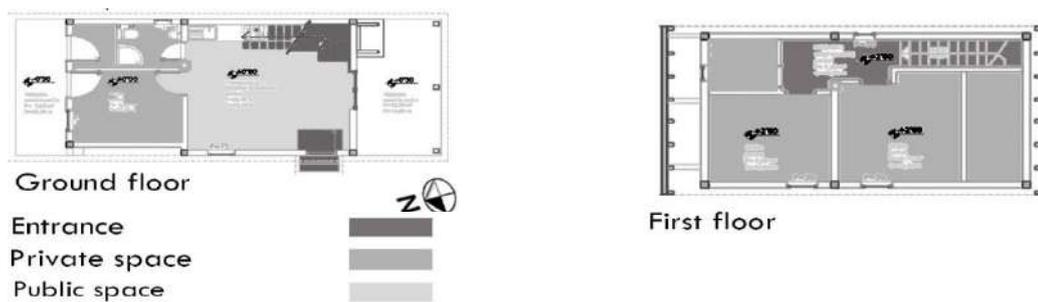
Figure 18.1 Floor plan of house

By analyzing the orientation of the house (**Figure 18.1**) as well as the organization of the rooms in it, the study found the following:

According to the analysis, the conclusion is that house 3 has a fairly good orientation and organization of spaces if compare with passive houses.

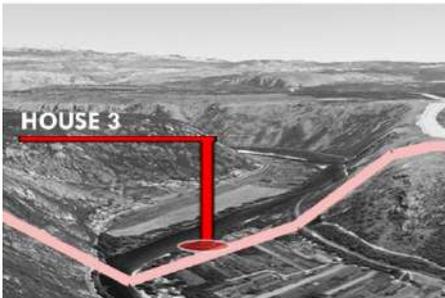
Figure 18.2 Graphical presentation of topography and position of the house 3 on the site.

The terrain where house 3 is is very specific which is concluded by a bird's eye view and a technical cross-section (Figures 18.2 and 18.3). The terrain looks like one huge canal leading from Mostar through the place where house 3 is to the sea. The height difference between the canal and the area above the canal is higher than 150 m.

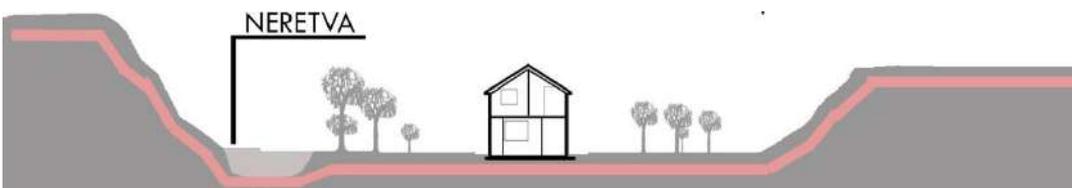
Figure 18.3 Graphical presentation of cross section through the house and the site where the house is located.

The river Neretva runs through this canal and as we have already mentioned, there are small villages and settlements along the entire canal. However, there are also inhabited places on the surface above the canal, ie on the edge of the riverbed.

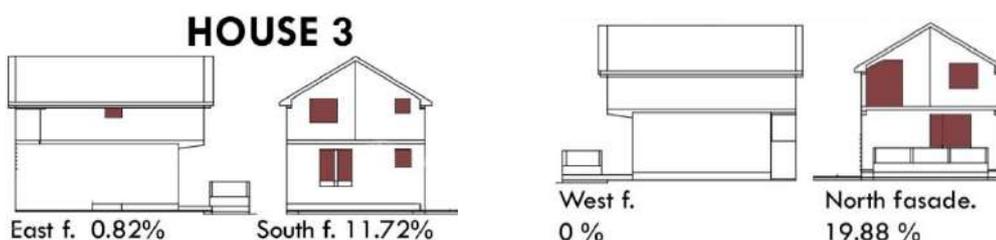
Figure 18.4 Percentage of the openings on facades

With the technical analysis of the facade (Figure 18.4), the study concludes the surface of the openings as well as their position concerning the space used. The northern façade has the highest percentage of openings, 19.88%, as already mentioned, there are private rooms on that side. The south façade has 11.72%, and on that side, there is public space on the ground floor while there are private rooms on the first floor. East side 0.82% and there is a service room (bathroom). On the west side, we have no openings.

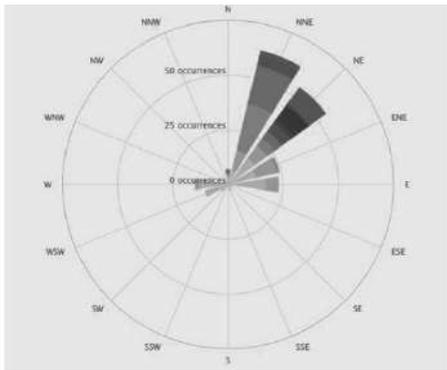
Figure 18.5 Wind rose for BIH-Čapljina

By comparing previous passive houses, as well as typical houses, usually, it is not a practice for the north side to have the highest percentage of openings. The factor that has a bad impact on the house is the wind, according to the analysis of winds (**Figure 18.5**) and the area of the openings on the north side, the study concludes that this is a disadvantage of house 3. Surfaces on the east and west sides are not used useful, also it is a disadvantage. According to a more detailed analysis, the south side does not have a sufficient surface area for a sufficient amount of natural light to enter the public space.

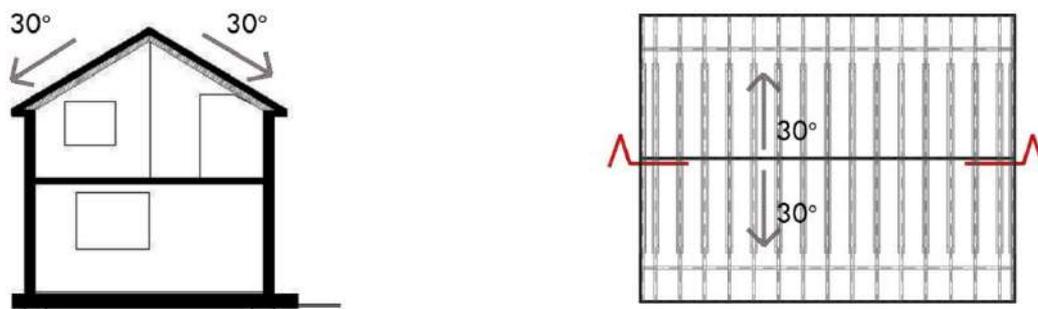
Figure 18.6 Cross section of the roof and roof plan

As already mentioned, that the house is located in the Mediterranean climate, accordingly, the architects envisioned a gabled roof.

The angle of the roof surfaces is 30°

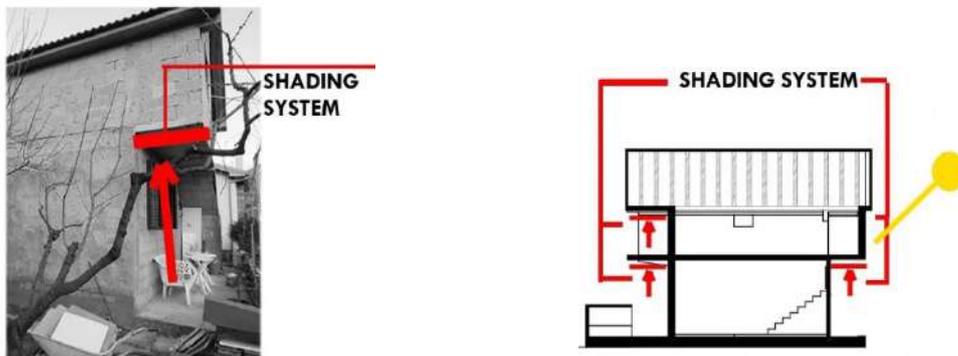
Figure 18.7 Method of the shading system

By a more detailed analysis through the technical cross-section (**Figure 18.7**) and the current state of house 3, the study shows the ways in which the house is protected from the sun's rays.

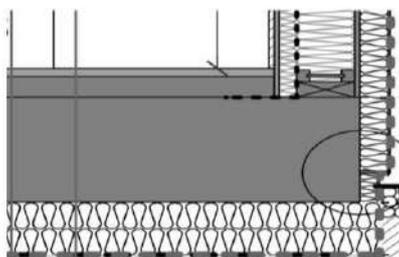
Figure 18.12 Cross section through the slab of the passive house from area where is alpine climate zone

In passive house (**Figure 18.12**), the thickness of the slab is 40 cm, while screed cement is 8 cm and XPS is 10 cm, which is an indicator that in the passive house the thickness of insulation materials is far thicker than house 3 in BiH.

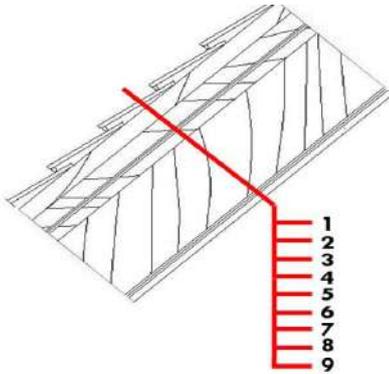
Figure 18.13 Cross section through the roof

Roof: 1. roof tiles 2. lath 3. lath 4. protective foil 5. roof sheathing 6. rafters 7. thermal insulation layers (wool) 8. aluminum holders 9. gypsum plasterboard.

By analyzing through the technical cross-section of the roof structure of house 3 (**Figure 18.13**) and comparing the roof structure of passive house (**Figure 18.14**), the study concluded a huge difference in the method of constructing and the type of the roof layers. House 3 in BiH has a traditional roof structure that together with all layers of thermal conductivity U-value of approximately $2.5 \text{ W / m}^2\text{K}$, which is a huge loss of thermal energy compared to passive house where $U\text{-value} = 0.122 \text{ W}/(\text{m}^2\text{K})$ far better result.
