# Prosthetic Rescue of Fractured Abutments Under an Existing Fixed Partial Denture: A Conservative Clinical Approach

**Abstract :** Fractures of abutment teeth under fixed prostheses pose a major prosthetic challenge, particularly when full reconstruction is contraindicated or refused by the patient. This paper shows a clinical case study of the fabrication and adaptation of two metallic inlaycores on teeth 21 and 12, designed to support a pre-existing anterior metal ceramic bridge. Thanks to a precise impression of the intaglio surface of the prosthesis and rigorous laboratory fitting, it was possible to reconstruct the endodontically treated abutments without removing or replacing the bridge. This conservative approach demonstrates the importance of conservative management solutions for prosthetic complications that may occur while or after achieving the prosthetic treatment, ensuring long-lasting functional and esthetic restoration.

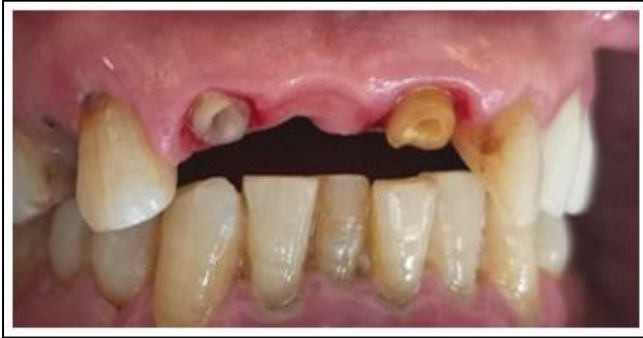
A 50-year-old patient, with no notable medical history, consulted our department with partial loosening of an anterior metal ceramic three-unit FPD replacing the tooth 11, performed 6 months ago. The patient reports discomfort on chewing and mobility of the bridge, with no associated pain. Clinical and radiological examination revealed a fracture of the fiber posts and resin build ups on the abutment teeth 12 and 21.

Fig 1 Intra-Oral View after Removal of the Fractured Fiber Post and Resin Build up

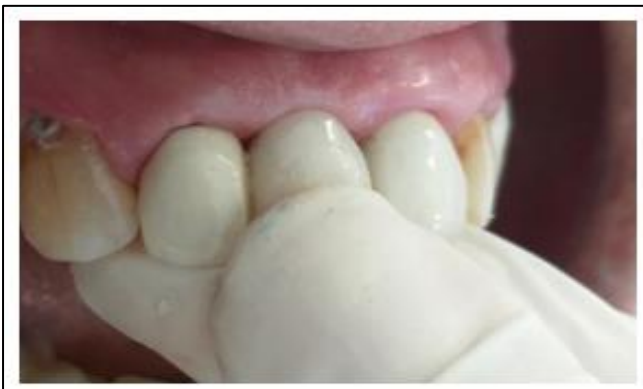
Fig 2 The FPD Try-in after Removal of the Fractured Fiber Post and Resin Build up

The bridge was gently removed to avoid any deformation or fracture of the metal framework or ceramic. Once removed, the intaglio surface of the prosthesis was cleaned with alcohol and then gently sandblasted with alumina oxide to remove cement residues and improve future adhesion. Then, a meticulous removal of the remaining fiber posts and rest cores was proceeded. Finally, a try in of the FPD was performed to make sure the bridge is well adapted to the residual structures of the abutment teeth.

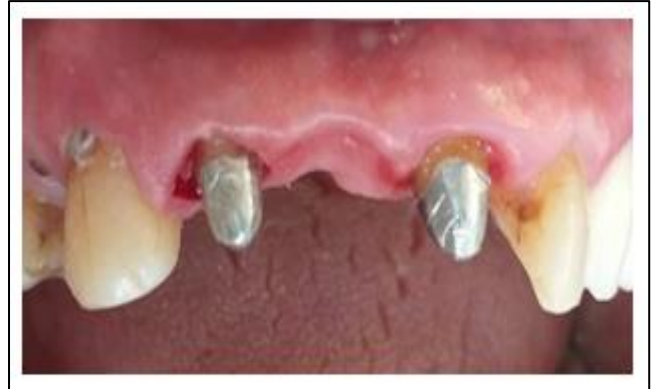
Fig 3 The Metallic Post and Cores Cemented on the Abutment Teeth

The direct technique was selected for optimal adaptation to the bridge intaglio surface. First, a good isolation of the abutment teeth was performed, the plastic post was fit in the flared canal. A thin layer of petroleum jelly was applied in the root canal and the pulp chamber of the teeth abutments. An autopolymerizing acrylic resin material (Duralay) was used to rebase the plastic post and to build up the missing coronal structure. The inner surface of the bridge was lubricated and the prosthesis was immediately placed on the direct resin post and core to ensure the fit. Once the resin has polymerized, the bridge was carefully removed. The two perfectly shaped calcinable abutments are then removed and sent to the laboratory.

The post and core pattern is then casted in non-precious alloy (Ni-Cr). Individual and combined mouth fitting of both inlay-cores was proceeded. Simultaneous control of passive

bridge insertion on the abutments was also performed, and minor adjustments were made with carbide bur. A radiographic verification of the post adjustment in the flared canal was conducted.

The inlay-cores were permanently cemented with a reinforced glass ionomer cement offering good adhesion to dentin and metal. Once fully set, the bridge was repositioned using glass ionomer cement. Excess cement was removed, and the occlusion was checked and balanced.

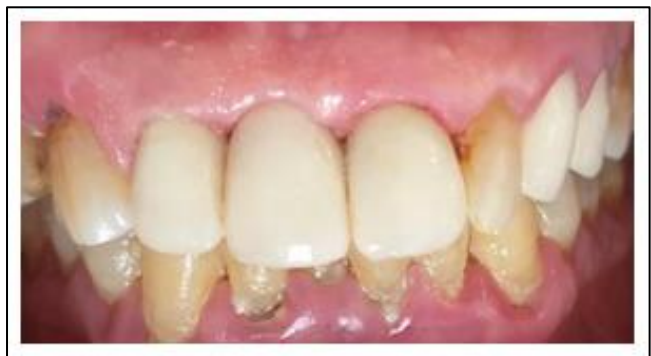
Fig 4 Cementation of the Metal Ceramic Bridge

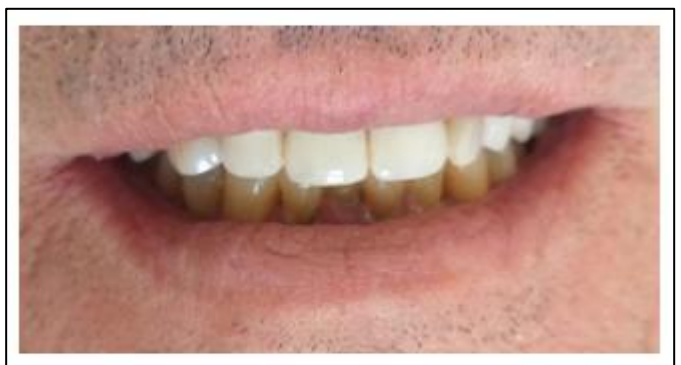
Fig 5 Final Result
